Battle Creek Public Schools Ann J. Kellogg School

306 Champion
Battle Creek, MI 49037

Tremco CPG

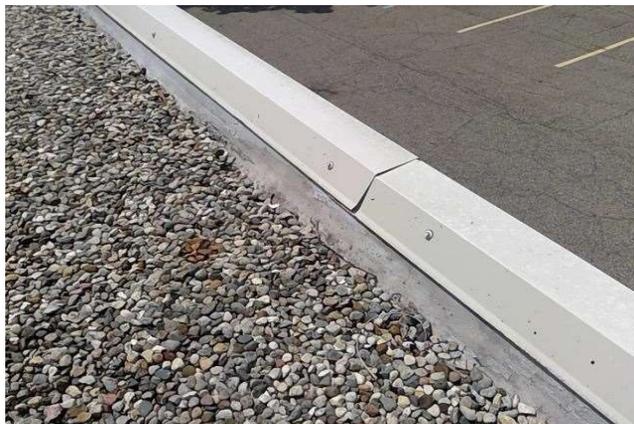
Weathered coating.

Work Beyond Scope of Maintenance Agreement (Customer Responsibility)			
Task	Year	Project \$	Task Description
Repairs Required, Minor	2020		Replace damaged perimeter metal.
Repairs Required, Minor	2020		Recommend applying aluminum coating to perimeter membrane flashings.
Tree Work	2020		Recommend trimming back the tree limbs that overhang the roof surface.

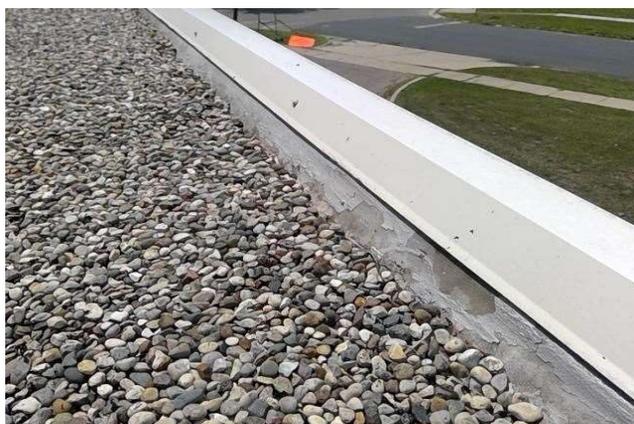
Weathered coating.

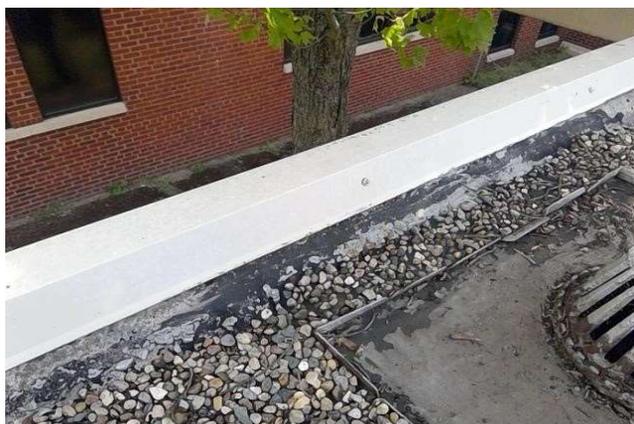
Weathered coating.

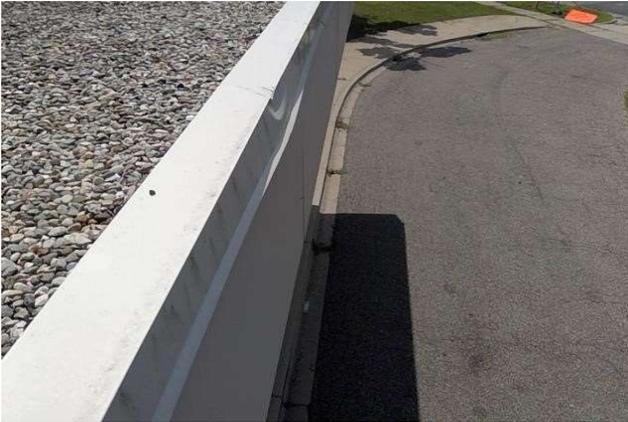
Damaged coping metal.

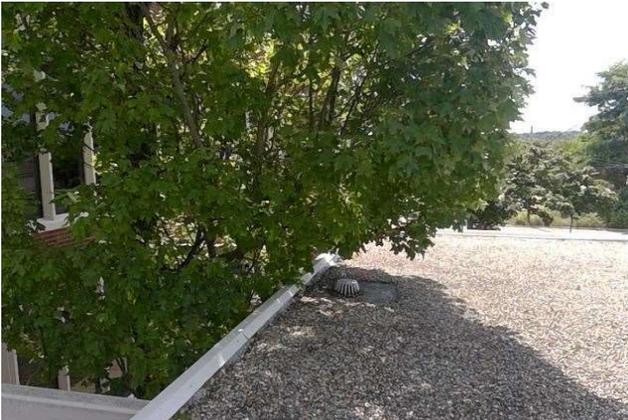
Overgrown tree limbs.

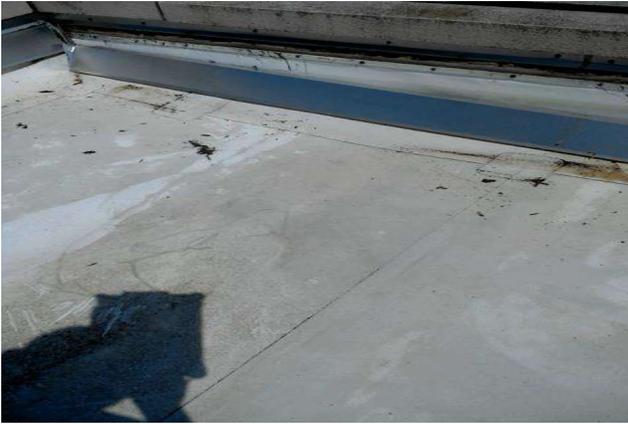
Missing counterflashing.

Work Beyond Scope of Maintenance Agreement (Customer Responsibility)			
Task	Year	Project \$	Task Description
Repairs Required, Minor	2023		Recommend reattaching missing counterflashing.

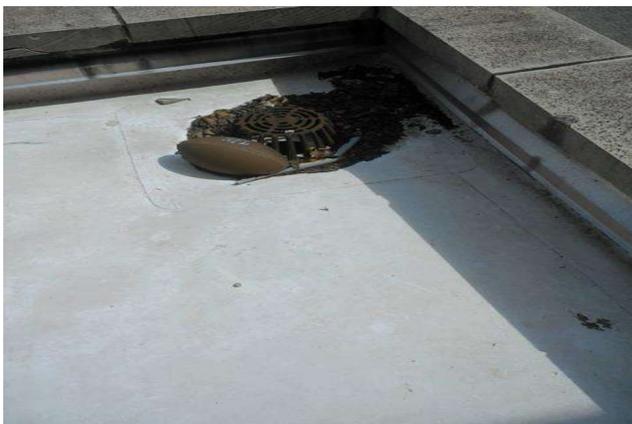
Debris.

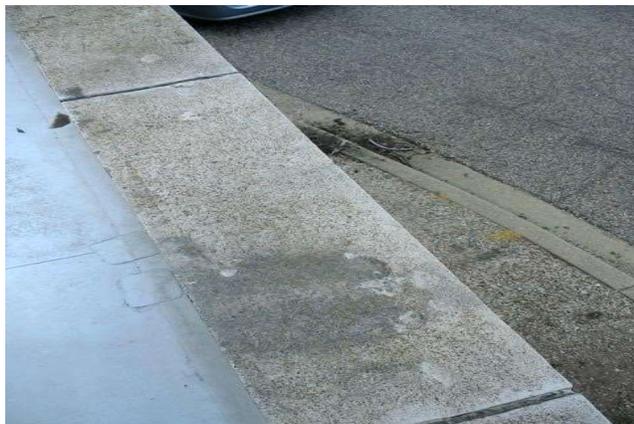
Unprotected edge.

Work Beyond Scope of Maintenance Agreement (Customer Responsibility)			
Task	Year	Project \$	Task Description
Perimeter Fall Protection	2023		Recommend rooftop safety assessment.

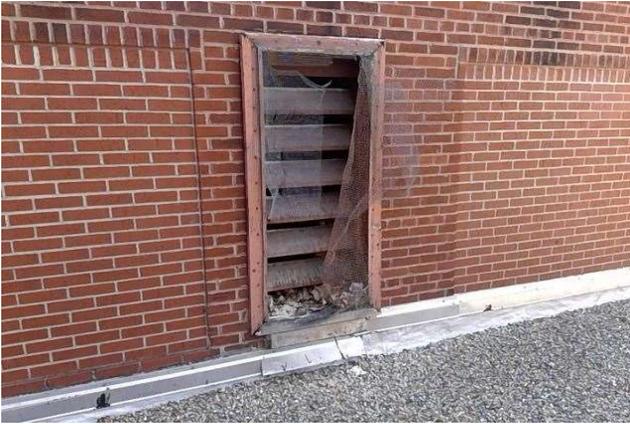
Damaged screen at louver.

Work Beyond Scope of Maintenance Agreement (Customer Responsibility)			
Task	Year	Project \$	Task Description
Repairs Required, Minor	2020		Recommend repairing damaged screen at louver.

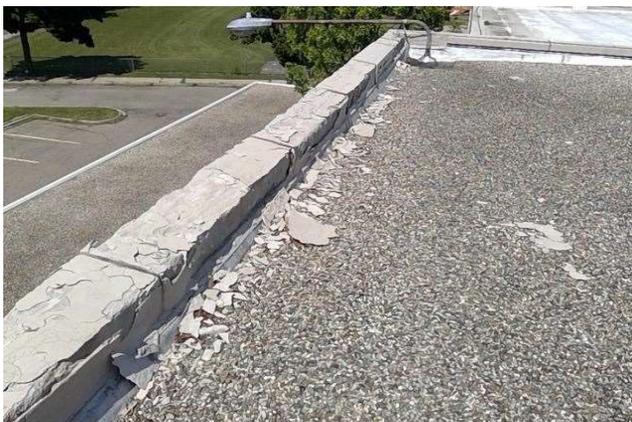
Spalling concrete coping.

Work Beyond Scope of Maintenance Agreement (Customer Responsibility)			
Task	Year	Project \$	Task Description
Repairs Required, Minor	2020		Recommend installing metal coping over deteriorated coping.
Repairs Required, Minor	2020		Recommend applying aluminum coating to areas of weathered flashing.
Repairs Required, Minor	2020		Recommend installing Kynar coated steel coping over deteriorating concrete.

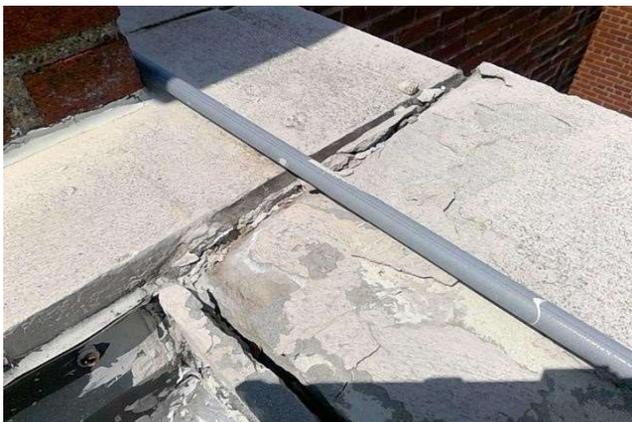
Spalling concrete coping and deteriorated sealant at joint.

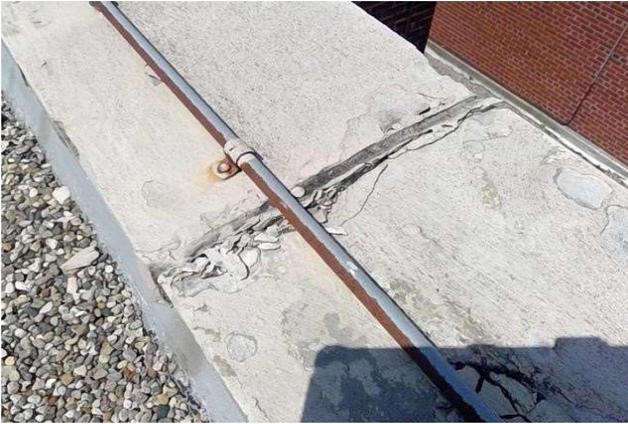
Spalling concrete coping and deteriorated sealant at joint.

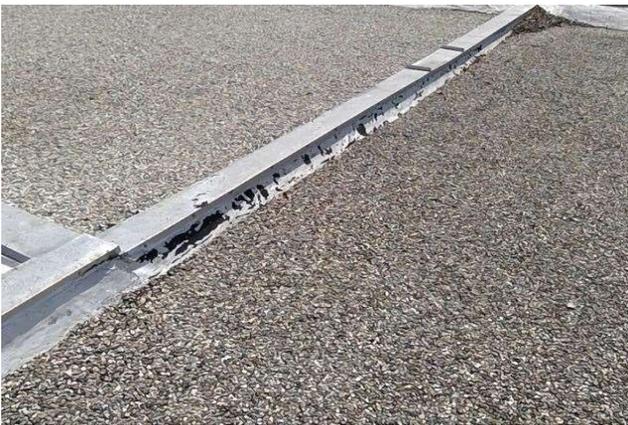
Weathered flashing membrane.

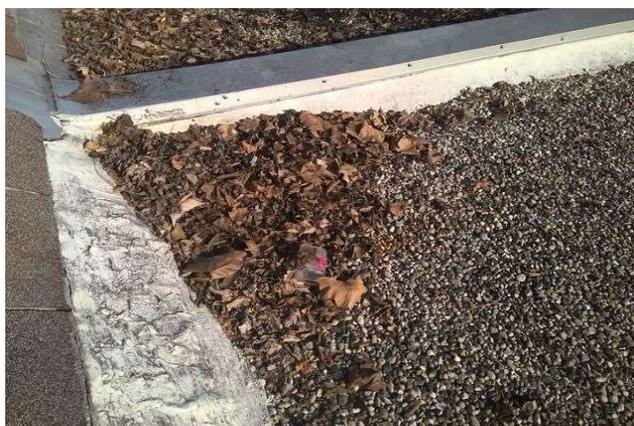
Debris on roof.

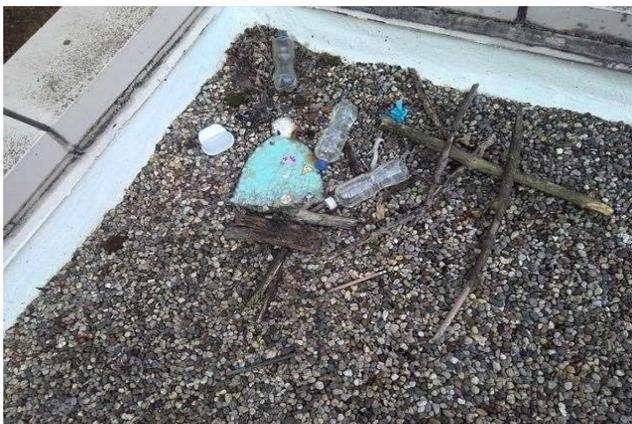
Debris on roof.

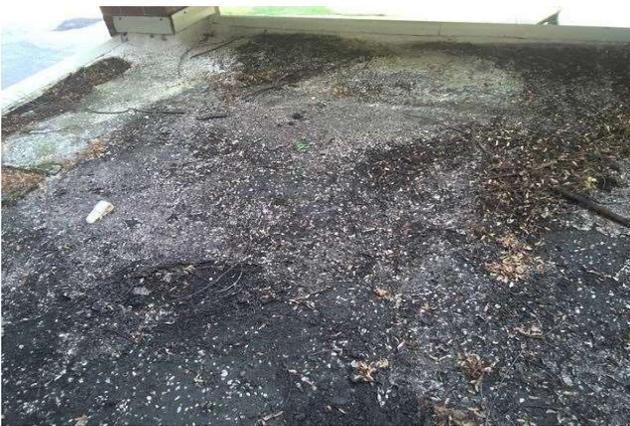
Debris on roof.
