**ASBESTOS SURVEY
REPORT FOR**

(Former) Southwestern Junior High School
390 S. Washington Avenue
Battle Creek, Michigan 49037

September 15, 16, 17, 18, 19, 23, 25 & 29, 2025
October 3 & 14, 2025
November 14, 24, 2025
December 23, 2025

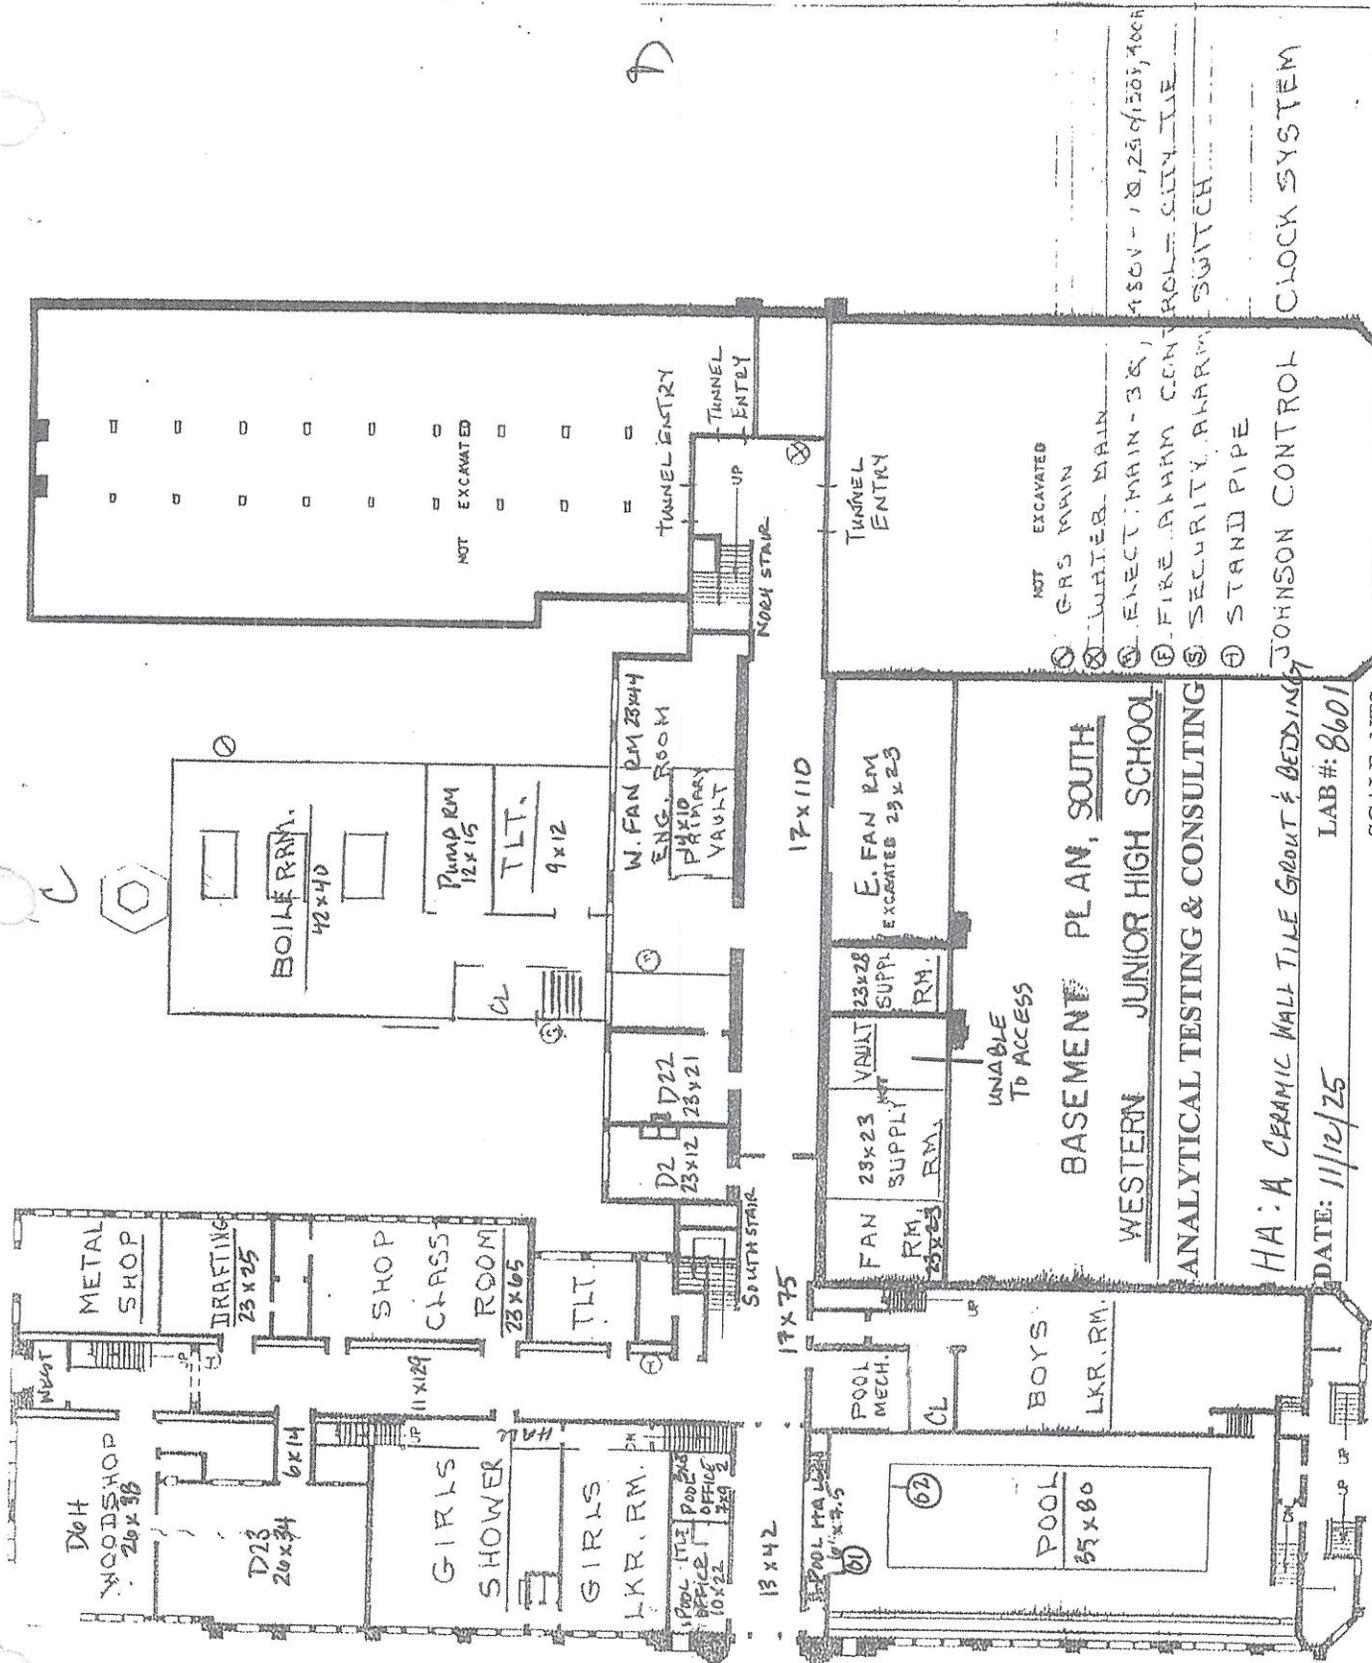
BASEMENT PLAN, SOUTH
 WESTERN JUNIOR HIGH SCHOOL
 ANALYTICAL TESTING & CONSULTING

HA LOCATION	Type SM/TSI/MM	Friability F/NF	Physical Condition	Size SF/LF/MF
Pool hall and stairwell	MM	NF	7	~600 SF
Pool walls and knee	MM	NF	7	~2,240 SF
TOTAL				~2,840 SF

Location	Recommendations
HA-A	Non Asbestos

HA: A CERAMIC WALL TILE Grout & Bedding
 DATE: 11/12/25
 LAB #: 8601
 SCALE: NTS

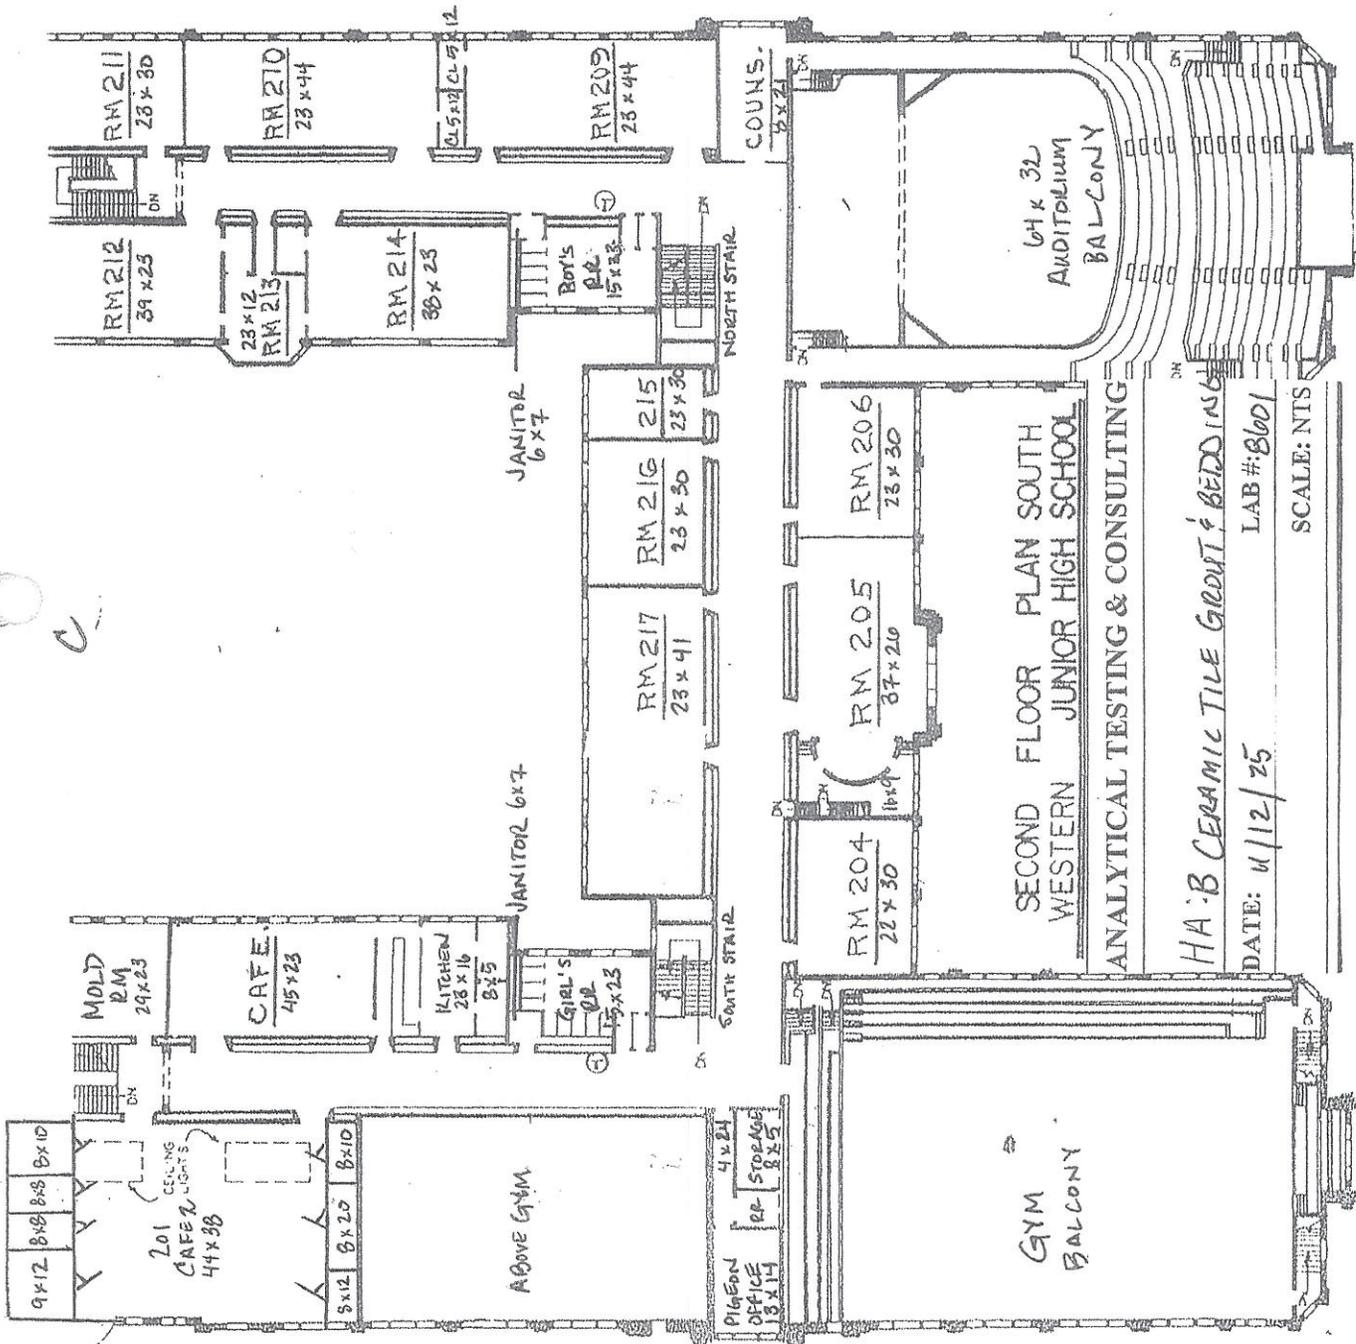
SECOND FLOOR PLAN SOUTH
 WESTERN JUNIOR HIGH SCHOOL
 ANALYTICAL TESTING & CONSULTING
 H.A. B. CERAMIC TILE GROUT & BEDDING
 LAB # 8001
 DATE: 4/12/25
 SCALE: NTS

HA LOCATION	Type SM/TSI/MM	Friability F/NF	Physical Condition	Size SF/LF/MF
Pool Hall	MM	NF	7	~45 SF
Pool	MM	NF	7	~2,250 SF
Toilet in pool office 1	MM	NF	7	~20 SF
Entry – near office and library	MM	NF	7	~192 SF
Teacher’s lounge	MM	NF	7	~32 SF
Pigeon office toilet	MM	NF	7	~40 SF
Side A entry to Auditorium	MM	NF	7	~264 SF
1 st and 2 nd floor Boy’s restroom	MM	NF	7	~100 SF
1 st and 2 nd floor Girl’s restroom	MM	NF	7	~100 SF
Lower level classroom hallway walls	MM	NF	7	~1,600 SF
TOTAL				~4,643 SF

Location	Recommendations
HA-B	Non Asbestos

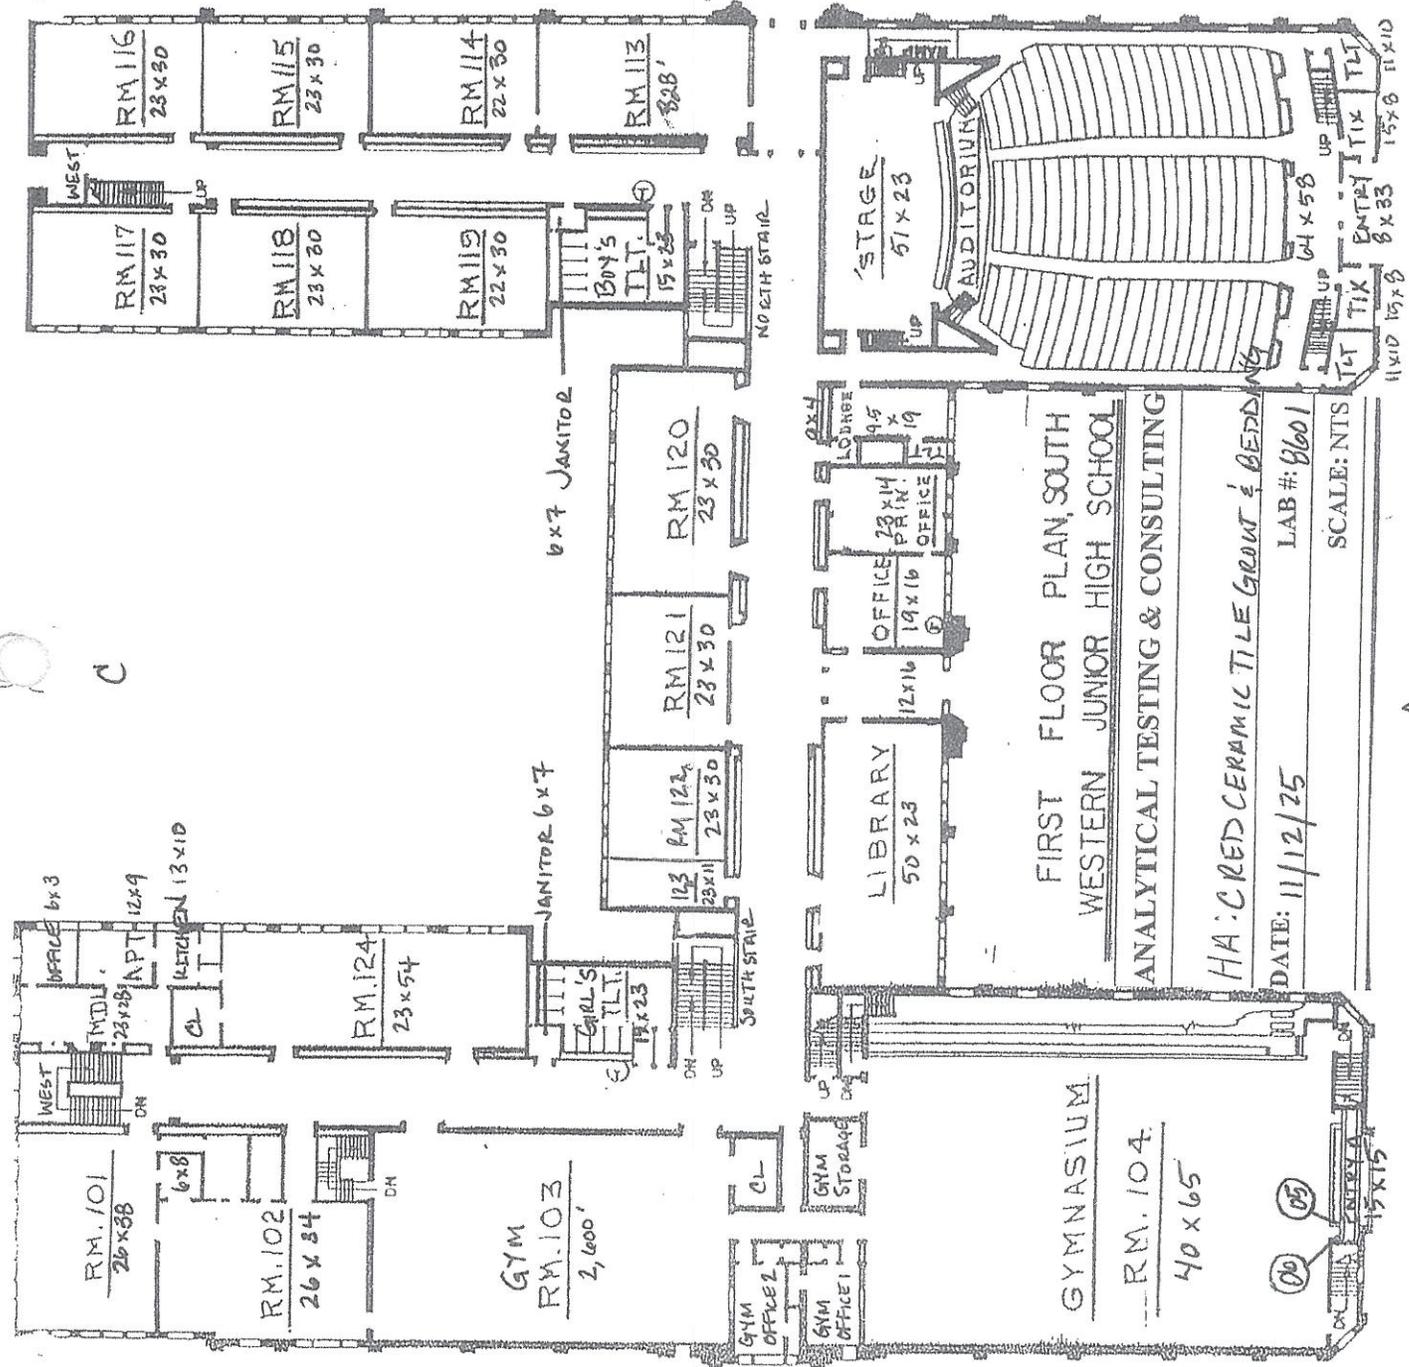
FIRST FLOOR PLAN, SOUTH
WESTERN JUNIOR HIGH SCHOOL
ANALYTICAL TESTING & CONSULTING

HA LOCATION	Type SM/TSI/MM	Friability F/NF	Physical Condition	Size SF/LF/MF
Gym entry A lower level	MM	NF	7	~225 SF
Gym entry A hall Side B	MM	NF	7	~64 SF
Gym entry A hall Side D	MM	NF	7	~64 SF
Gym entry A upper level	MM	NF	7	~240 SF
TOTAL				~593 SF

Location	Recommendations
HA-C	Non Asbestos

HA: CRED CERAMIC TILE GROUT & BEDDING
LAB #: 8601
SCALE: NTS
DATE: 11/12/25

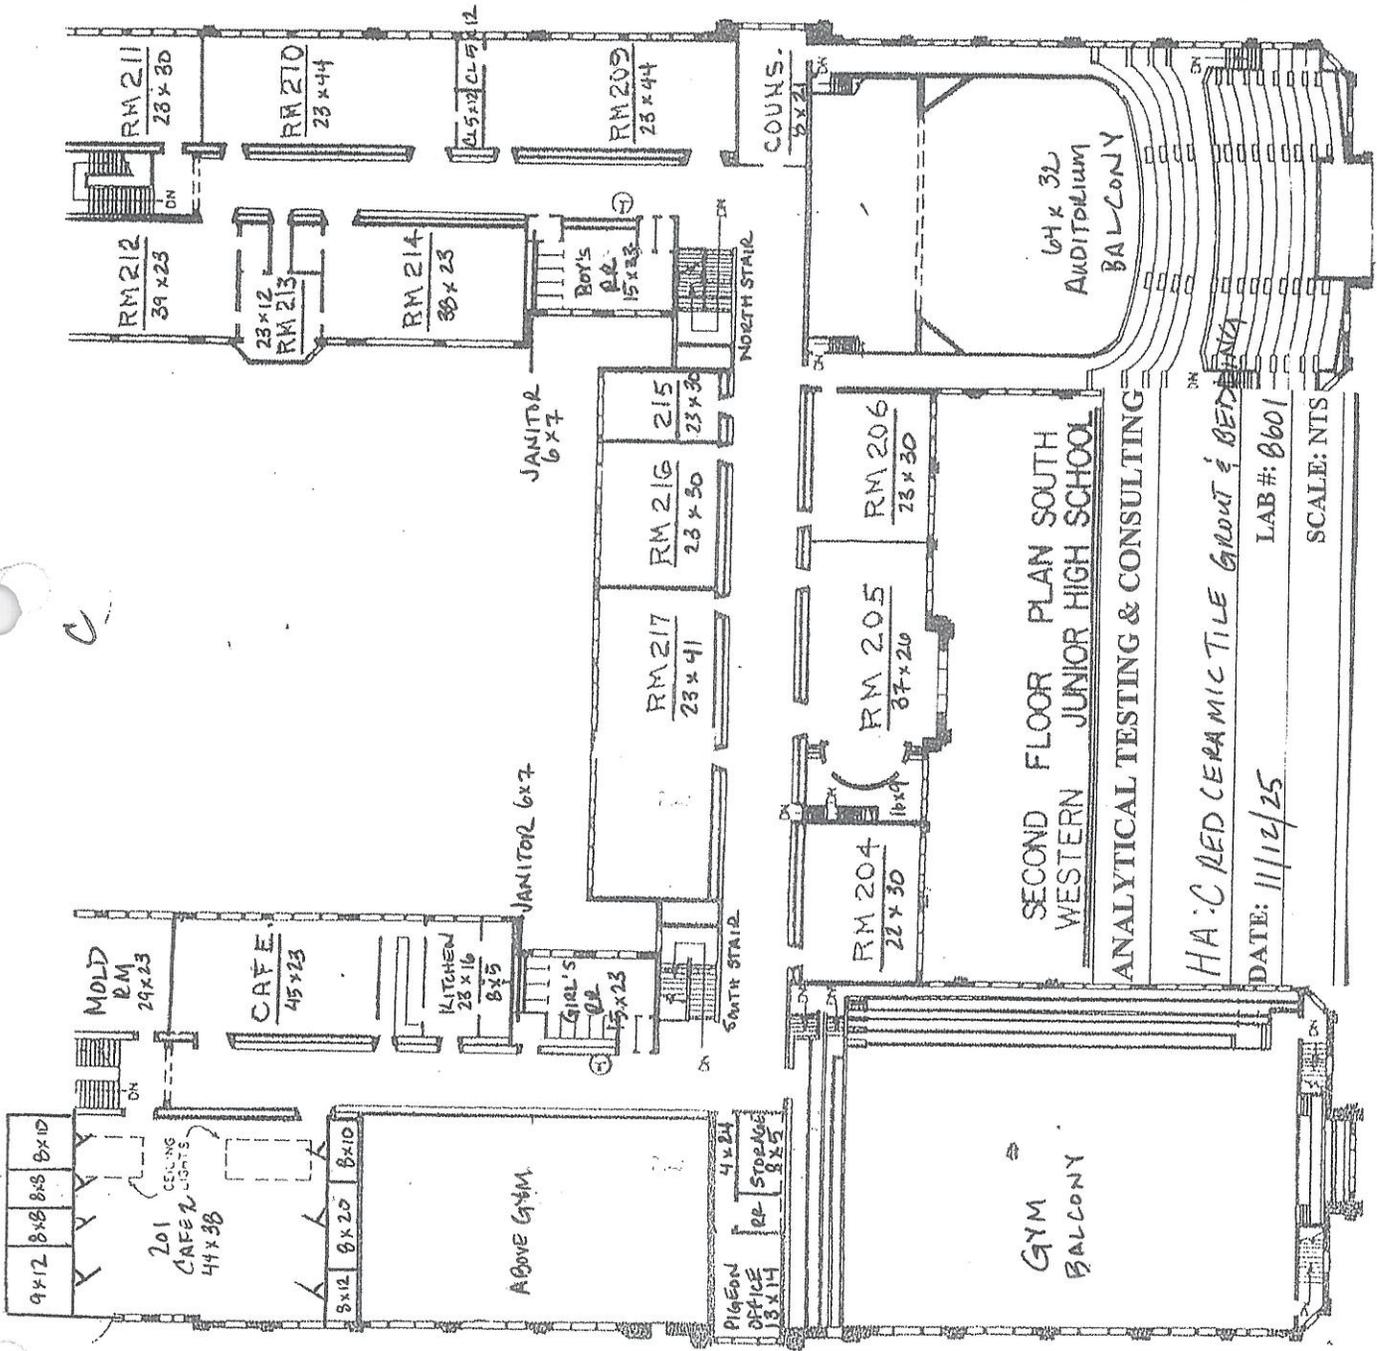
SECOND FLOOR PLAN SOUTH
WESTERN JUNIOR HIGH SCHOOL

HA: C RED CERAMIC TILE GILLOUT & BEDDING

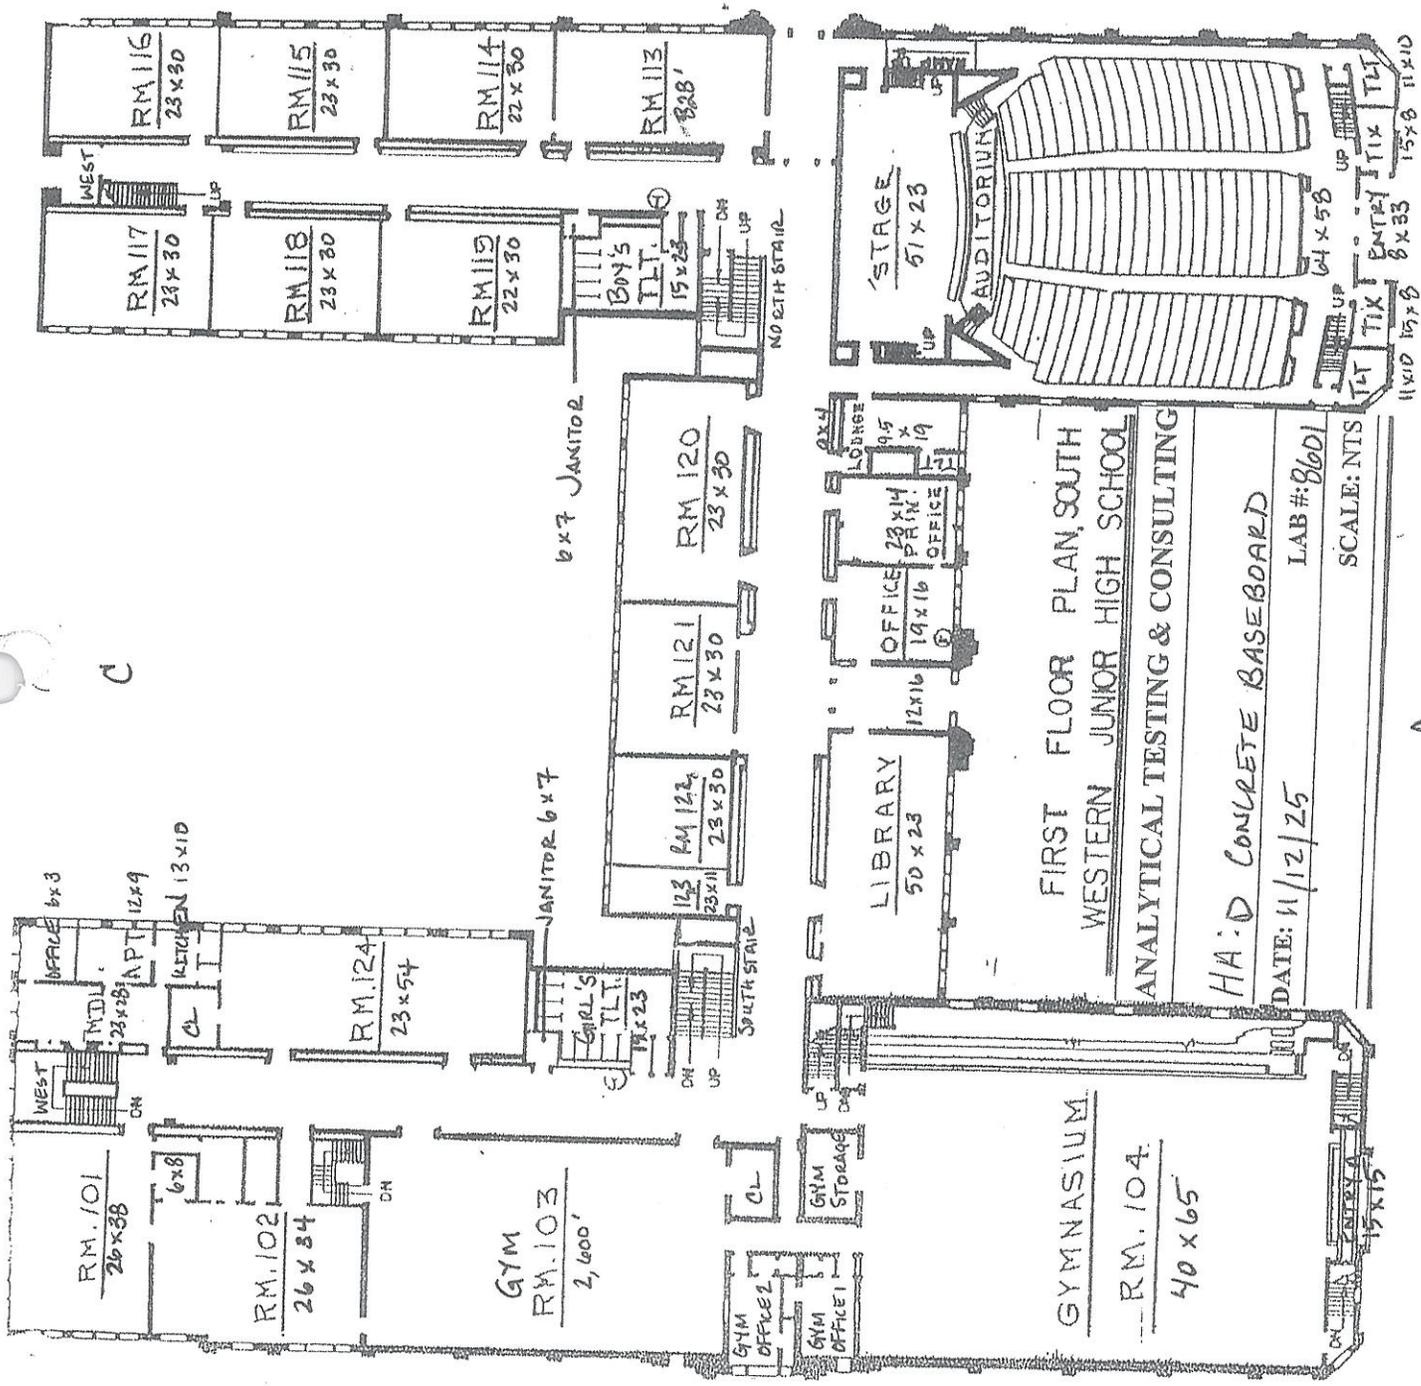
FIRST FLOOR PLAN, SOUTH
WESTERN JUNIOR HIGH SCHOOL
ANALYTICAL TESTING & CONSULTING

HA LOCATION	Type SM/TSI/MM	Friability F/NF	Physical Condition	Size SF/LF/MF
Gym entry A lower level	MM	NF	7	~40 LF
Gym Hall B in Entry A	MM	NF	7	~40 LF
Gym Hall D in Entry A	MM	NF	7	~40 LF
Main Entry	MM	NF	7	~40 LF
Auditorium Entry	MM	NF	7	~40 LF
TOTAL				~160 LF / ~67 SF

Location	Recommendations
HA-D	Non Asbestos

HA: D CONCRETE BASEBOARD
LAB #: 8601
SCALE: NTS
DATE: 11/12/25

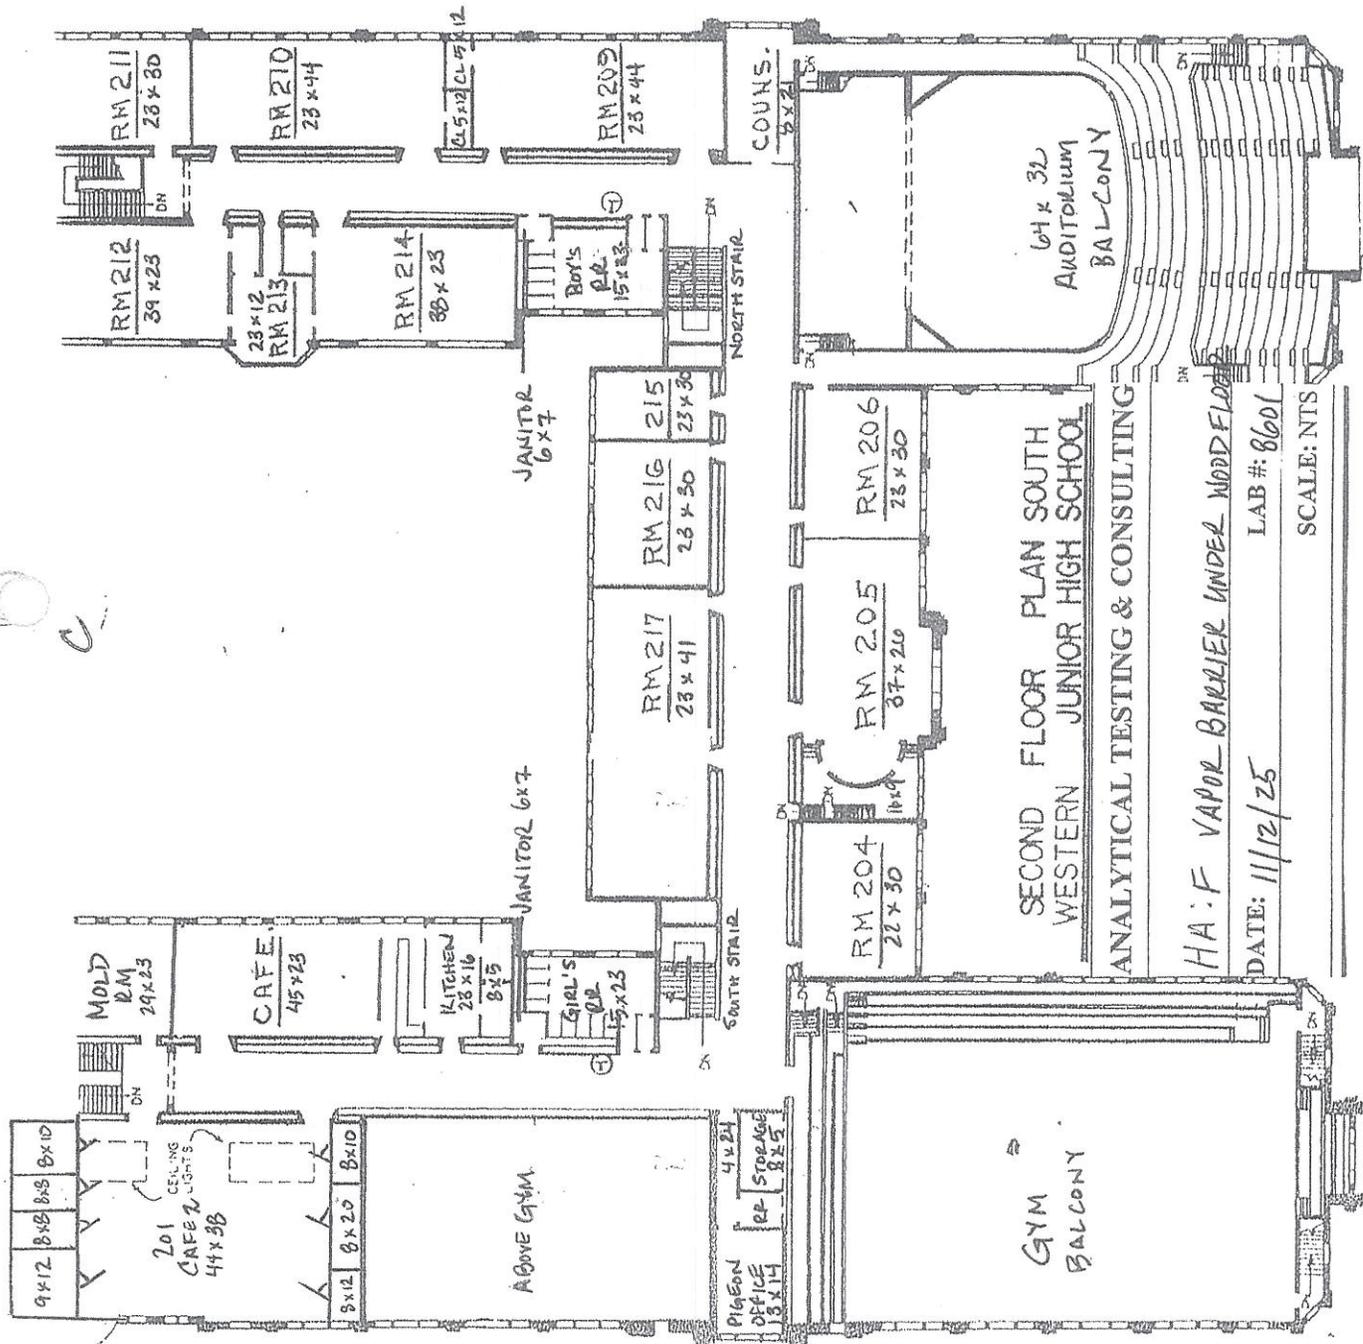
SECOND FLOOR PLAN SOUTH
 WESTERN JUNIOR HIGH SCHOOL
 ANALYTICAL TESTING & CONSULTING

HA: F VAPOR BARRIER UNDER WOOD FLOOR
 DATE: 11/12/25
 LAB #: 8601
 SCALE: NTS

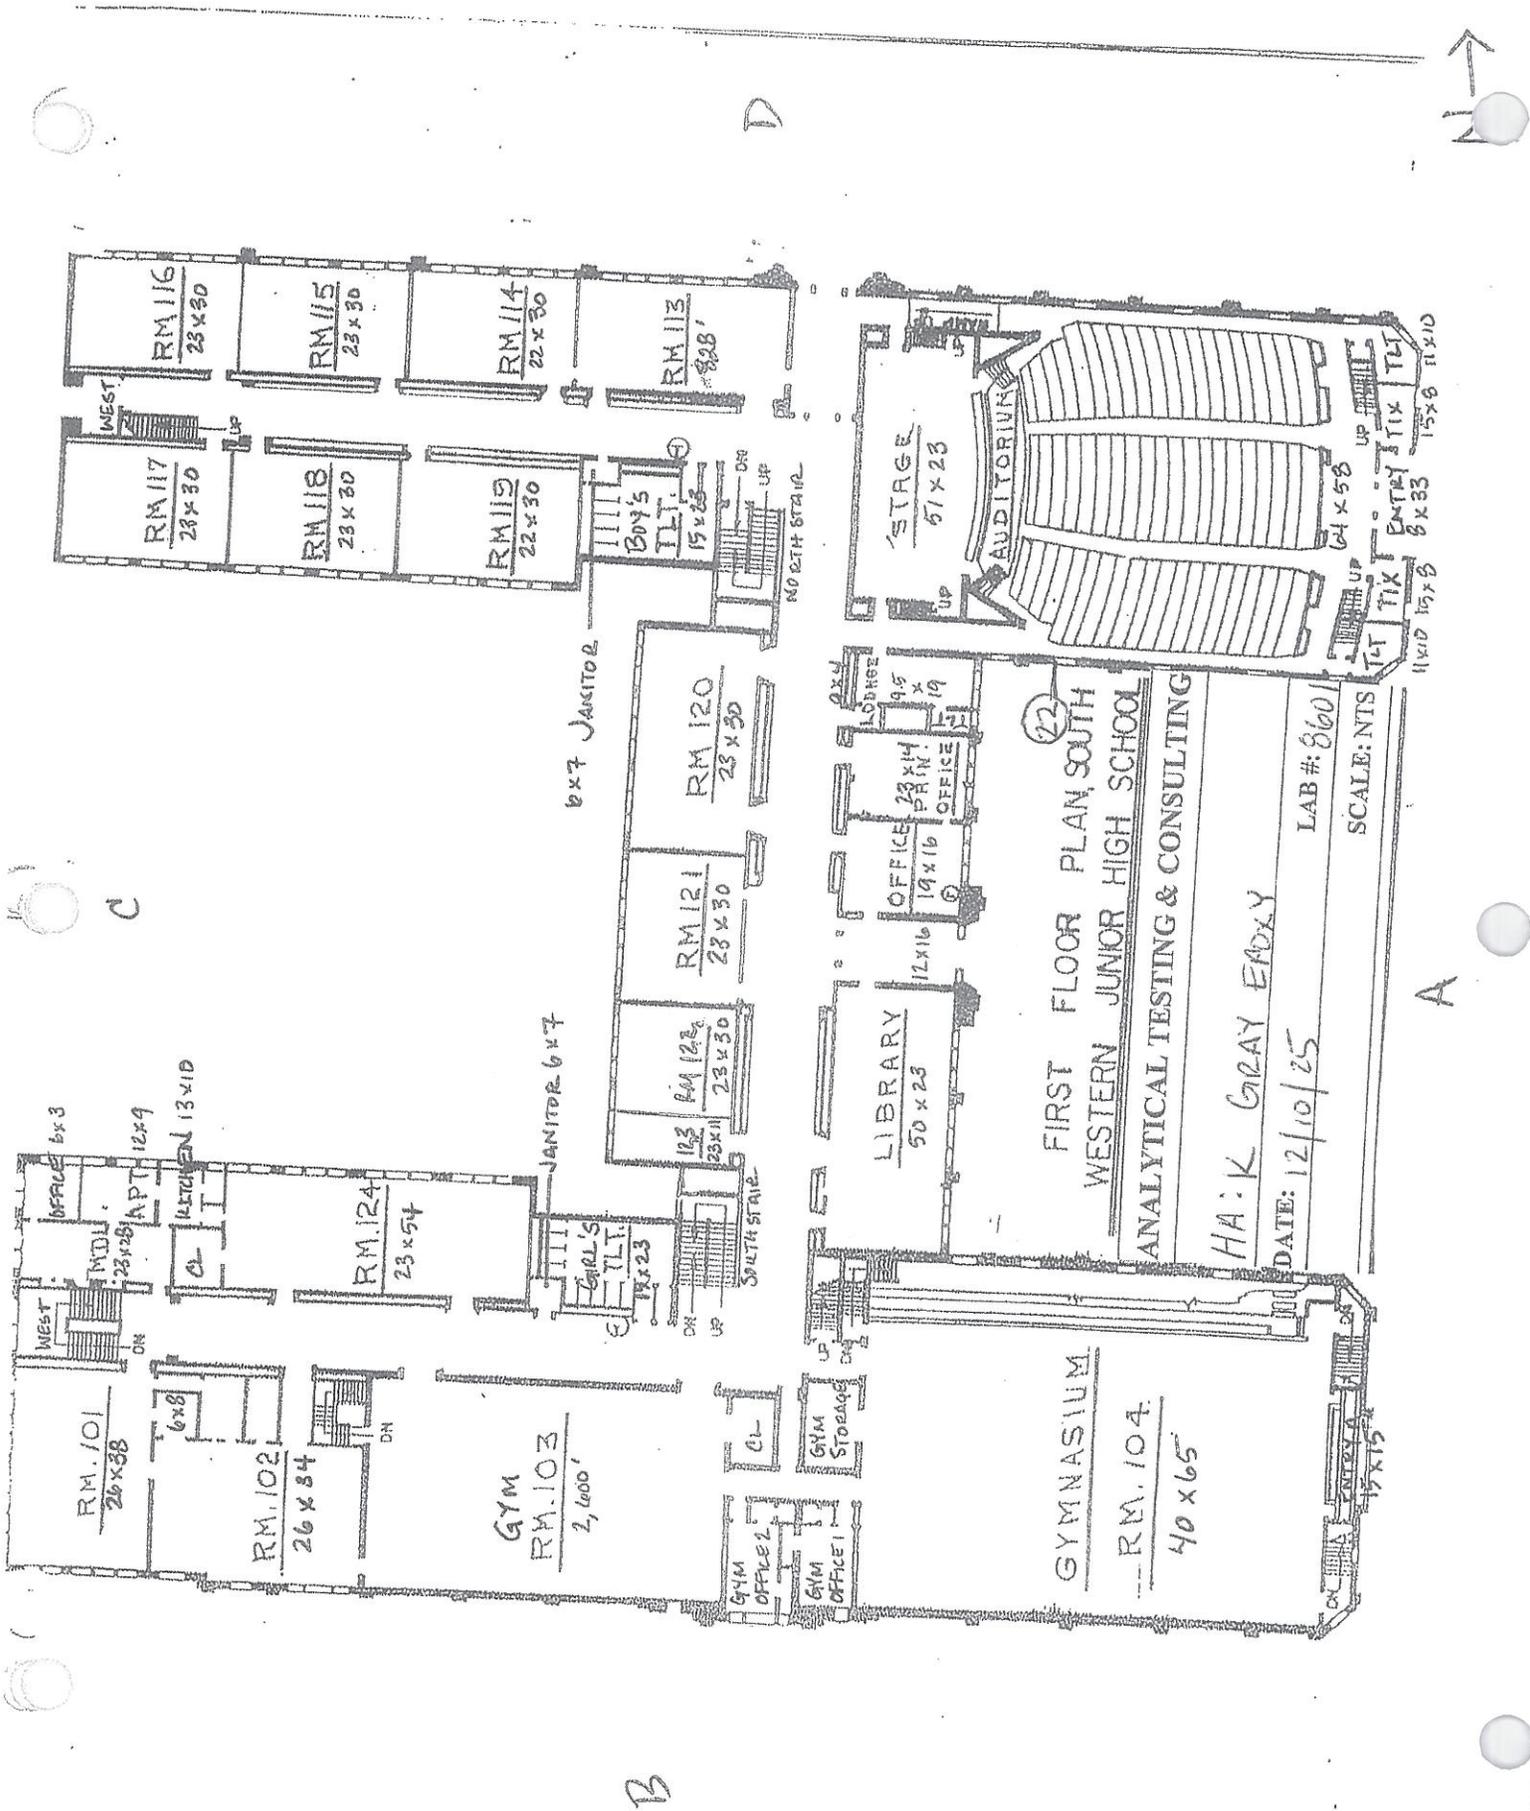
22
 FIRST FLOOR PLAN SOUTH
 WESTERN JUNIOR HIGH SCHOOL
 ANALYTICAL TESTING & CONSULTING

HA LOCATION	Type SM/TSI/MM	Friability F/NF	Physical Condition	Size SF/LF/MF
Used for repair around window casings and door casings *Also, on some window sills – between sections of limestone Boiler roof – used as a repair on seams between limestone sections (roof cap)	MM	NF	7	~1,000 LF / ~42 SF
TOTAL				~1,000 LF / ~42 SF

Location	Recommendations
HA-K	Non Asbestos

HA: K GRAY EADY

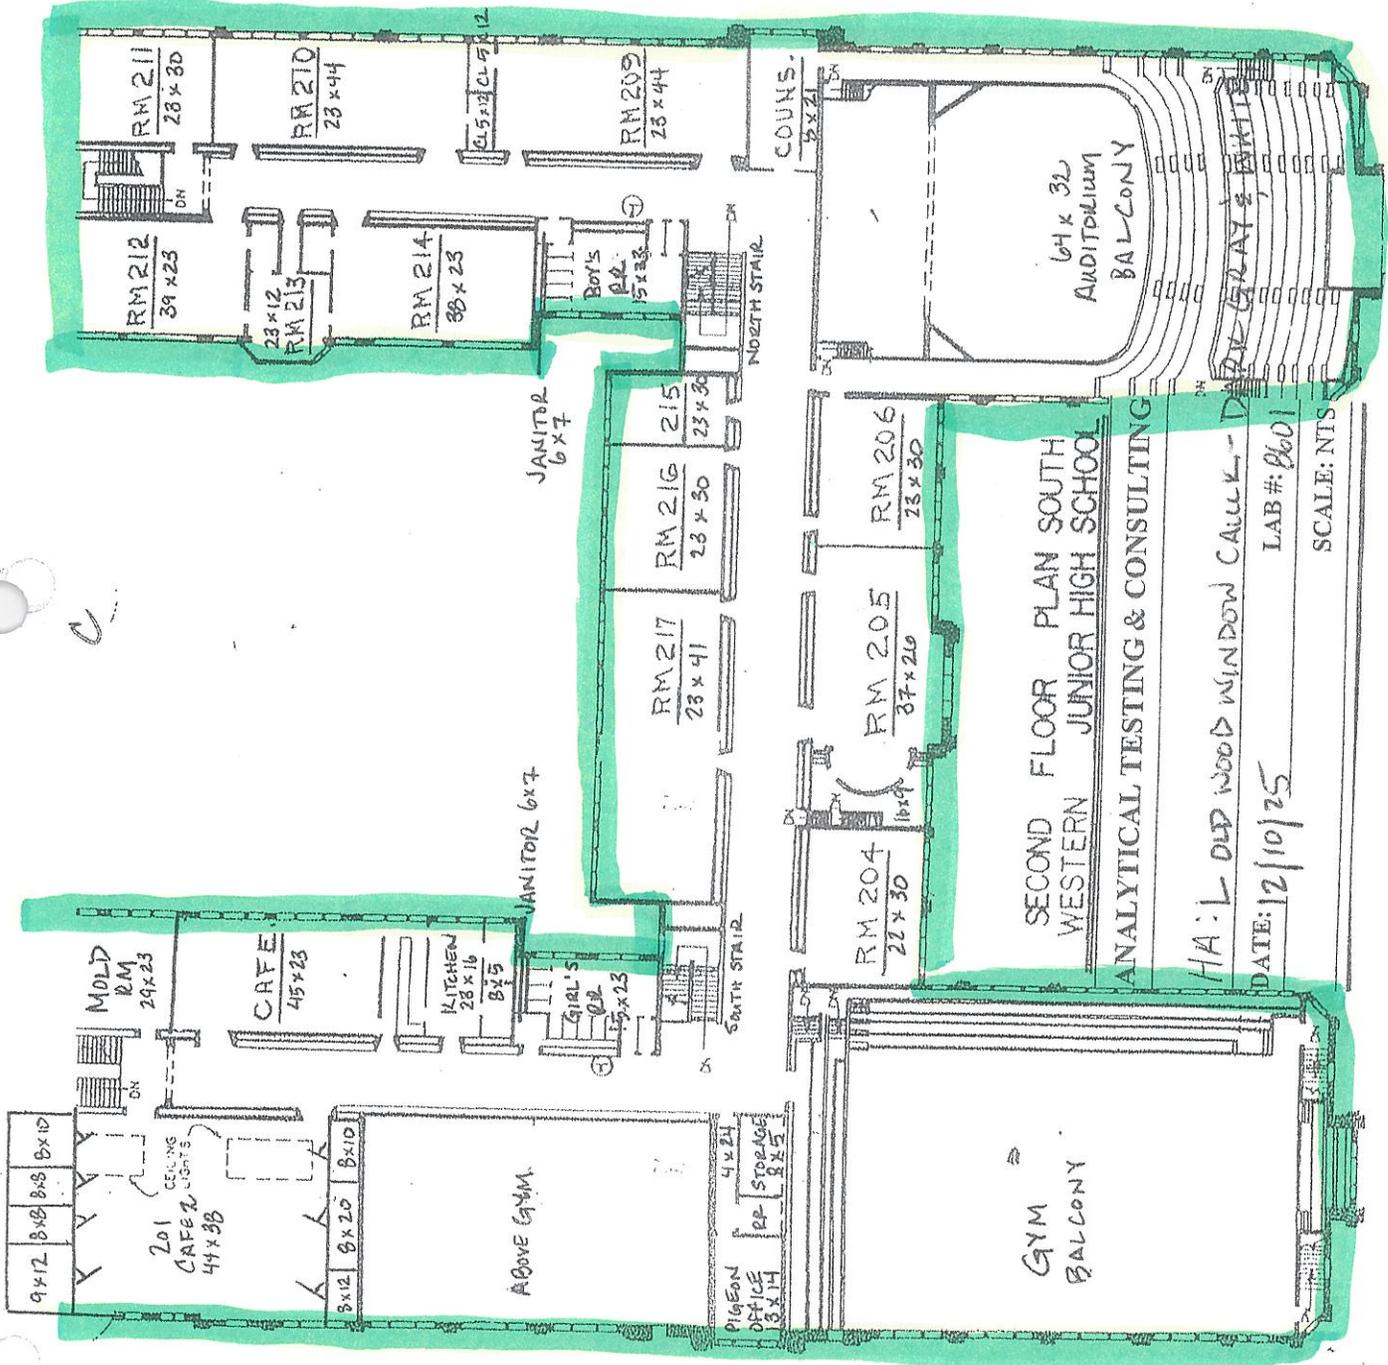
SECOND FLOOR PLAN SOUTH WESTERN JUNIOR HIGH SCHOOL
ANALYTICAL TESTING & CONSULTING

HA LOCATION	Type SM/TSI/MM	Friability F/NF	Physical Condition	Size SF/LF/MF
Under metal casings and sills –window casings and sills (~261 window openings)	MM	NF	7	~7,400 LF / ~309 SF
			TOTAL	~7,400 LF / ~309 SF

HA: L OLD WOOD WINDOW CALL -
DATE: 12/10/25
LAB #: B601
SCALE: NTS

Location	Recommendations
HA-L	Remove Asbestos Prior to Demolition/ Renovation

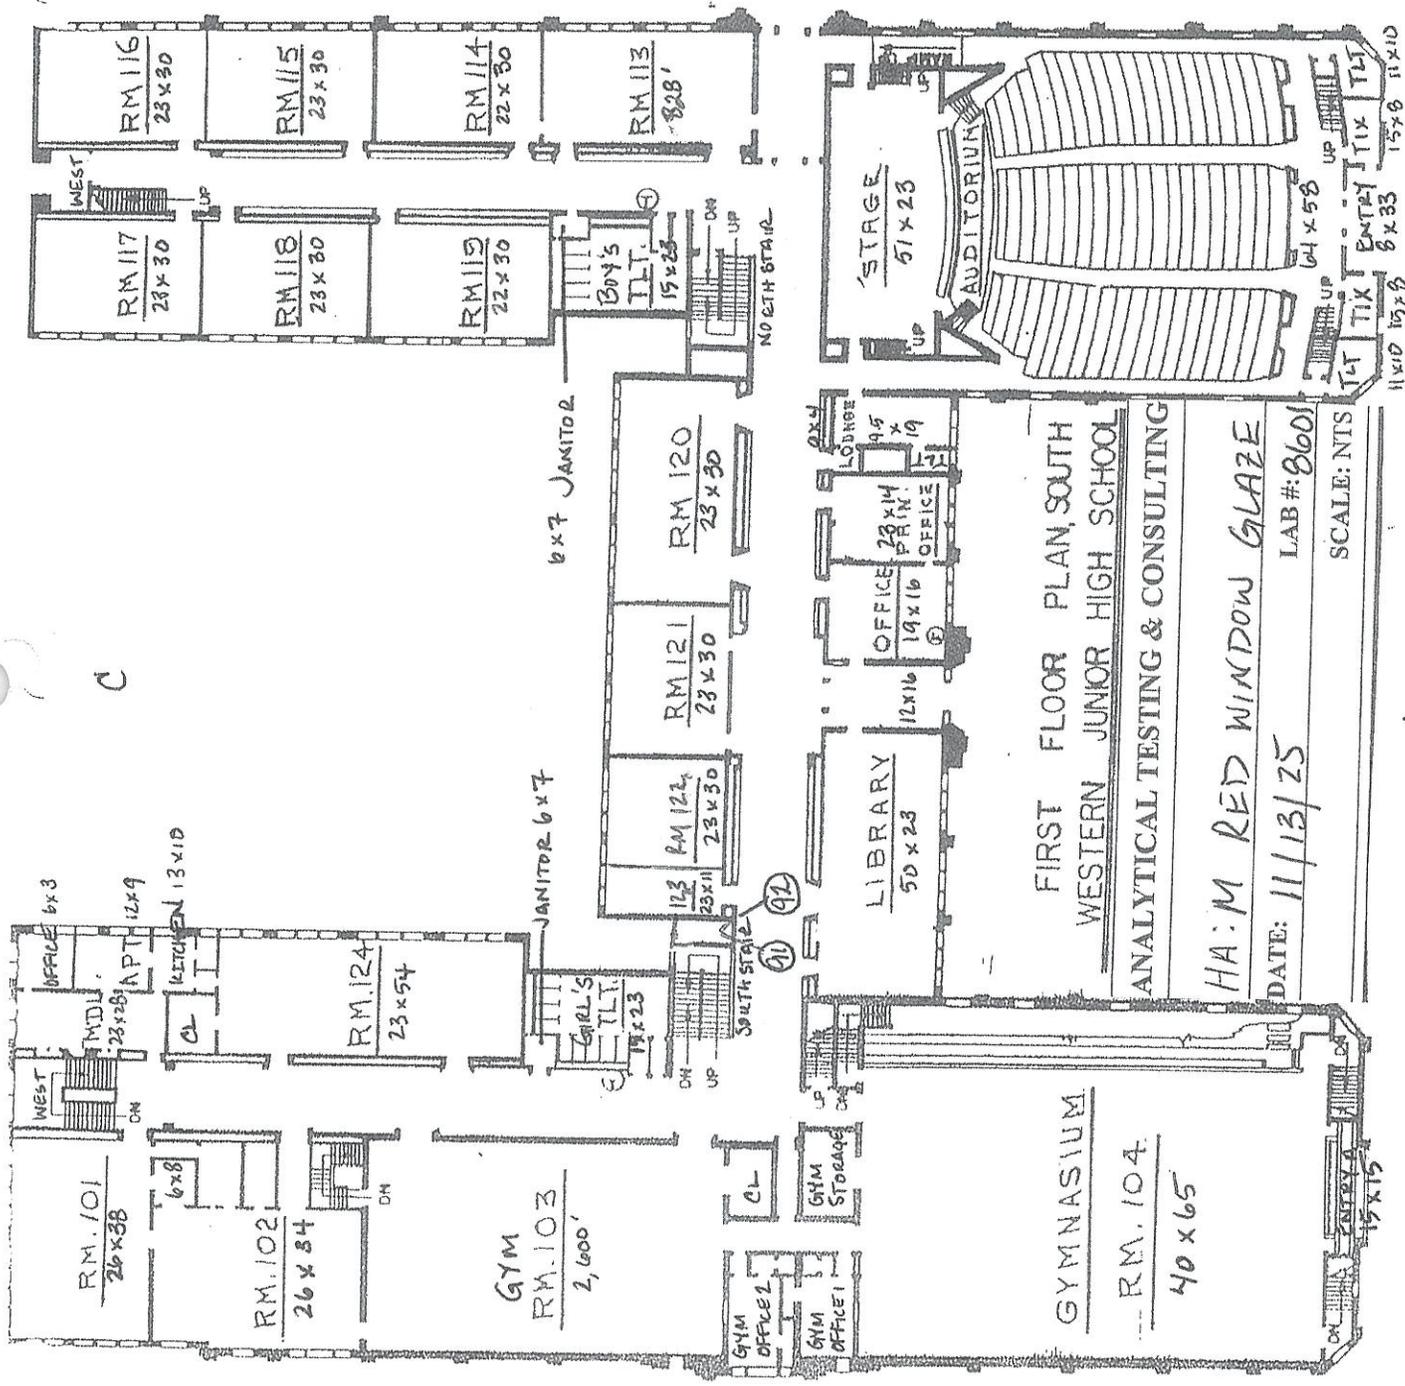
FIRST FLOOR PLAN, SOUTH
 WESTERN JUNIOR HIGH SCHOOL
 ANALYTICAL TESTING & CONSULTING
 HA: M RED WINDOW GLAZE
 DATE: 11/13/25
 LAB #: 8601
 SCALE: NTS

HA LOCATION	Type SM/TSI/MM	Friability F/NF	Physical Condition	Size SF/LF/MF
Side C – 5 attic windows	MM	NF	7	~5 Windows ~70 LF
Side B – 3 attic windows	MM	NF	7	~3 Windows ~36 LF
Side D – 3 attic windows	MM	NF	7	~3 Windows ~36 LF
Boiler Room – 1	MM	NF	7	~1 Window ~12 LF
Boy's locker room – 6	MM	NF	7	~6 Windows ~72 LF
Pipe chases (2) 10 windows	MM	NF	7	~10 Windows ~120 LF
Girl's locker room hall – 3	MM	NF	7	~3 Windows ~36 LF
Basement hall near primary vault – 2	MM	NF	7	~2 Windows ~24 LF
Fan Room – 1	MM	NF	7	~1 Window ~12 LF
Lower level restroom – 1	MM	NF	7	~1 Window ~12 LF
Tunnel windows – 6	MM	NF	7	~6 Windows ~72 LF
D23 Storage – 1	MM	NF	7	~1 Window ~12 LF
TOTAL				~42 Windows ~562 LF / ~21.5 SF

Location	Recommendations
HA-M	Non Asbestos

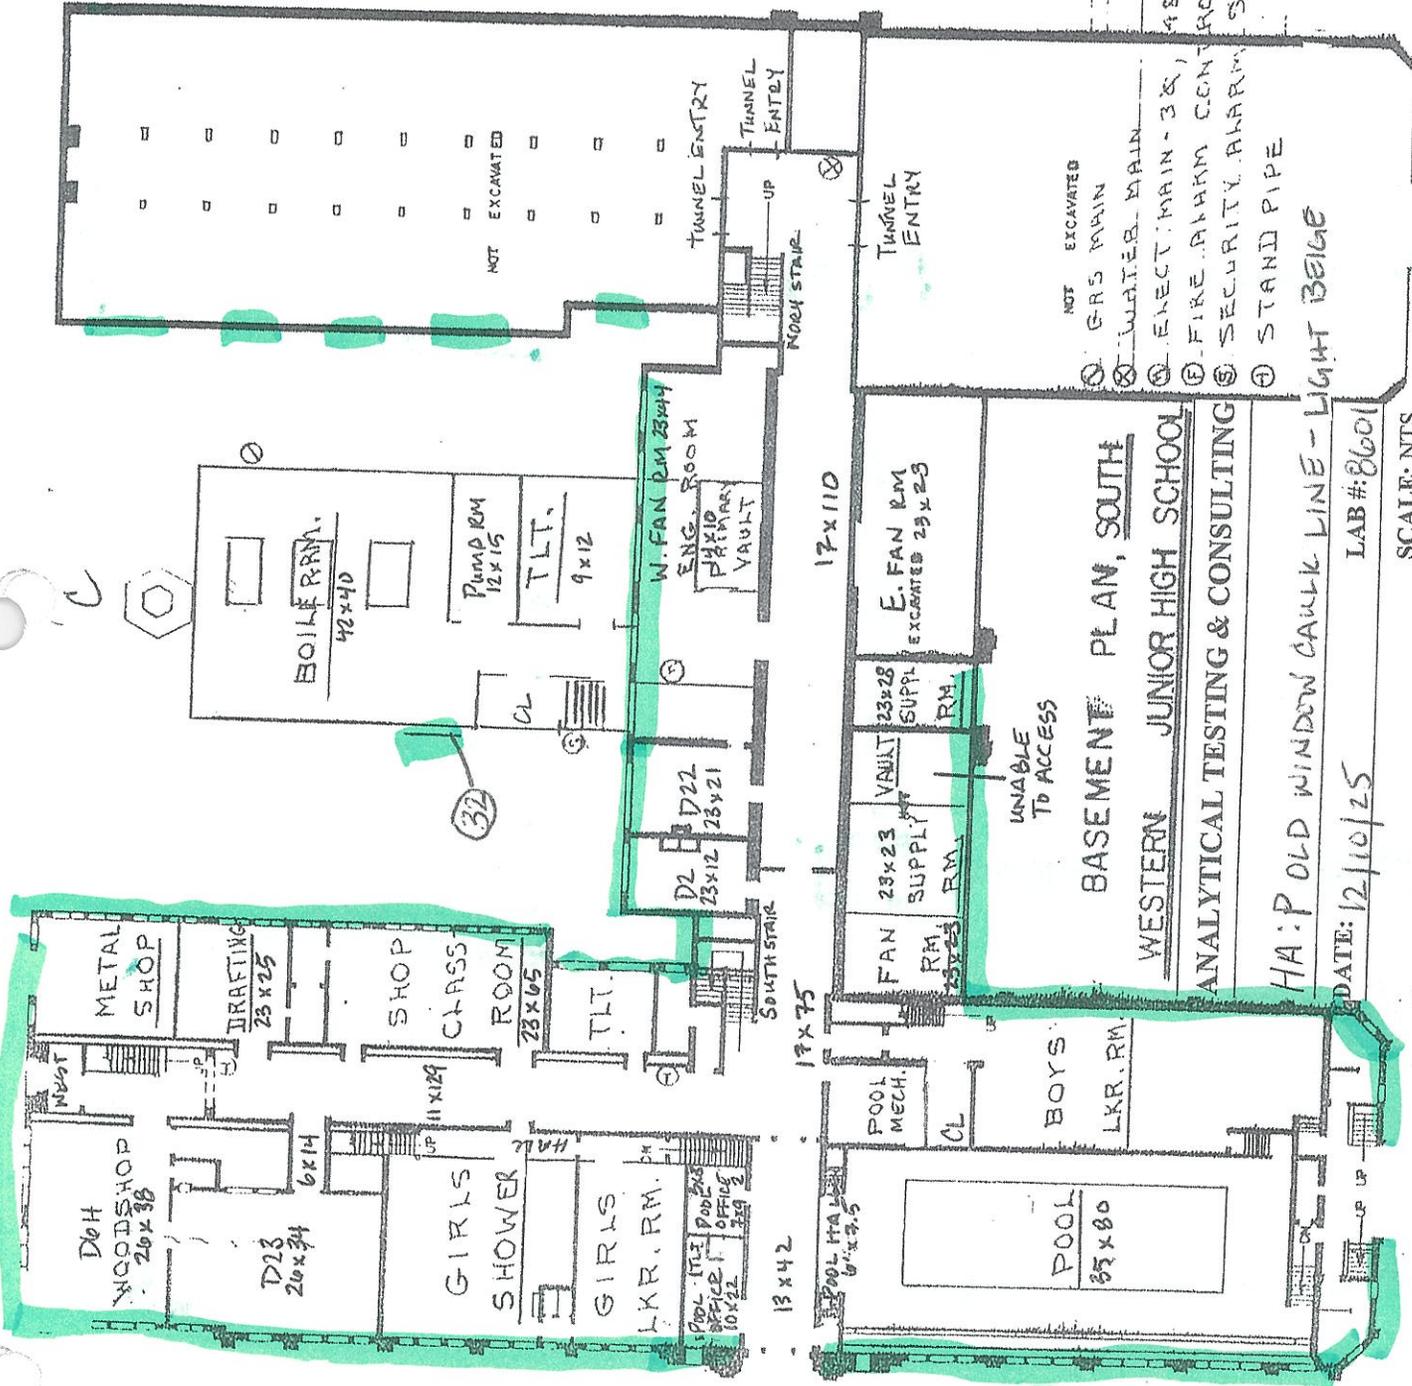
BASEMENT PLAN, SOUTH
 WESTERN JUNIOR HIGH SCHOOL
 ANALYTICAL TESTING & CONSULTING
 HA: P OLD WINDOW CAULK LINE - LIGHT BEIGE
 DATE: 12/10/25
 LAB #: 8601
 SCALE: NTS

HA LOCATION	Type SM/TSI/MM	Friability F/NF	Physical Condition	Size SF/LF/MF
Under metal window casings – old caulk line from old windows ~261 window openings	MM	NF	5	~7,400 LF / ~309 SF
TOTAL				~7,400 LF / ~309 SF

Location	Recommendations
HA-P	Remove Asbestos Prior to Demolition/ Renovation
