**ASBESTOS SURVEY
REPORT FOR**

(Former) Southwestern Junior High School
390 S. Washington Avenue
Battle Creek, Michigan 49037

September 15, 16, 17, 18, 19, 23, 25 & 29, 2025
October 3 & 14, 2025
November 14, 24, 2025
December 23, 2025

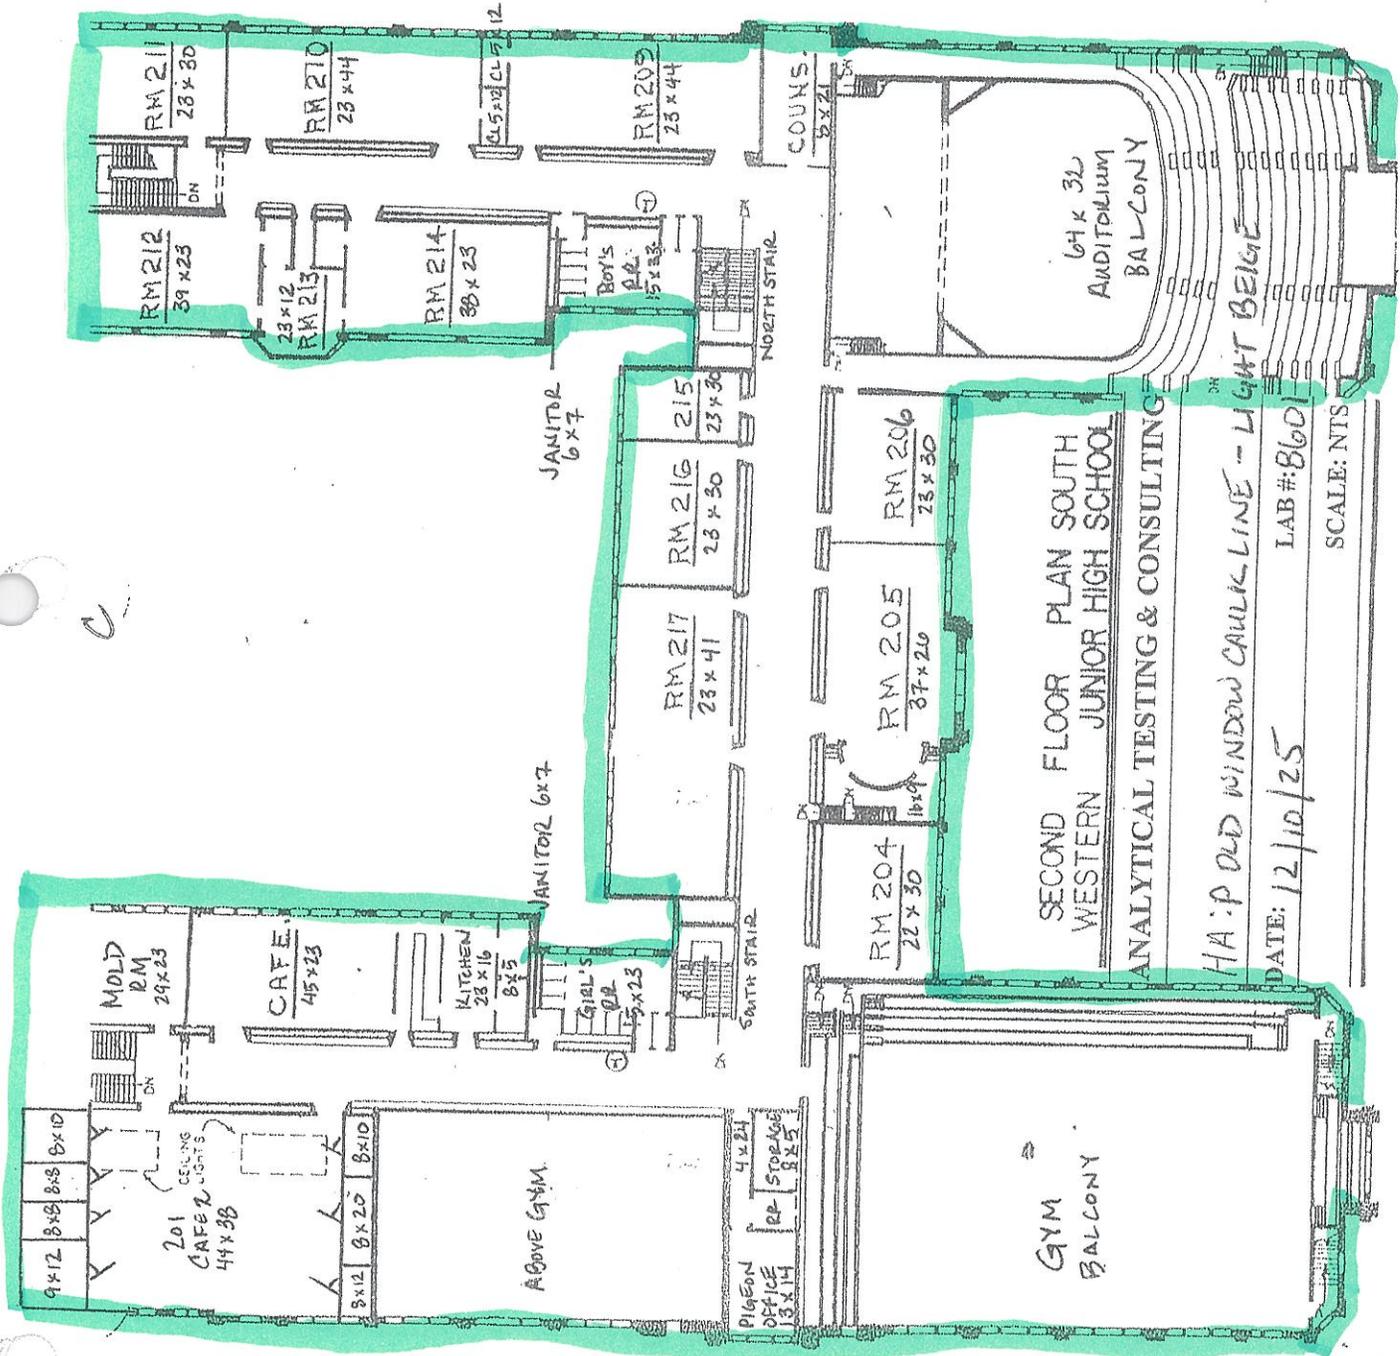
SECOND FLOOR PLAN SOUTH
WESTERN JUNIOR HIGH SCHOOL
ANALYTICAL TESTING & CONSULTING

HA LOCATION	Type SM/TSI/MM	Friability F/NF	Physical Condition	Size SF/LF/MF
Under metal window casings – old caulk line from old windows ~261 window openings	MM	NF	5	~7,400 LF / ~309 SF
TOTAL				~7,400 LF / ~309 SF

HA: P OLD WINDOW CAULK LINE - LIGHT BEIGE

Location	Recommendations
HA-P	Remove Asbestos Prior to Demolition/ Renovation
