ASBESTOS SURVEY DATA FORM

LOCATION: Southwestern Junior High School

ADDRESS: 390 S. Washington, Battle Creek, Michigan 49017

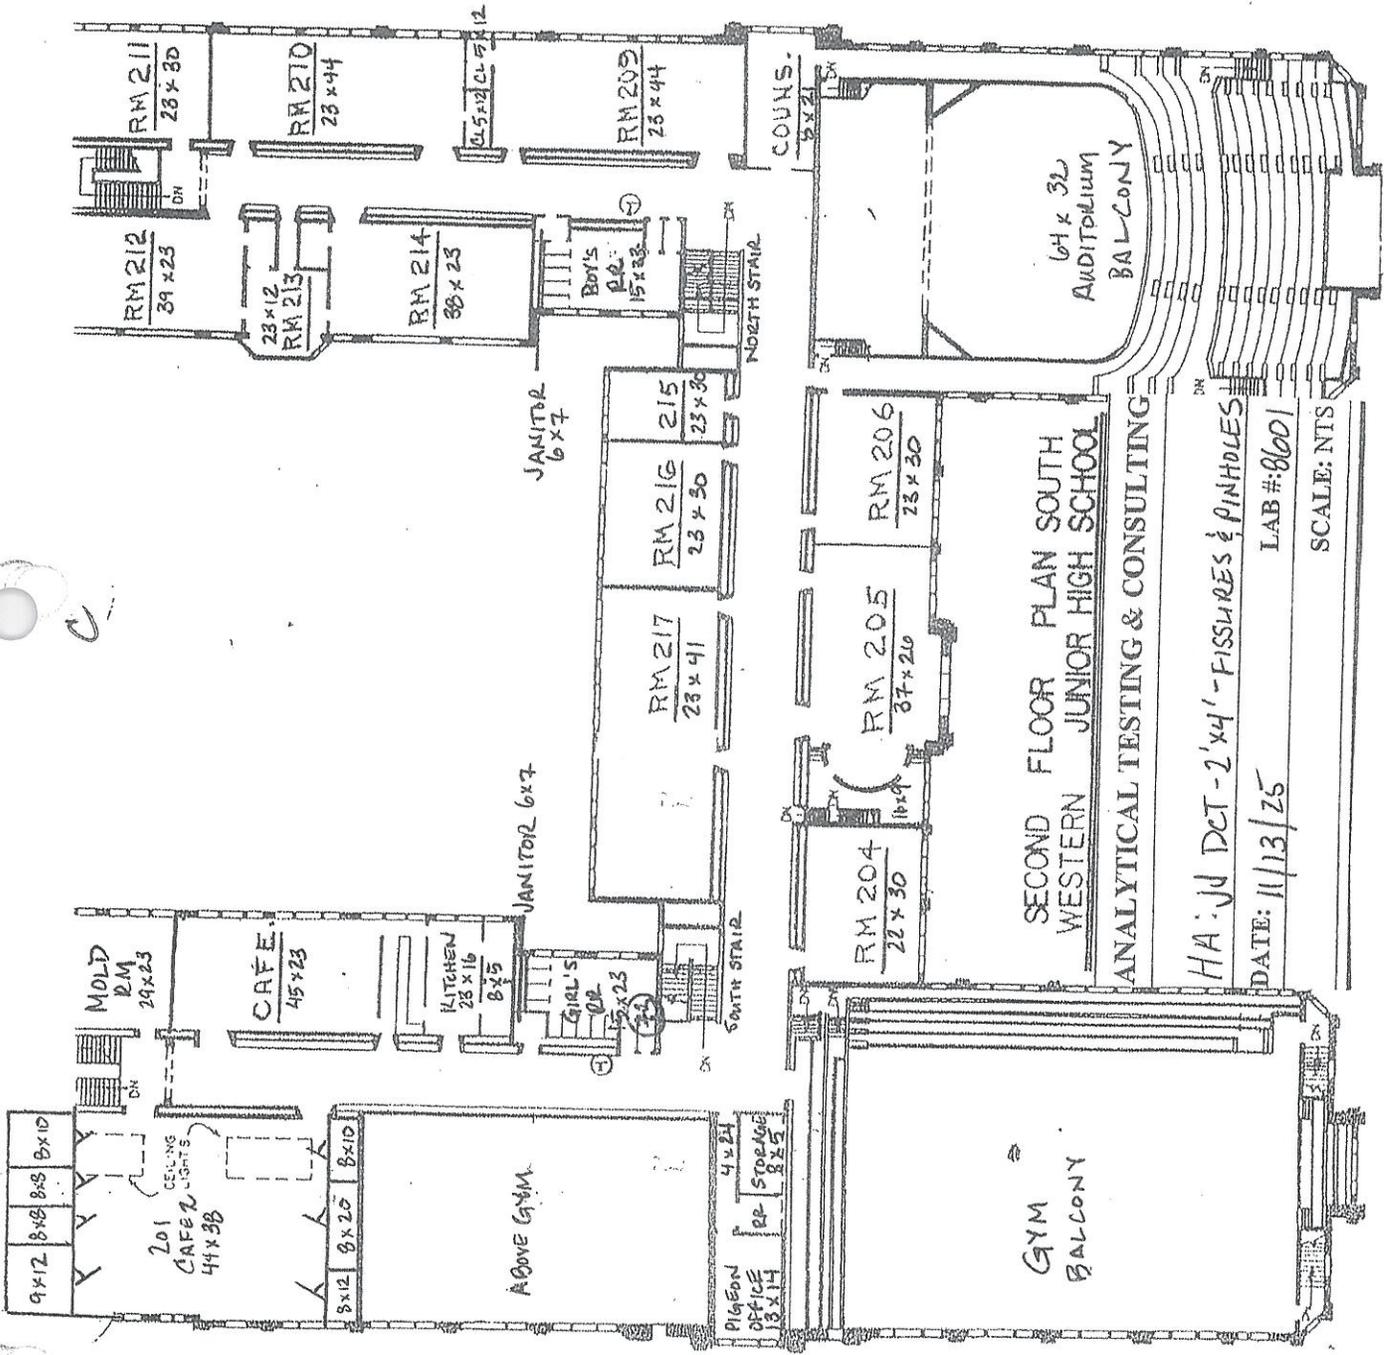
SECOND FLOOR PLAN SOUTH
WESTERN JUNIOR HIGH SCHOOL
ANALYTICAL TESTING & CONSULTING

HA: JJ DET - 2'x4' - FISSURES & PINHOLES
DATE: 11/13/25
LAB #: 8001
SCALE: NTS

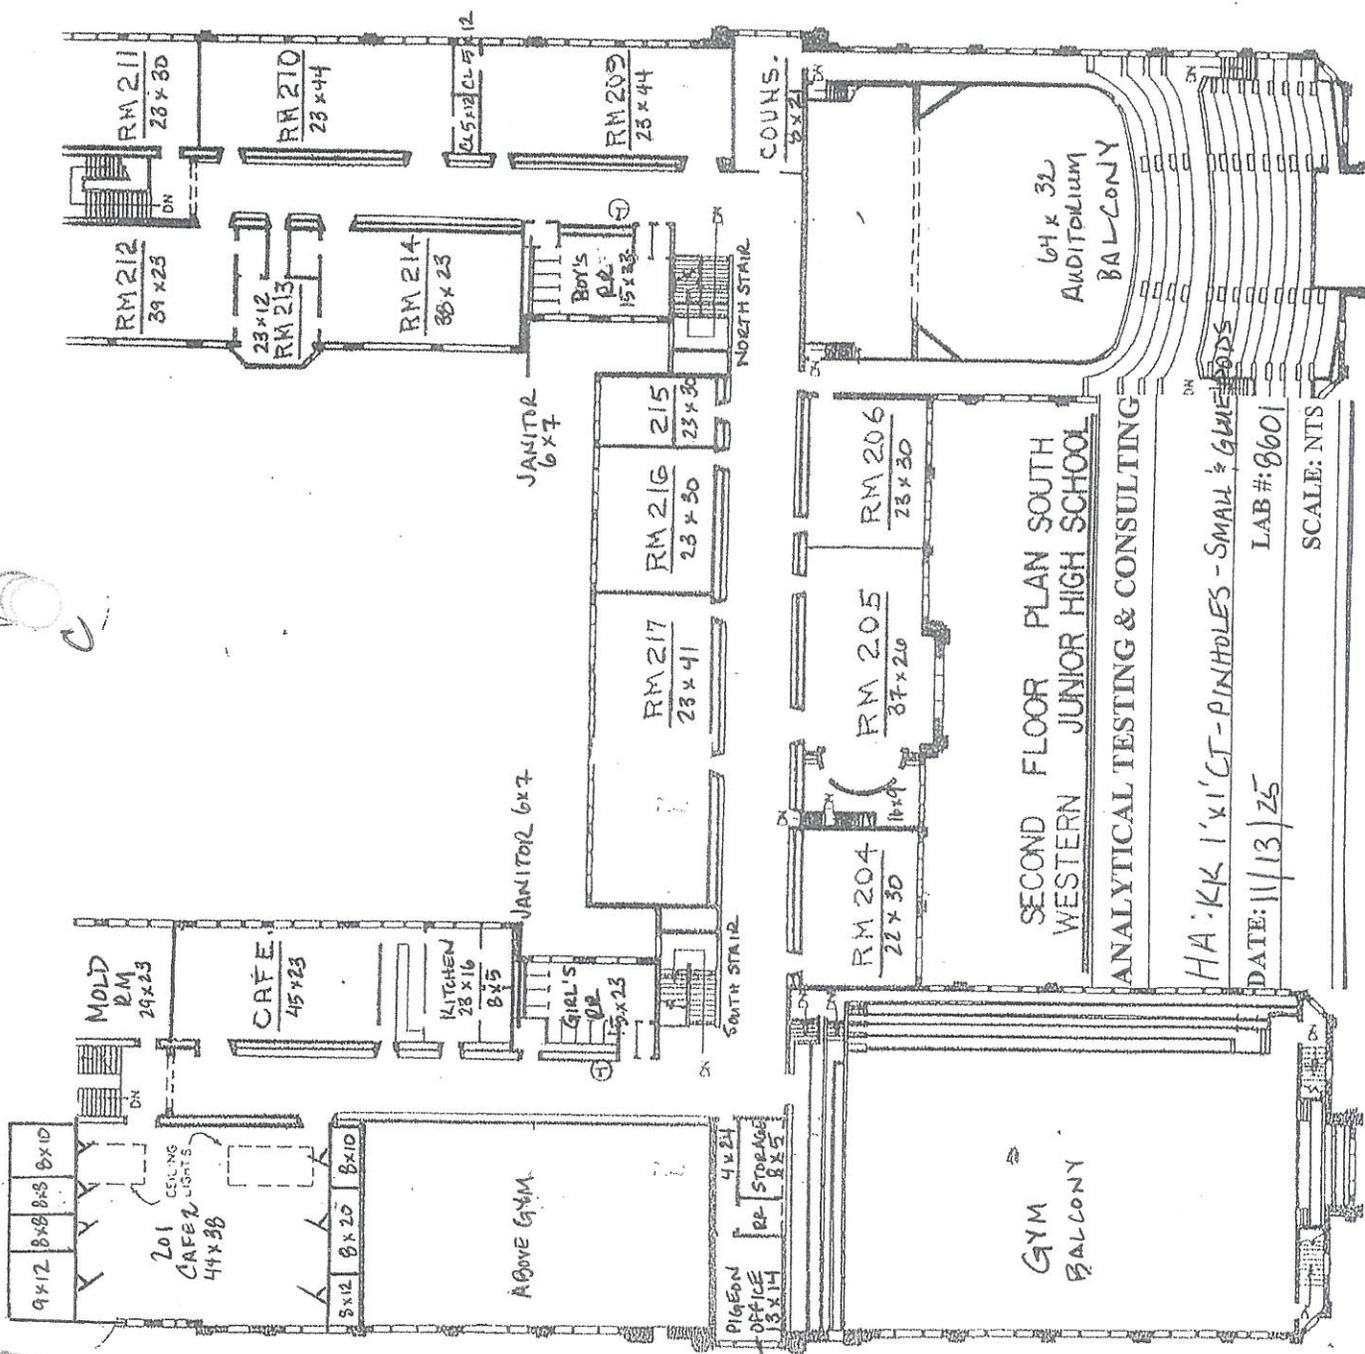
SECOND FLOOR PLAN SOUTH
WESTERN JUNIOR HIGH SCHOOL
ANALYTICAL TESTING & CONSULTING

HA: KK 1'x1' CT - PINHOLES - SMALL & GYM BALCONIES
LAB #: 8001
DATE: 11/13/25
SCALE: NTS

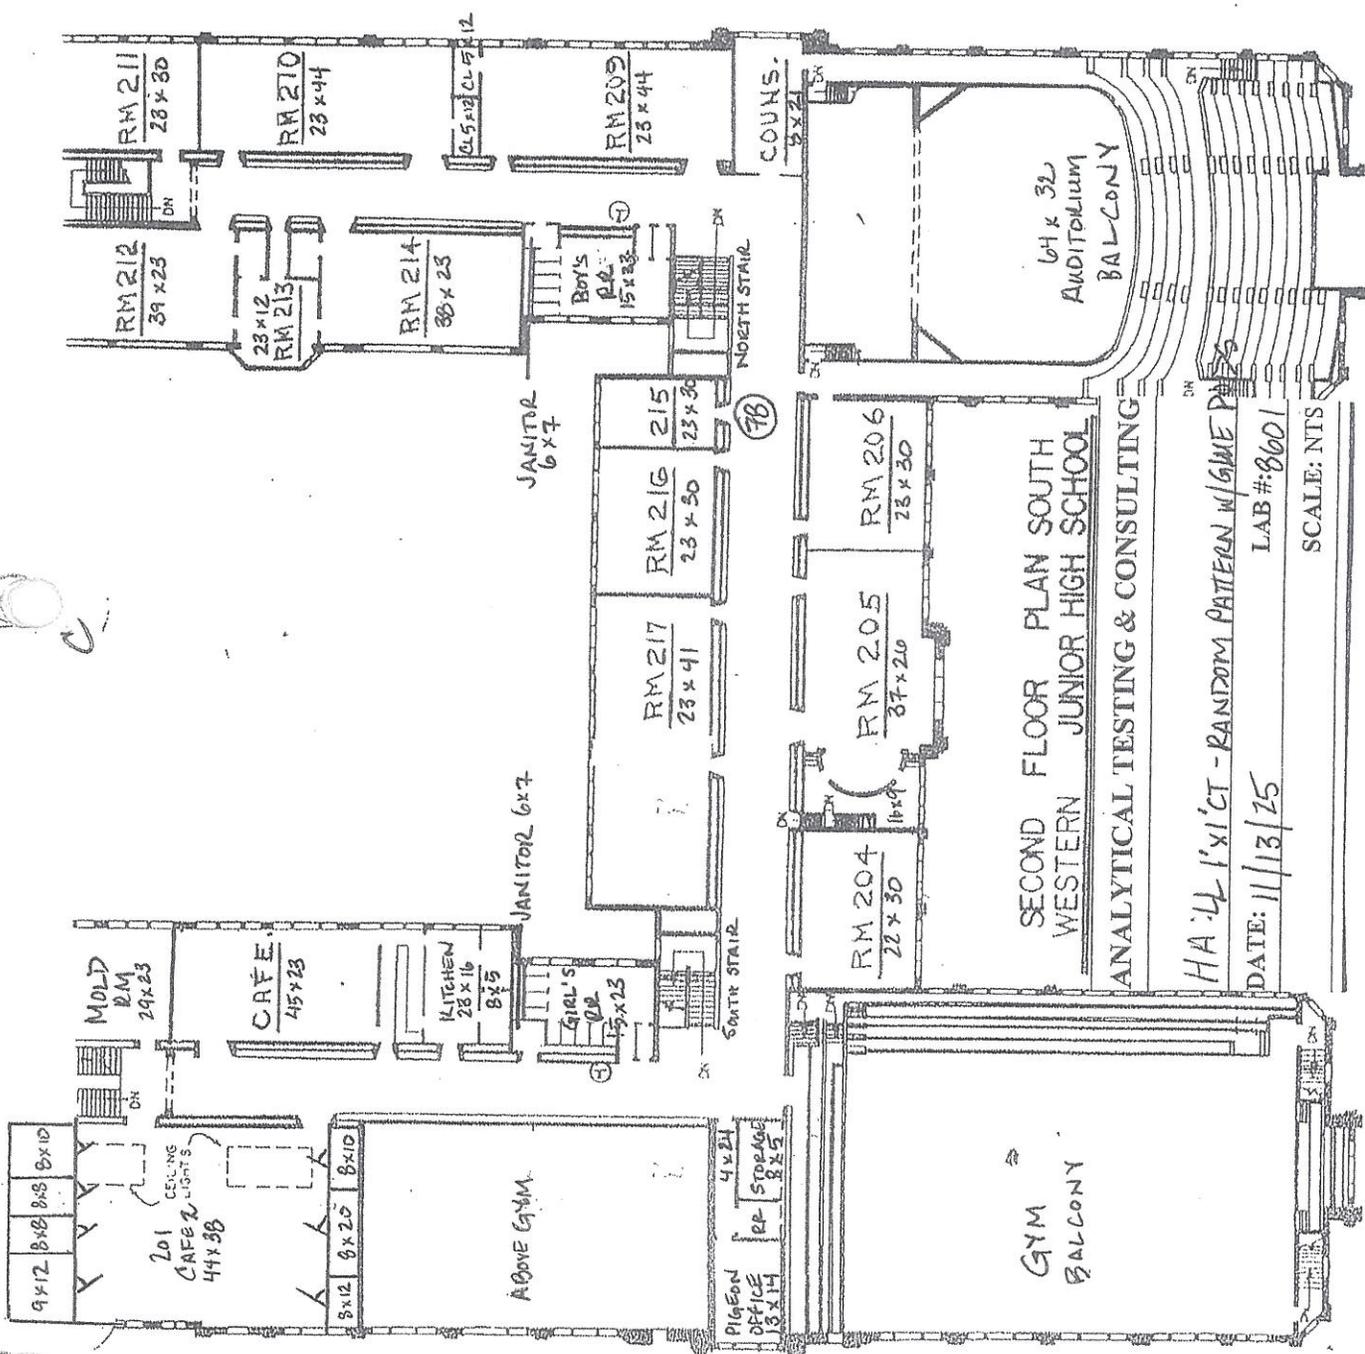
SECOND FLOOR PLAN SOUTH
 WESTERN JUNIOR HIGH SCHOOL
 ANALYTICAL TESTING & CONSULTING

HA 44 1'x1' CT - RANDOM PATTERN W/ GYM PAGES
 LAB #: 8601
 DATE: 11/13/25

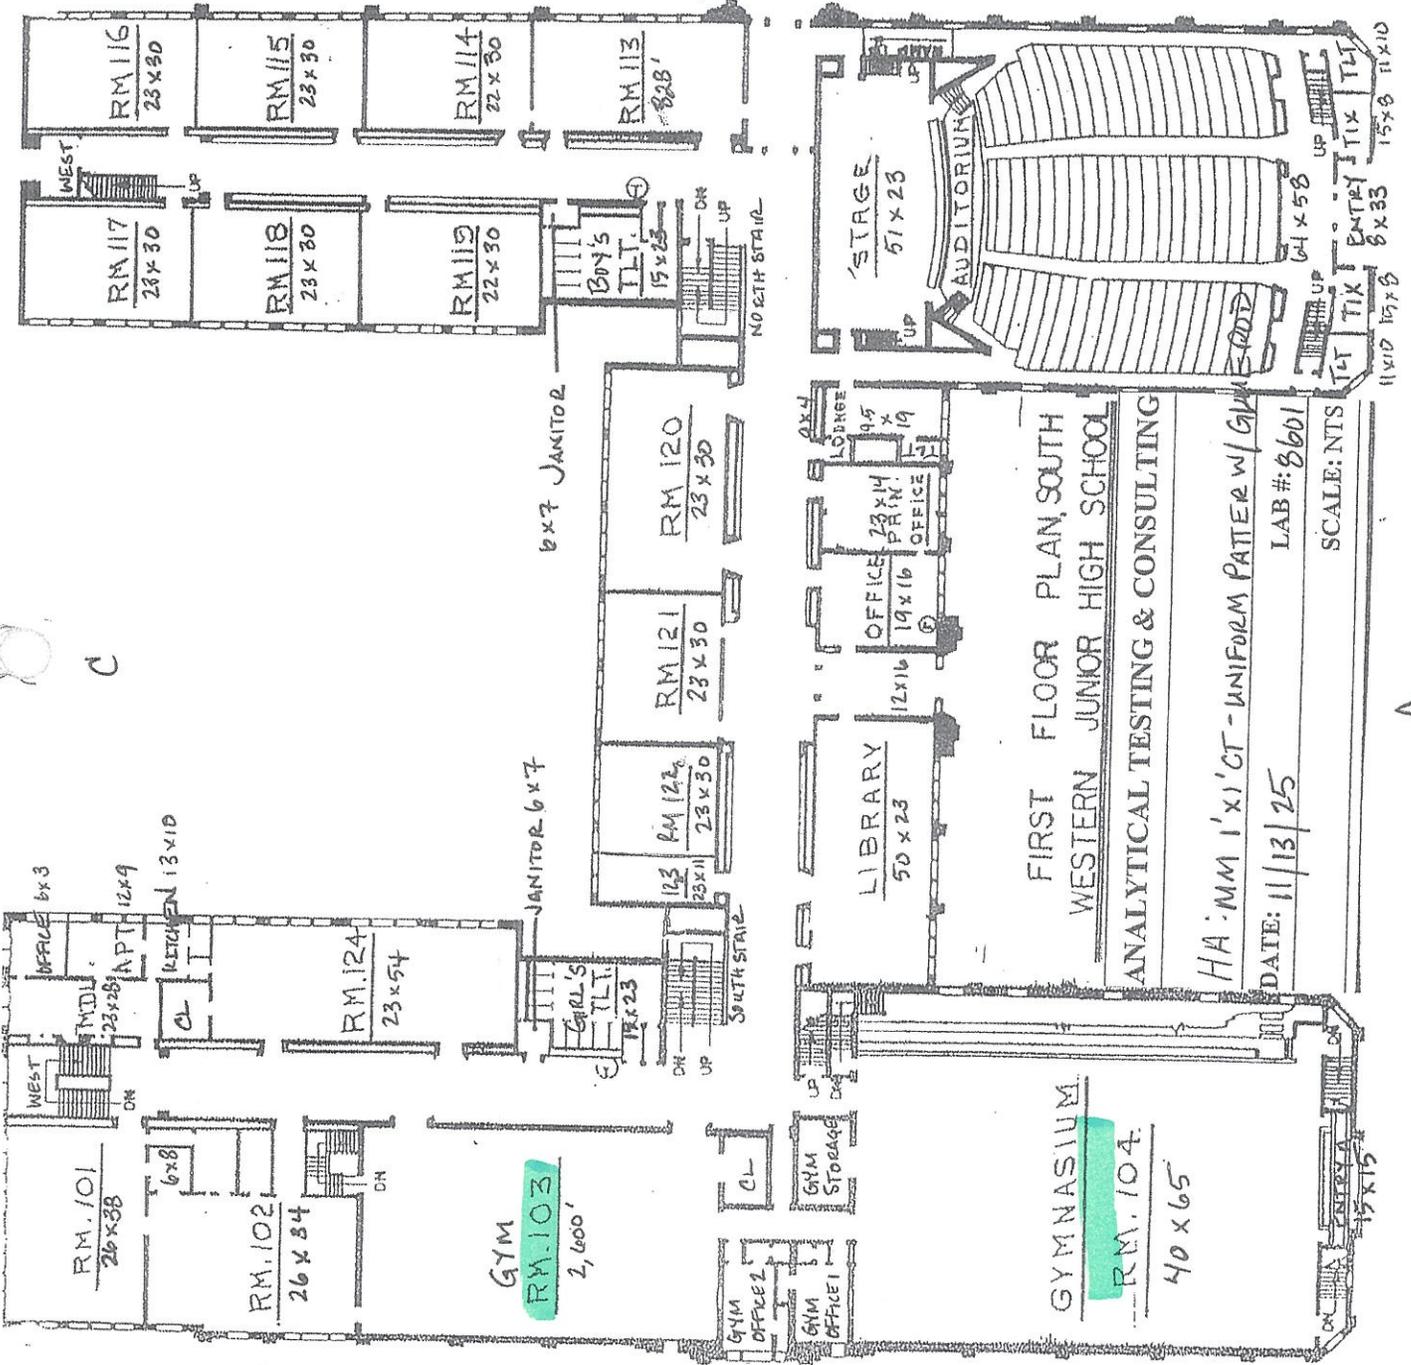
FIRST FLOOR PLAN, SOUTH
 WESTERN JUNIOR HIGH SCHOOL
 ANALYTICAL TESTING & CONSULTING

HA LOCATION	Type SM/TSI/MM	Friability F/NF	Physical Condition	Size SF/LF/MF
Room 205	MM	F	7	~962 SF
Room 206	MM	F	7	~690 SF
Room 211	MM	F	7	~690 SF
Gym 104	MM	F	7	~4,770 SF
Girl's Gym 103	MM	F	7	~2,600 SF
TOTAL				~9,712 SF

Sample No.	Description and Location	Results (%)
8601-79	Sample of ceiling tile from Room 211 center	Layer 1 – None Detected Layer 2 – 5% Chrysotile
8601-80	Sample of ceiling tile from Room 205 center	Layer 1 – None Detected Layer 2 – 5% Chrysotile
*Note: All samples were collected in a statistically random manner representative of Homogeneous Area in accordance with 40 CFR 763.86.

HA: MM 1'x1' CT - UNIFORM PATER W/ GYM
 DATE: 11/13/25
 LAB #: 8601
 SCALE: NTS

Location	Recommendations
HA-MM	Remove Asbestos Prior to Demolition/ Renovation
