## ASBESTOS SURVEY DATA FORM

**LOCATION:** Southwestern Junior High School

**ADDRESS:** 390 S. Washington, Battle Creek, Michigan 49017

**DATE:** Sept/Oct/Nov/Dec 2025

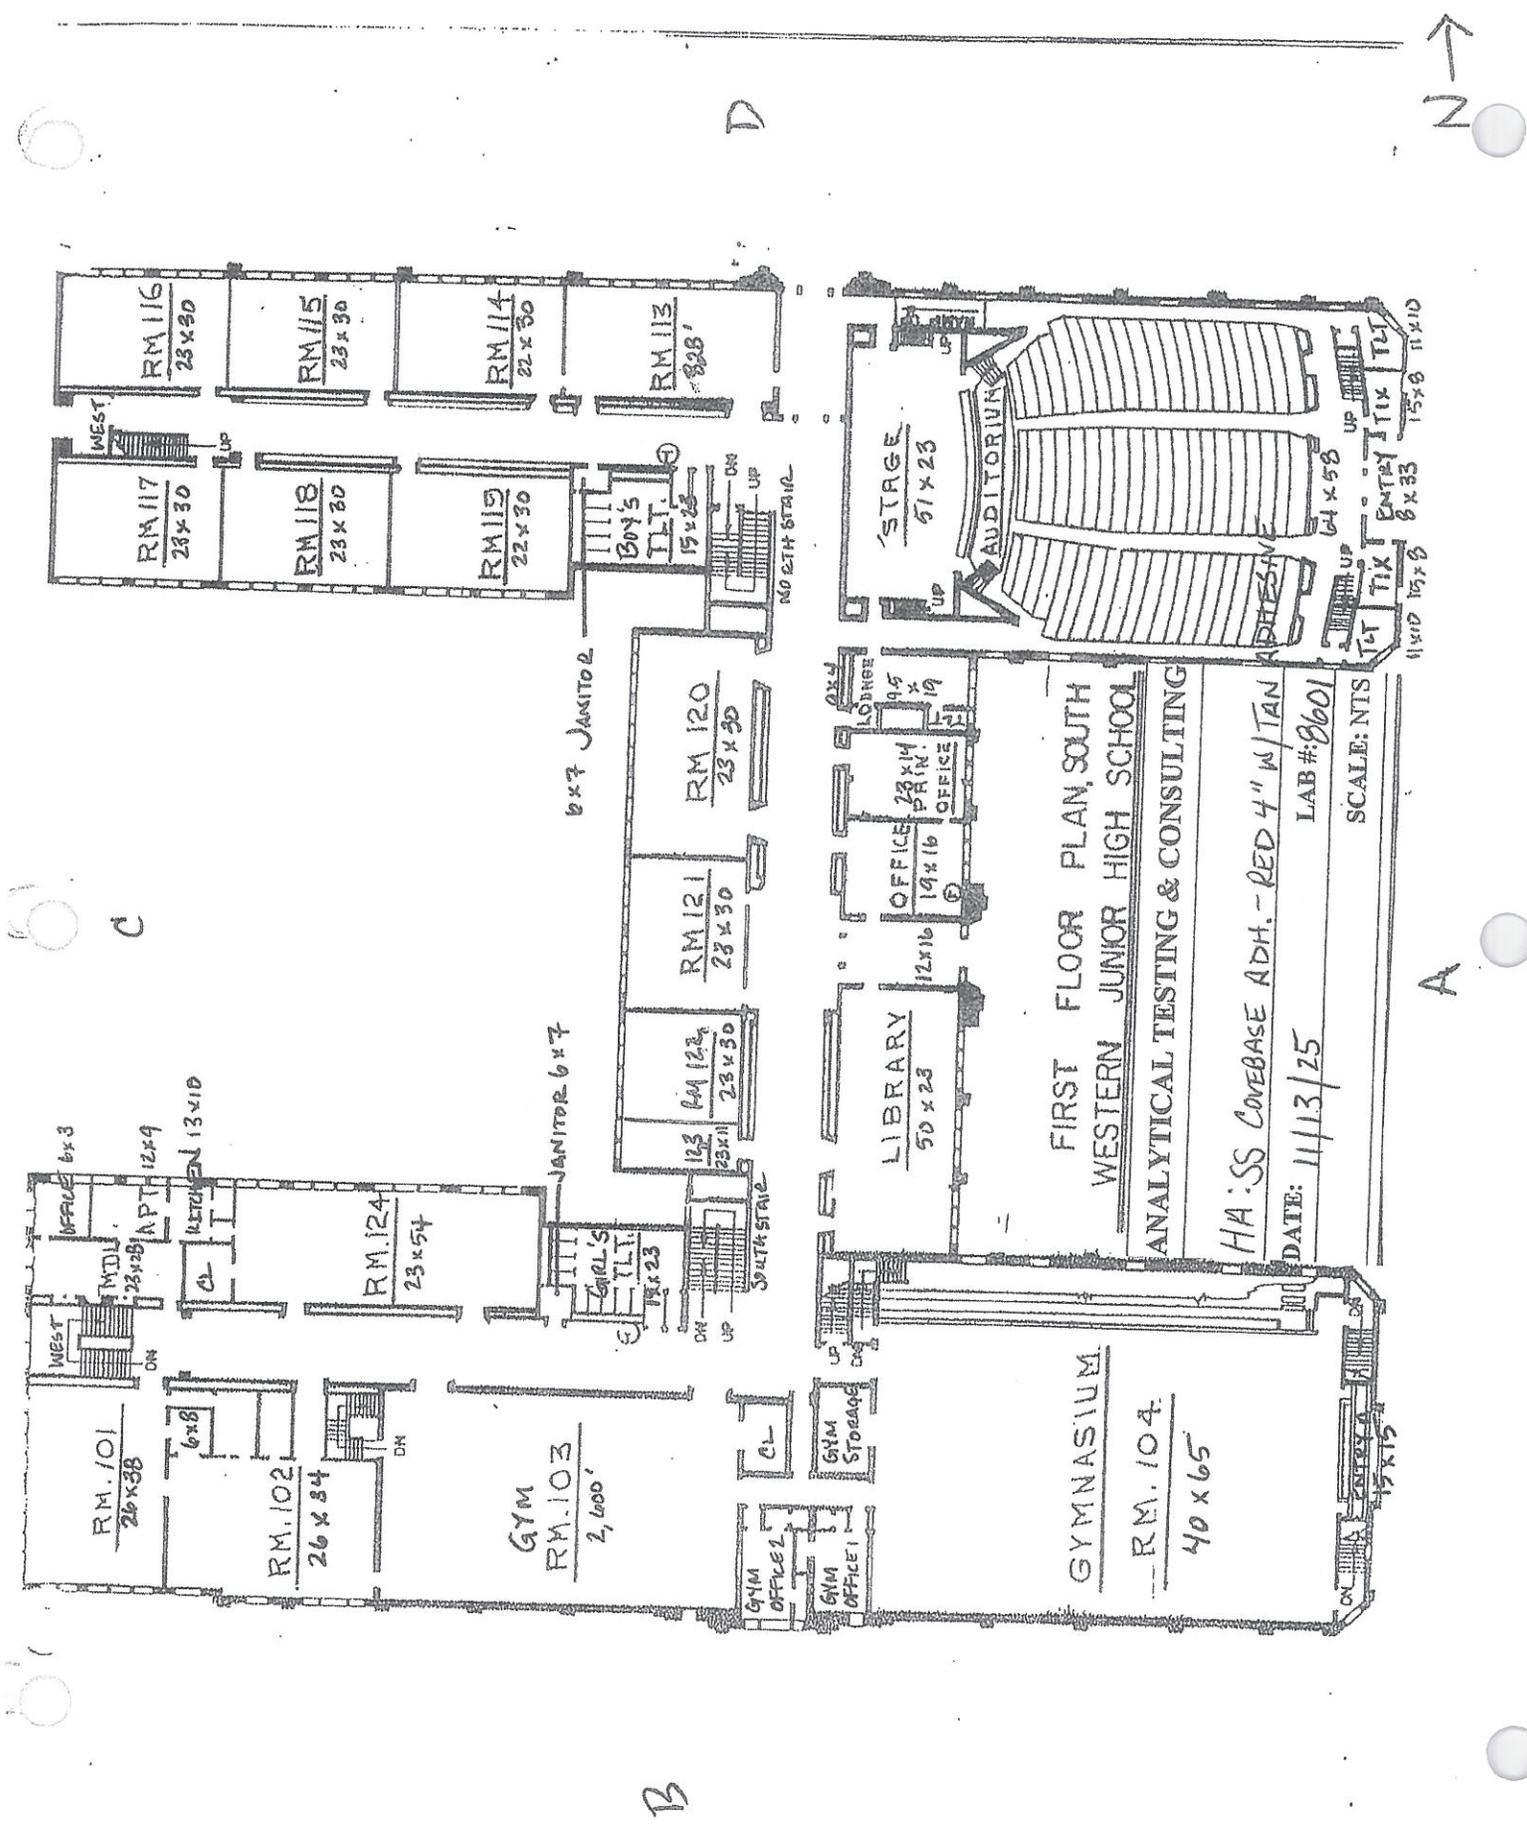
HA:SS COVERBASE ADH. - RED 4" W/TAN  
LAB #: 8601  
DATE: 11/13/25  
SCALE: NTS

**HA DESCRIPTION:** Covebase Adhesive – Red 4” with Tan Adhesive

HA LOCATION	Type SM/TSI/MM	Friability F/NF	Physical Condition	Size SF/LF/MF
Main office	MM	NF	4	~70 LF
Principal's office	MM	NF	4	~74 LF
Pigeon office	MM	NF	4	~54 LF
Room 214	MM	NF	4	~122 LF
<b>TOTAL</b>				~320 LF / ~80 SF

Sample No.	Description and Location	Results (%)
8601-101	Sample of covebase adhesive over metal from the Pigeon office Side C	Layer 1 – None Detected Layer 2 – None Detected
8601-102	Sample of covebase adhesive from Room 214	Layer 1 – None Detected Layer 2 – None Detected
*Note: All samples were collected in a statistically random manner representative of Homogeneous Area in accordance with 40 CFR 763.86.

Location	Recommendations
HA-SS	Non Asbestos

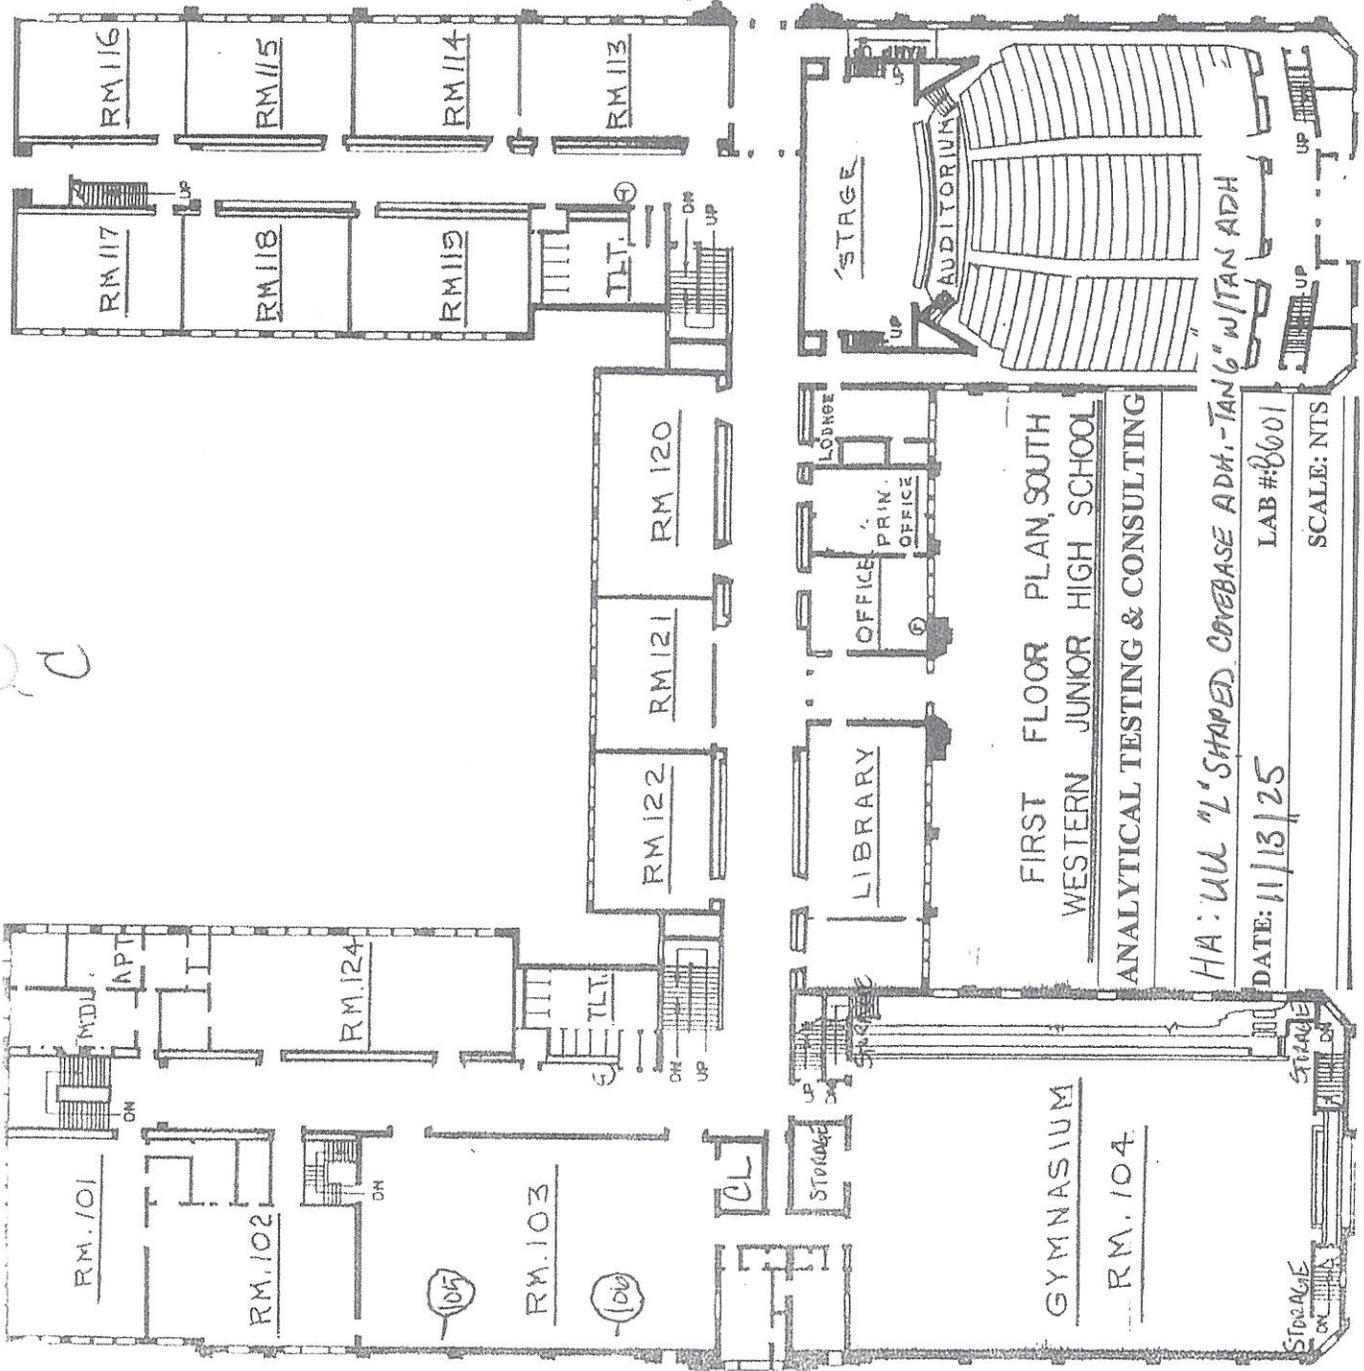
HA: ULL "L" SHAPED COVERBASE ADH. - TAN 6" W/TAN ADH

**HA DESCRIPTION:** "L" Shaped Covebase Adhesive – Tan 6" with Tan Adhesive

HA LOCATION	Type SM/TSI/MM	Friability F/NF	Physical Condition	Size SF/LF/MF
Gym – 103 and closet	MM	NF	7	~200 LF
Gym – 104 and all storage rooms	MM	NF	7	~290 LF
<b>TOTAL</b>				~490 LF / ~245 SF

Sample No.	Description and Location	Results (%)
8601-105	Sample of covebase adhesive from Gym 103 Side B	None Detected
8601-106	Sample of covebase adhesive from Gym 103	None Detected

Location	Recommendations
HA-UU	<b>Non Asbestos</b>

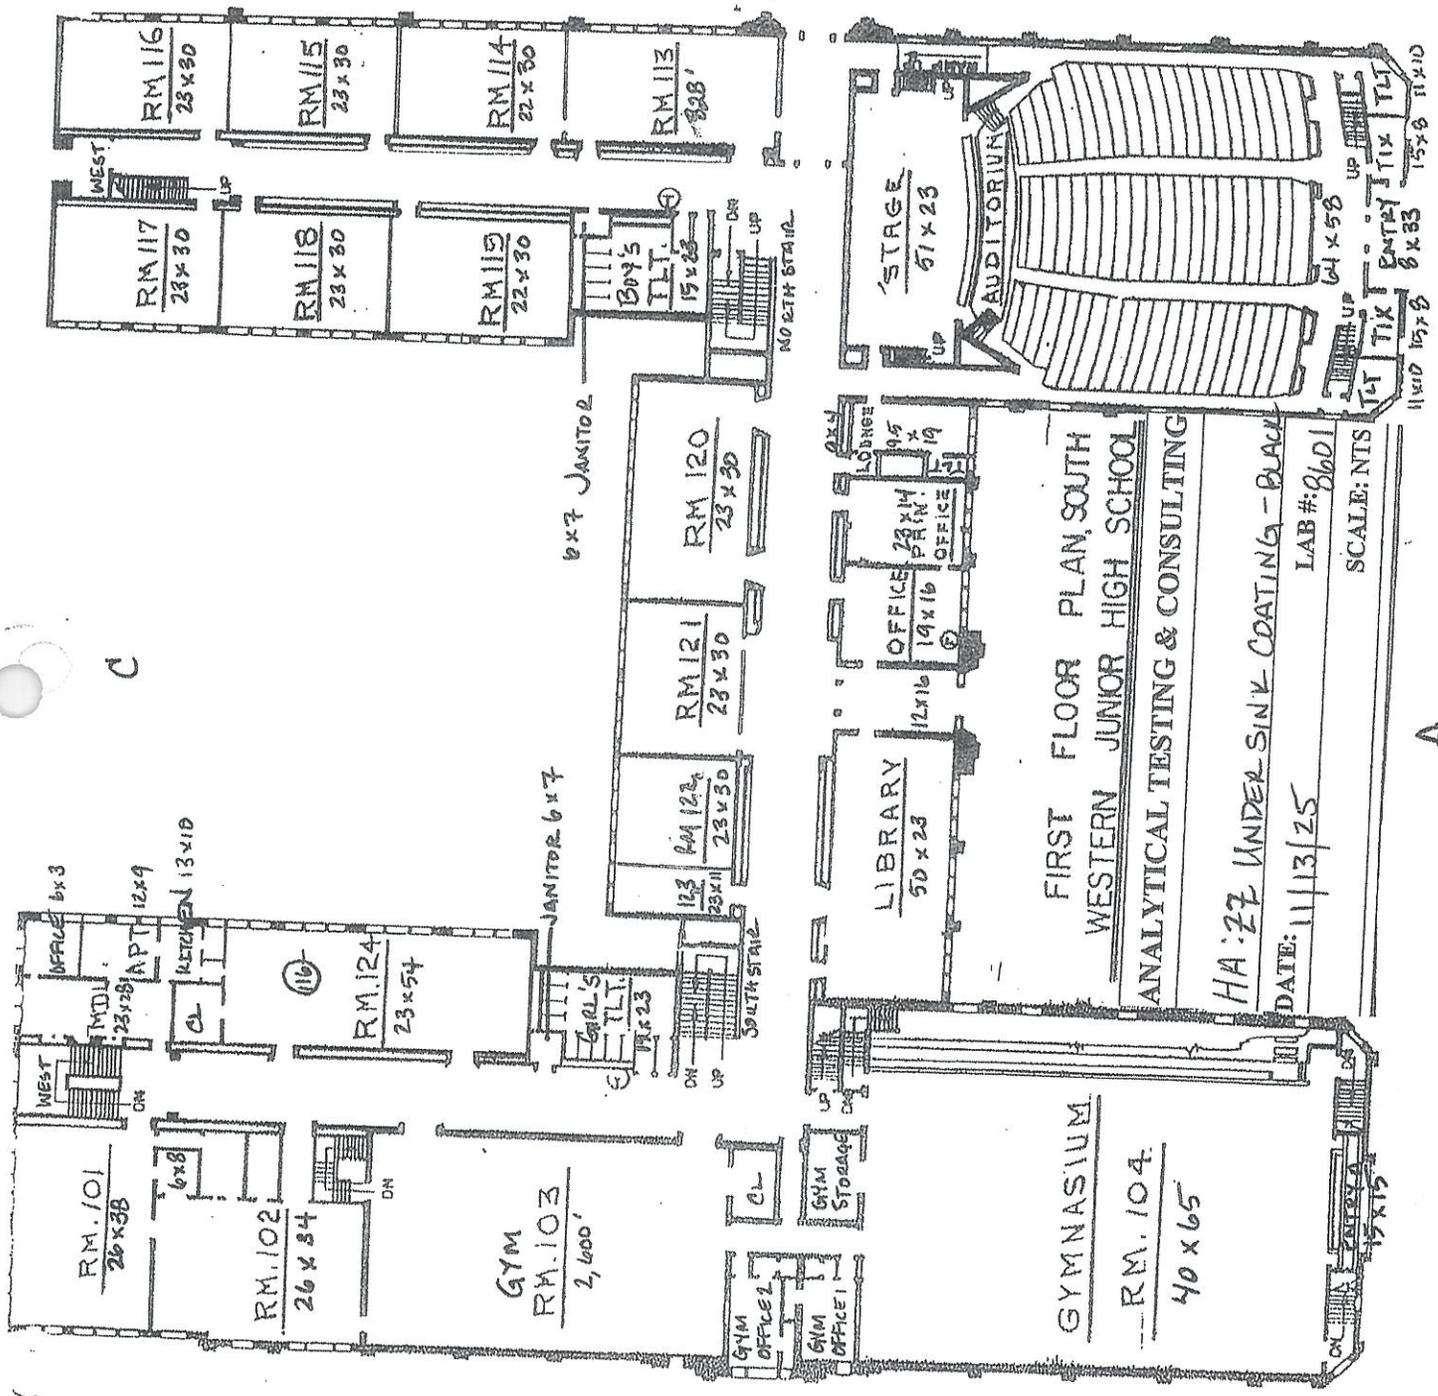
HA: 27 UNDER SINK COATING - BLACK  
 DATE: 11/13/25  
 LAB #: 8601  
 SCALE: NTS

**HA DESCRIPTION:** Under Sink Coating – Black

HA LOCATION	Type SM/TSI/MM	Friability F/NF	Physical Condition	Size SF/LF/MF
2 (double) sinks – Room 210; stainless steel	MM	F	4	~8 SF
5 (double) sinks – Room 124; stainless steel	MM	F	4	~40 SF
Kitchen office 124 (double)	MM	F	4	~8 SF
<b>TOTAL</b>				~56 SF

Sample No.	Description and Location	Results (%)
8601-115	Sample of sink coating from Room 210 Side B	None Detected
8601-116	Sample of sink coating from Room 124	None Detected
*Note: All samples were collected in a statistically random manner representative of Homogeneous Area in accordance with 40 CFR 763.86.

Location	Recommendations
HA-ZZ	<b>Non Asbestos</b>

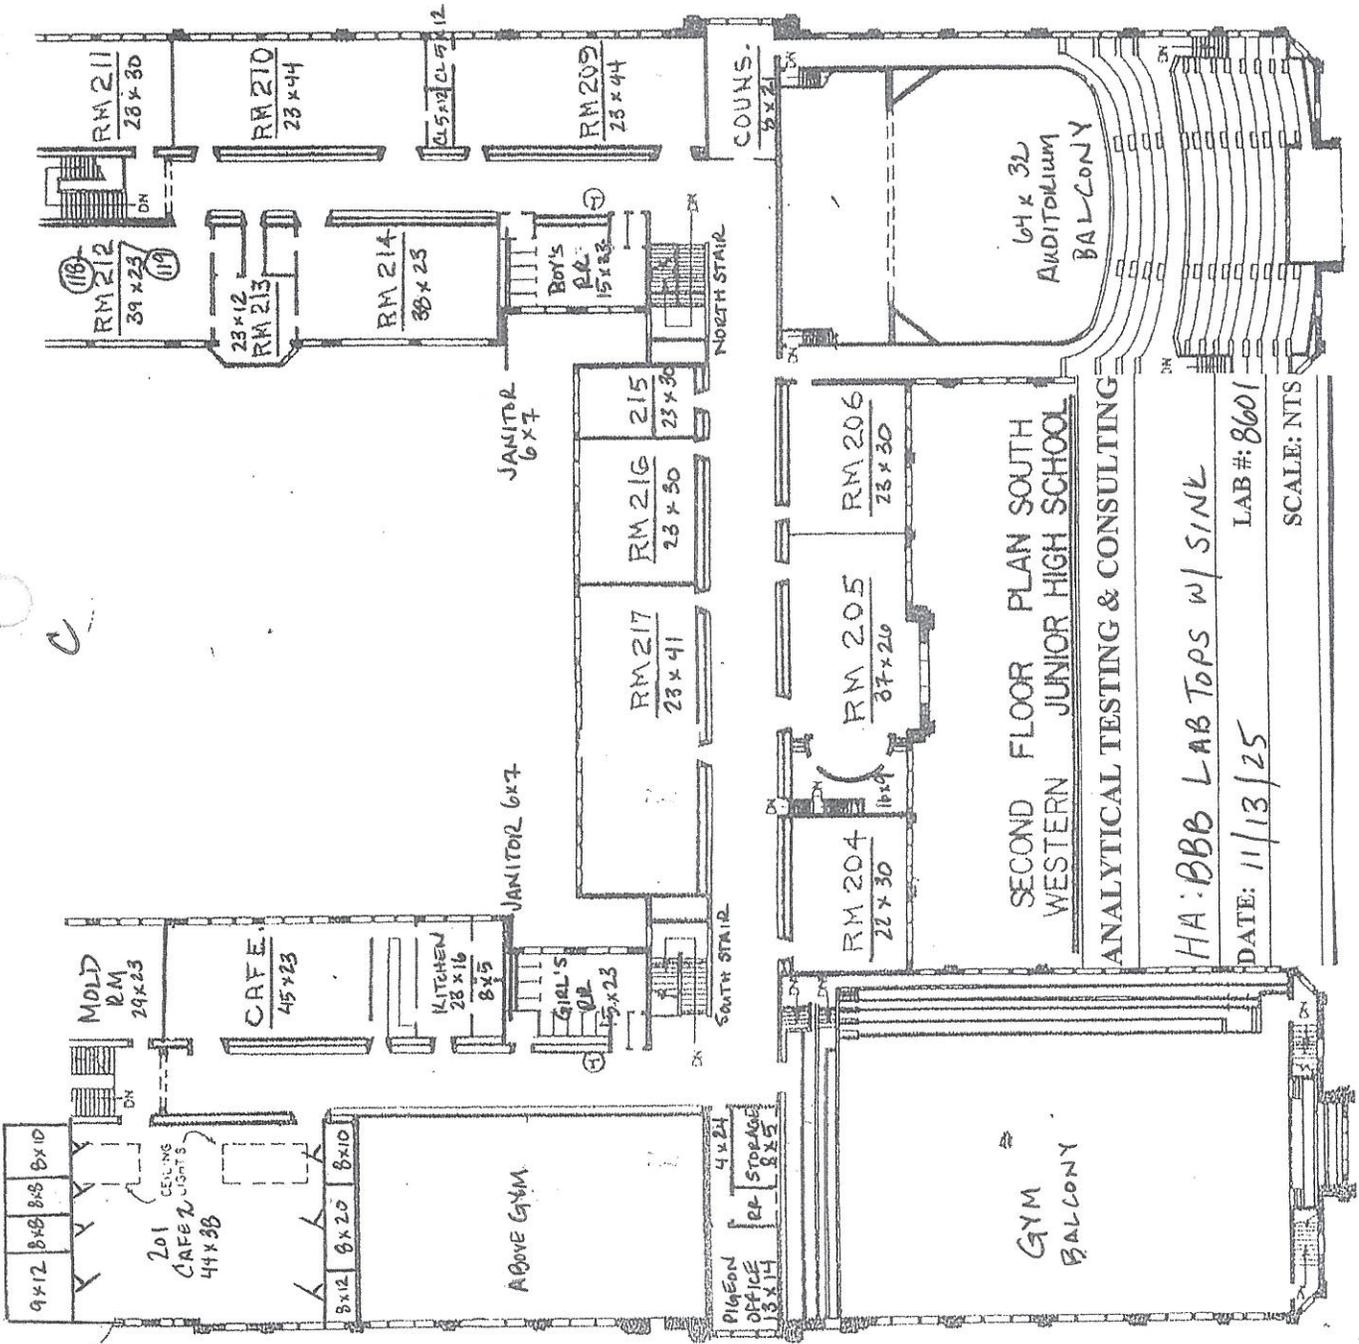
SECOND FLOOR PLAN SOUTH  
WESTERN JUNIOR HIGH SCHOOL  
ANALYTICAL TESTING & CONSULTING  
HA: BBB LAB TOPS w/ SINK  
LAB #: 8601  
DATE: 11/13/25  
SCALE: NTS

**HA DESCRIPTION:** Lab Tops with Sink

HA LOCATION	Type SM/TSI/MM	Friability F/NF	Physical Condition	Size SF/LF/MF
Room 212	MM	NF	2	~10 SF
Room 213	MM	NF	2	~2 SF
<b>TOTAL</b>				~12 SF

Sample No.	Description and Location	Results (%)
8601-118	Sample of lab tops with sink from Room 212	None Detected
8601-119	Sample of lab tops with sink from Room 212	None Detected
<p><i>*Note: All samples were collected in a statistically random manner representative of Homogeneous Area in accordance with 40 CFR 763.86.</i></p>

Location	Recommendations
HA-BBB	<b>Non Asbestos</b>

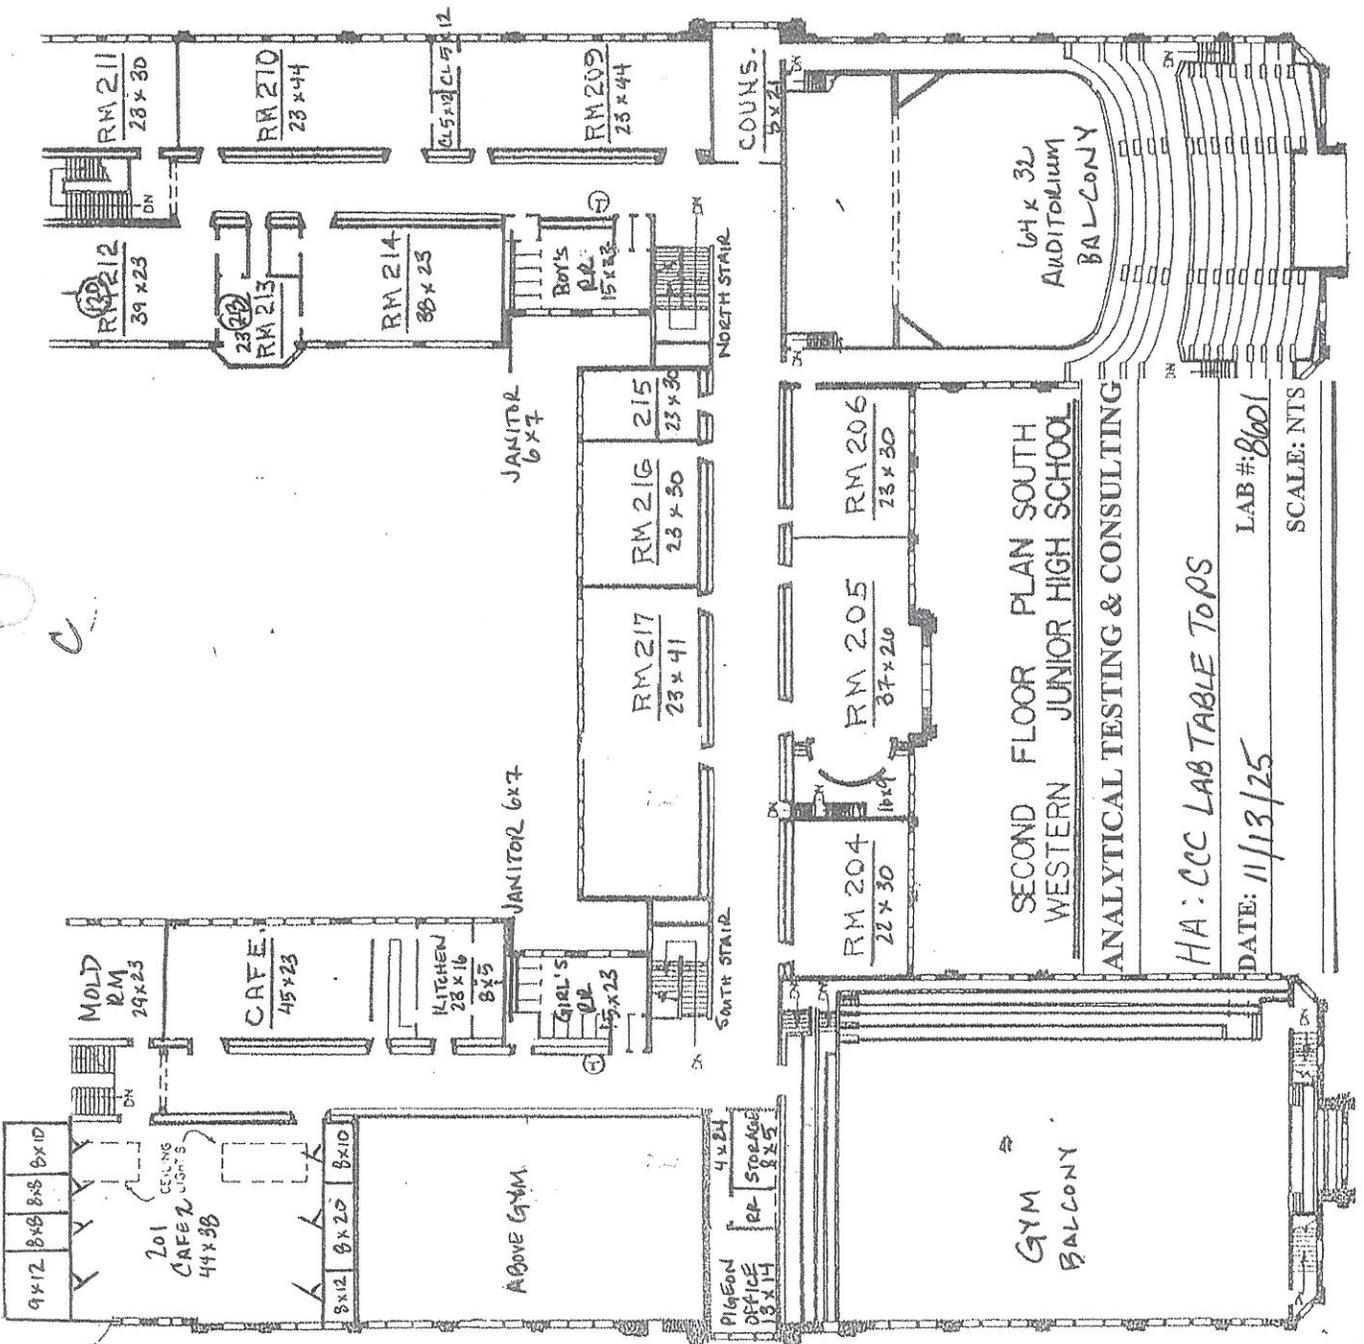
**HA DESCRIPTION:** Lab Table Tops

HA LOCATION	Type SM/TSI/MM	Friability F/NF	Physical Condition	Size SF/LF/MF
Room 212	MM	NF	2	~129 SF
Room 213	MM	NF	2	~105 SF
<b>TOTAL</b>				~234 SF

Sample No.	Description and Location	Results (%)
8601-120	Sample of lab table top from Room 212	None Detected
8601-121	Sample of lab table top from Room 213	None Detected
*Note: All samples were collected in a statistically random manner representative of Homogeneous Area in accordance with 40 CFR 763.86.

Location	Recommendations
HA-CCC	<b>Non Asbestos</b>

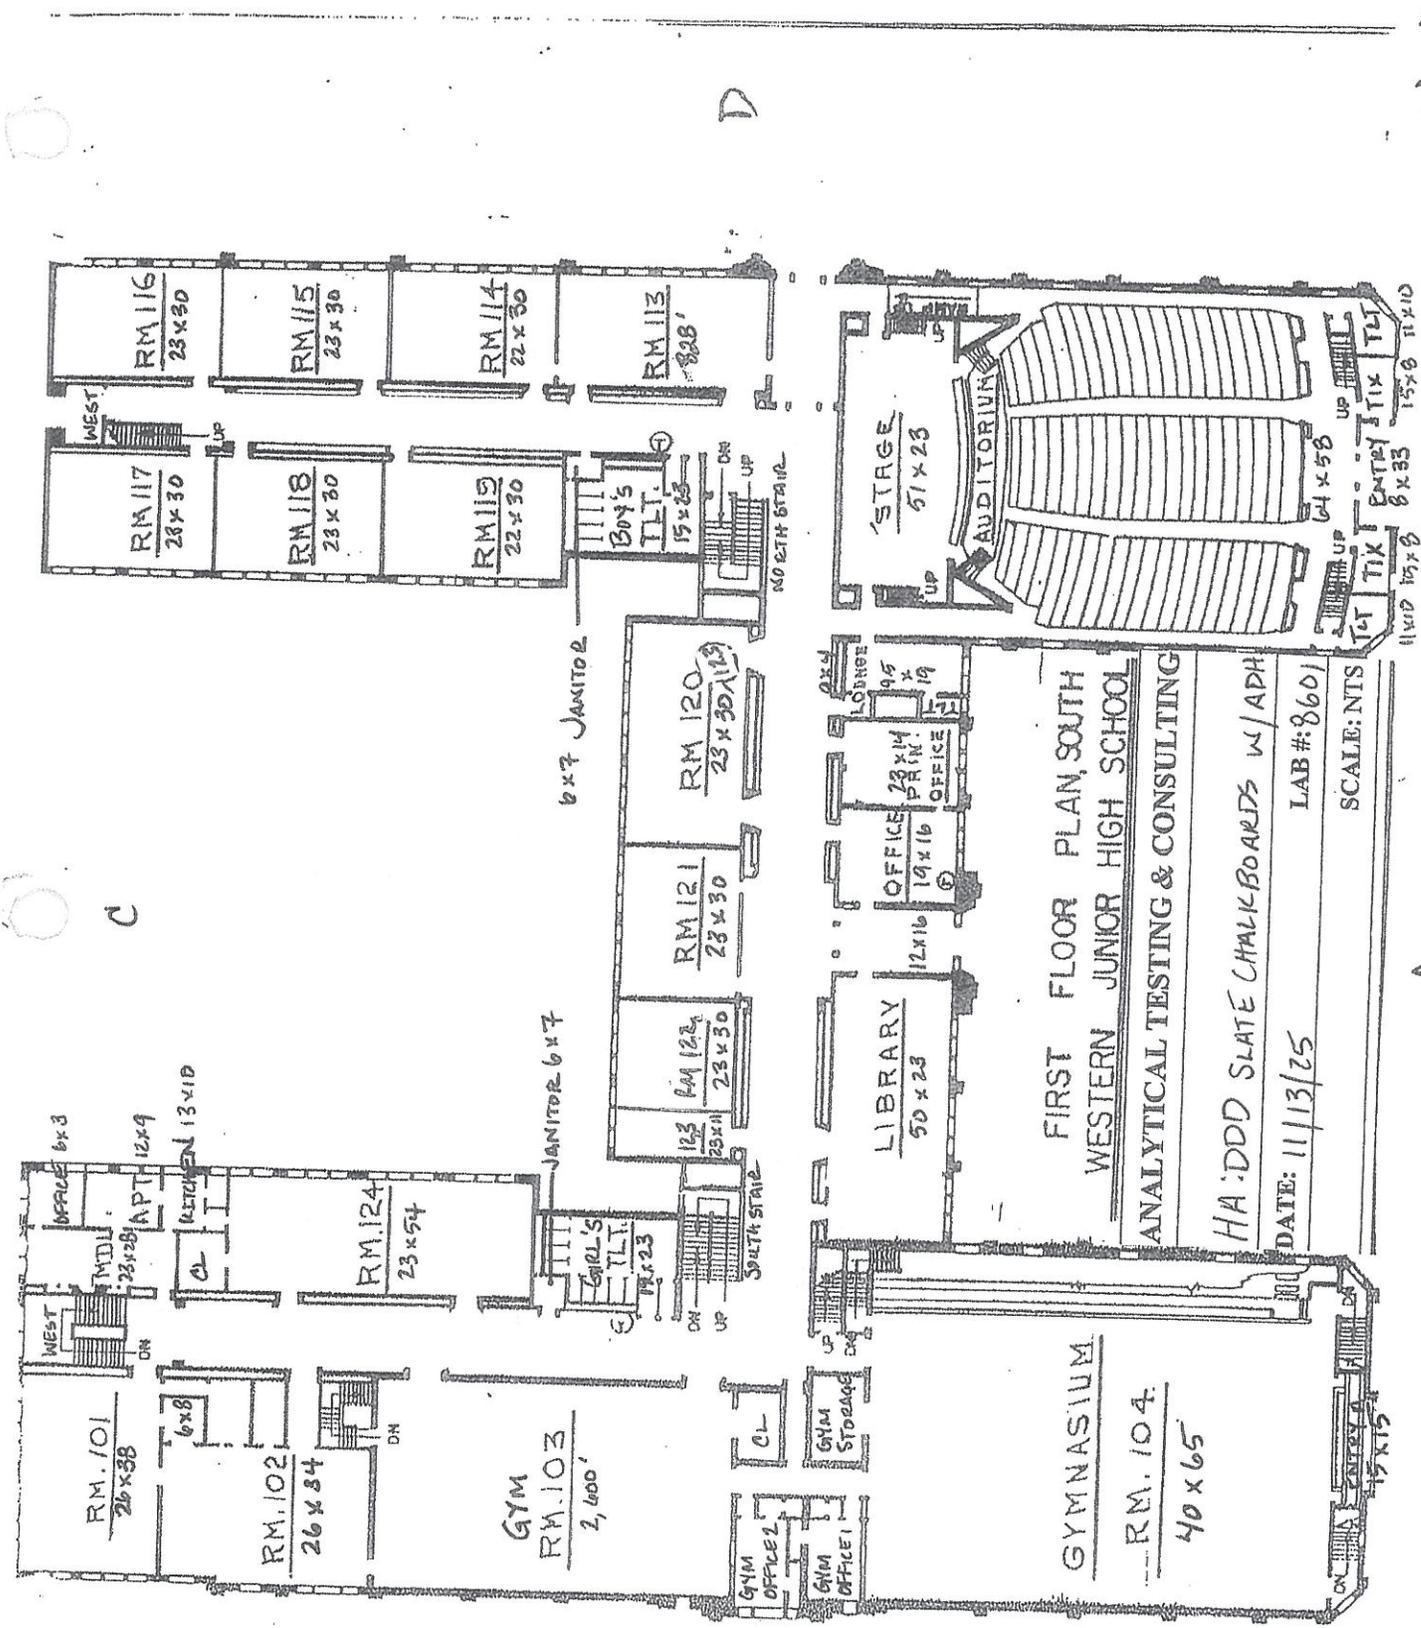
HA:DDD SLATE CHALKBOARDS W/ADH  
DATE: 11/13/75  
LAB #: 8601  
SCALE: NTS

**HA DESCRIPTION:** Slate Chalkboards with Adhesive

HA LOCATION	Type SM/TSI/MM	Friability F/NF	Physical Condition	Size SF/LF/MF
D23 (1)	MM	NF	2	~100 SF
Shop classroom (1)	MM	NF	2	~100 SF
Room 124 (1)	MM	NF	2	~100 SF
Room 113 (3)	MM	NF	2	~300 SF
Room 114 (3)	MM	NF	2	~300 SF
Room 115 (3)	MM	NF	2	~300 SF
Room 116 (3)	MM	NF	2	~300 SF
Room 117 (3)	MM	NF	2	~300 SF
Room 118 (2)	MM	NF	2	~200 SF
Room 119 (3)	MM	NF	2	~300 SF
Room 120 (3)	MM	NF	2	~300 SF
Room 121 (3)	MM	NF	2	~300 SF
Mold Room (3)	MM	NF	2	~300 SF
Room 204 (3)	MM	NF	2	~300 SF
Room 205 (2)	MM	NF	2	~200 SF
Room 206 (2)	MM	NF	2	~200 SF
Room 209 (3)	MM	NF	2	~300 SF
Room 210 (3)	MM	NF	2	~300 SF
Room 211 (2)	MM	NF	2	~200 SF
Room 212 (1)	MM	NF	2	~100 SF
Room 215 (3)	MM	NF	2	~300 SF
Room 216 (3)	MM	NF	2	~300 SF
Room 217 (3)	MM	NF	2	~300 SF
<b>TOTAL</b>				~5,700 SF

Sample No.	Description and Location	Results (%)
8601-122	Sample of slate chalkboard with adhesive from Room 215	Layer 1 – None Detected Layer 2 – None Detected
8601-123	Sample of slate chalkboard with adhesive from Room 120	Layer 1 – None Detected Layer 2 – None Detected
*Note: All samples were collected in a statistically random manner representative of Homogeneous Area in accordance with 40 CFR 763.86.

Location	Recommendations
HA-DDD	Non Asbestos
