ASBESTOS SURVEY DATA FORM

LOCATION: Southwestern Junior High School

ADDRESS: 390 S. Washington, Battle Creek, Michigan 49017

DATE: Sept/Oct/Nov/Dec 2025

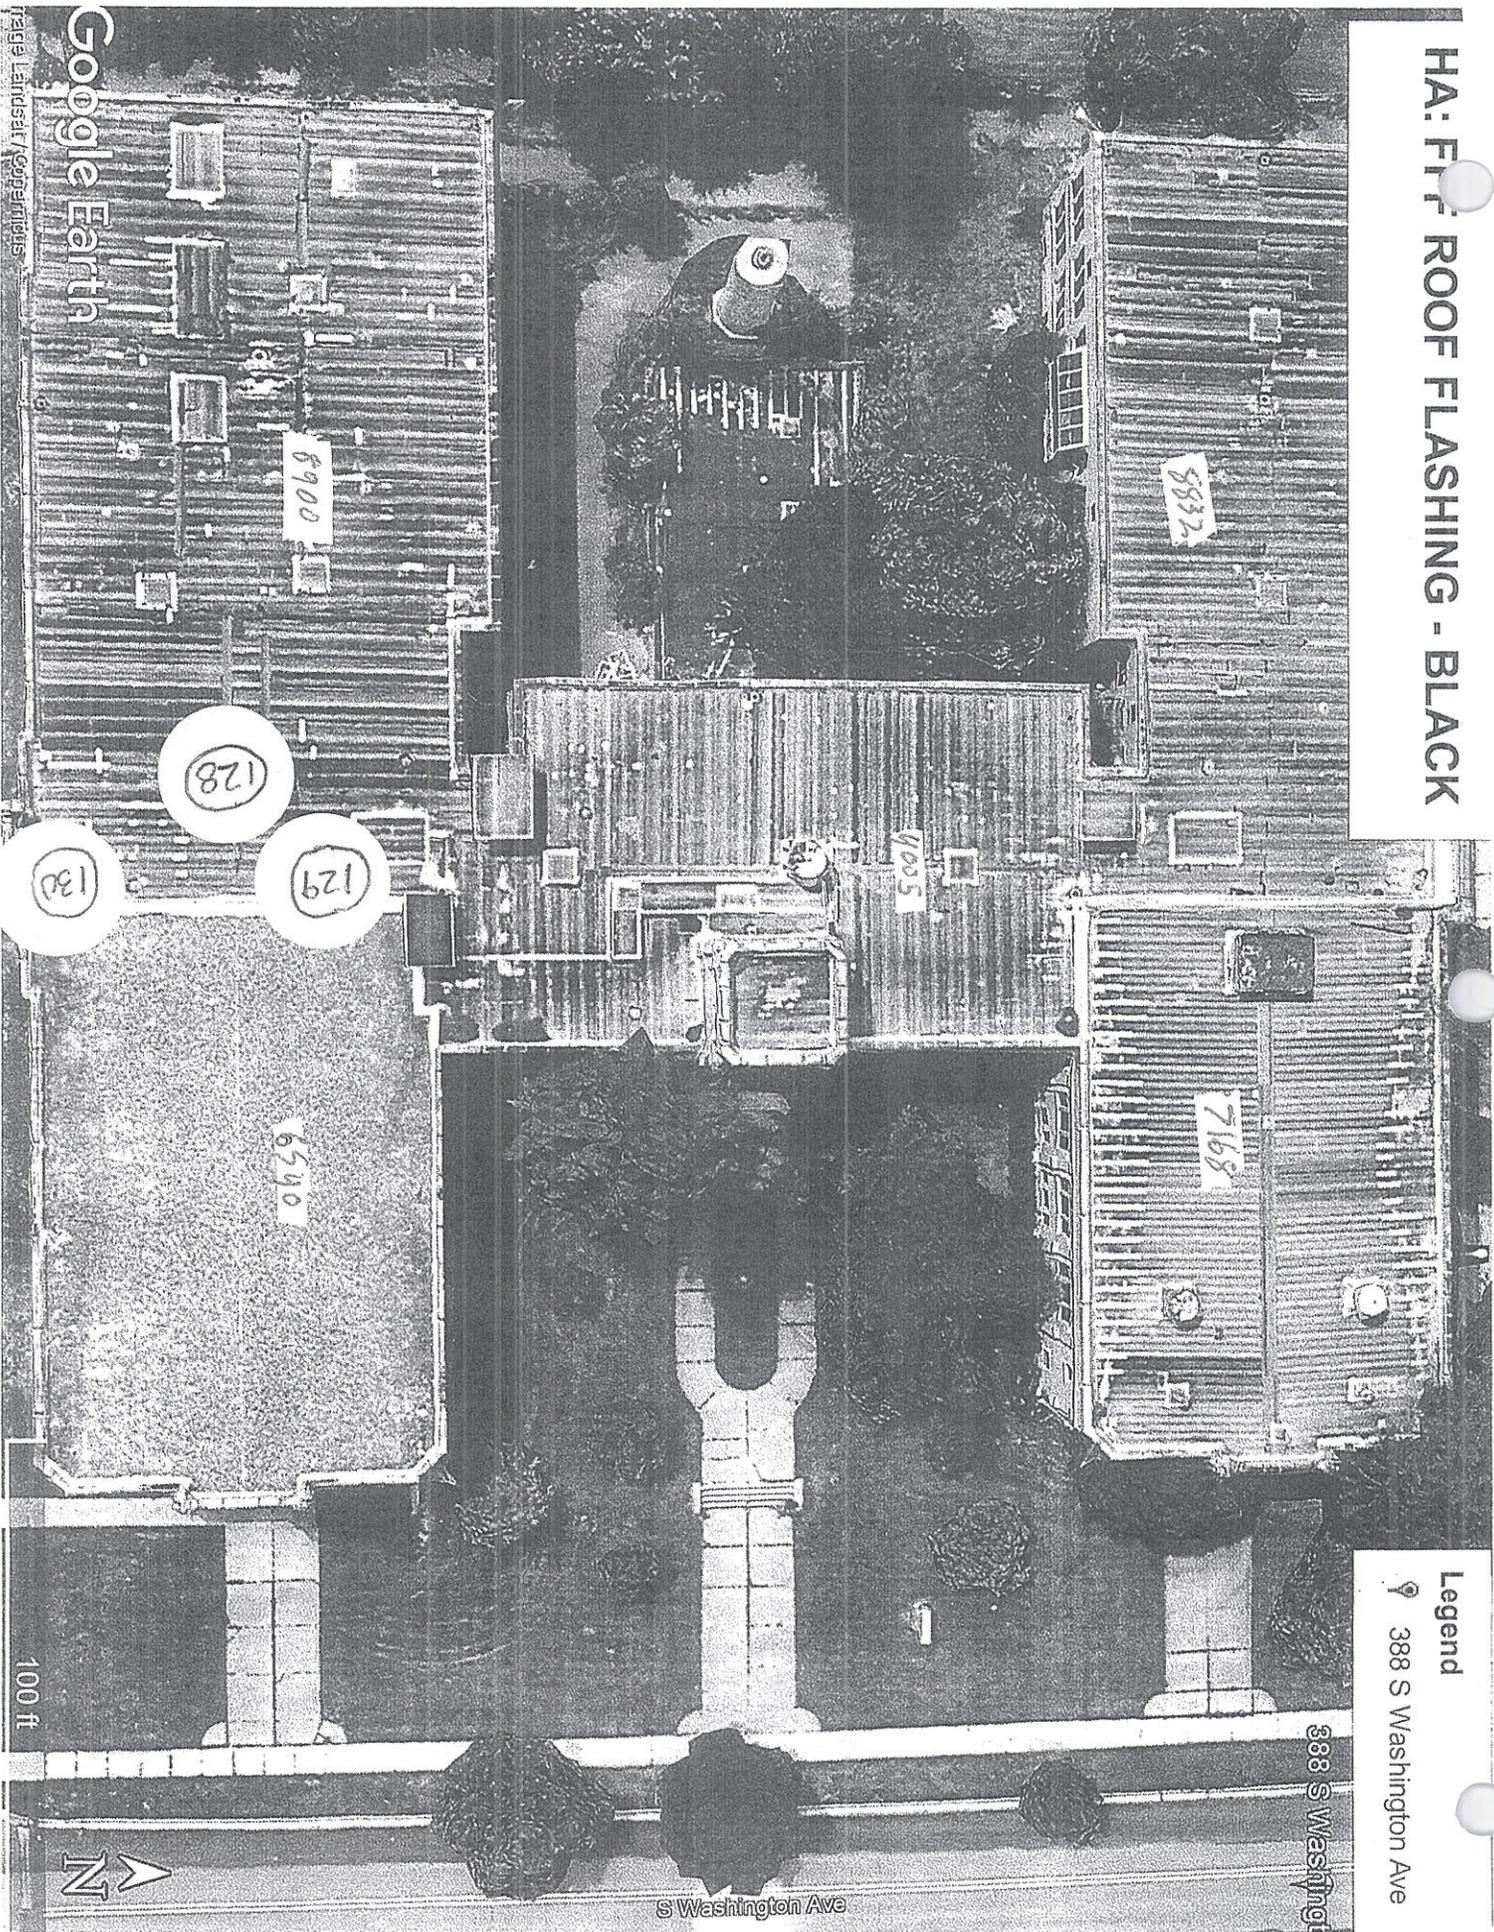
HA: FIRE ROOF FLASHING - BLACK

HA DESCRIPTION: Roof Flashing on Main Building

HA LOCATION	Type SM/TSI/MM	Friability F/NF	Physical Condition	Size SF/LF/MF
Stink pipes, roof flashing, vents, roof drains	MM	NF	1	~35,445 SF
TOTAL				~35,445 SF

Sample No.	Description and Location	Results (%)
8601-128	Sample of roof flashing from above Girl's Gym 103 center	10% Chrysotile
8601-129	Sample of flashing from parapet over gym Room 103 Side A	20% Chrysotile
8601-130	Sample of flashing from gym roof stink pipe Side A Room 103	20% Chrysotile
<p><i>*Note: All samples were collected in a statistically random manner representative of Homogeneous Area in accordance with 40 CFR 763.86.</i></p>

Location	Recommendations
HA-FFF	Remove Asbestos Prior to Demolition/ Renovation

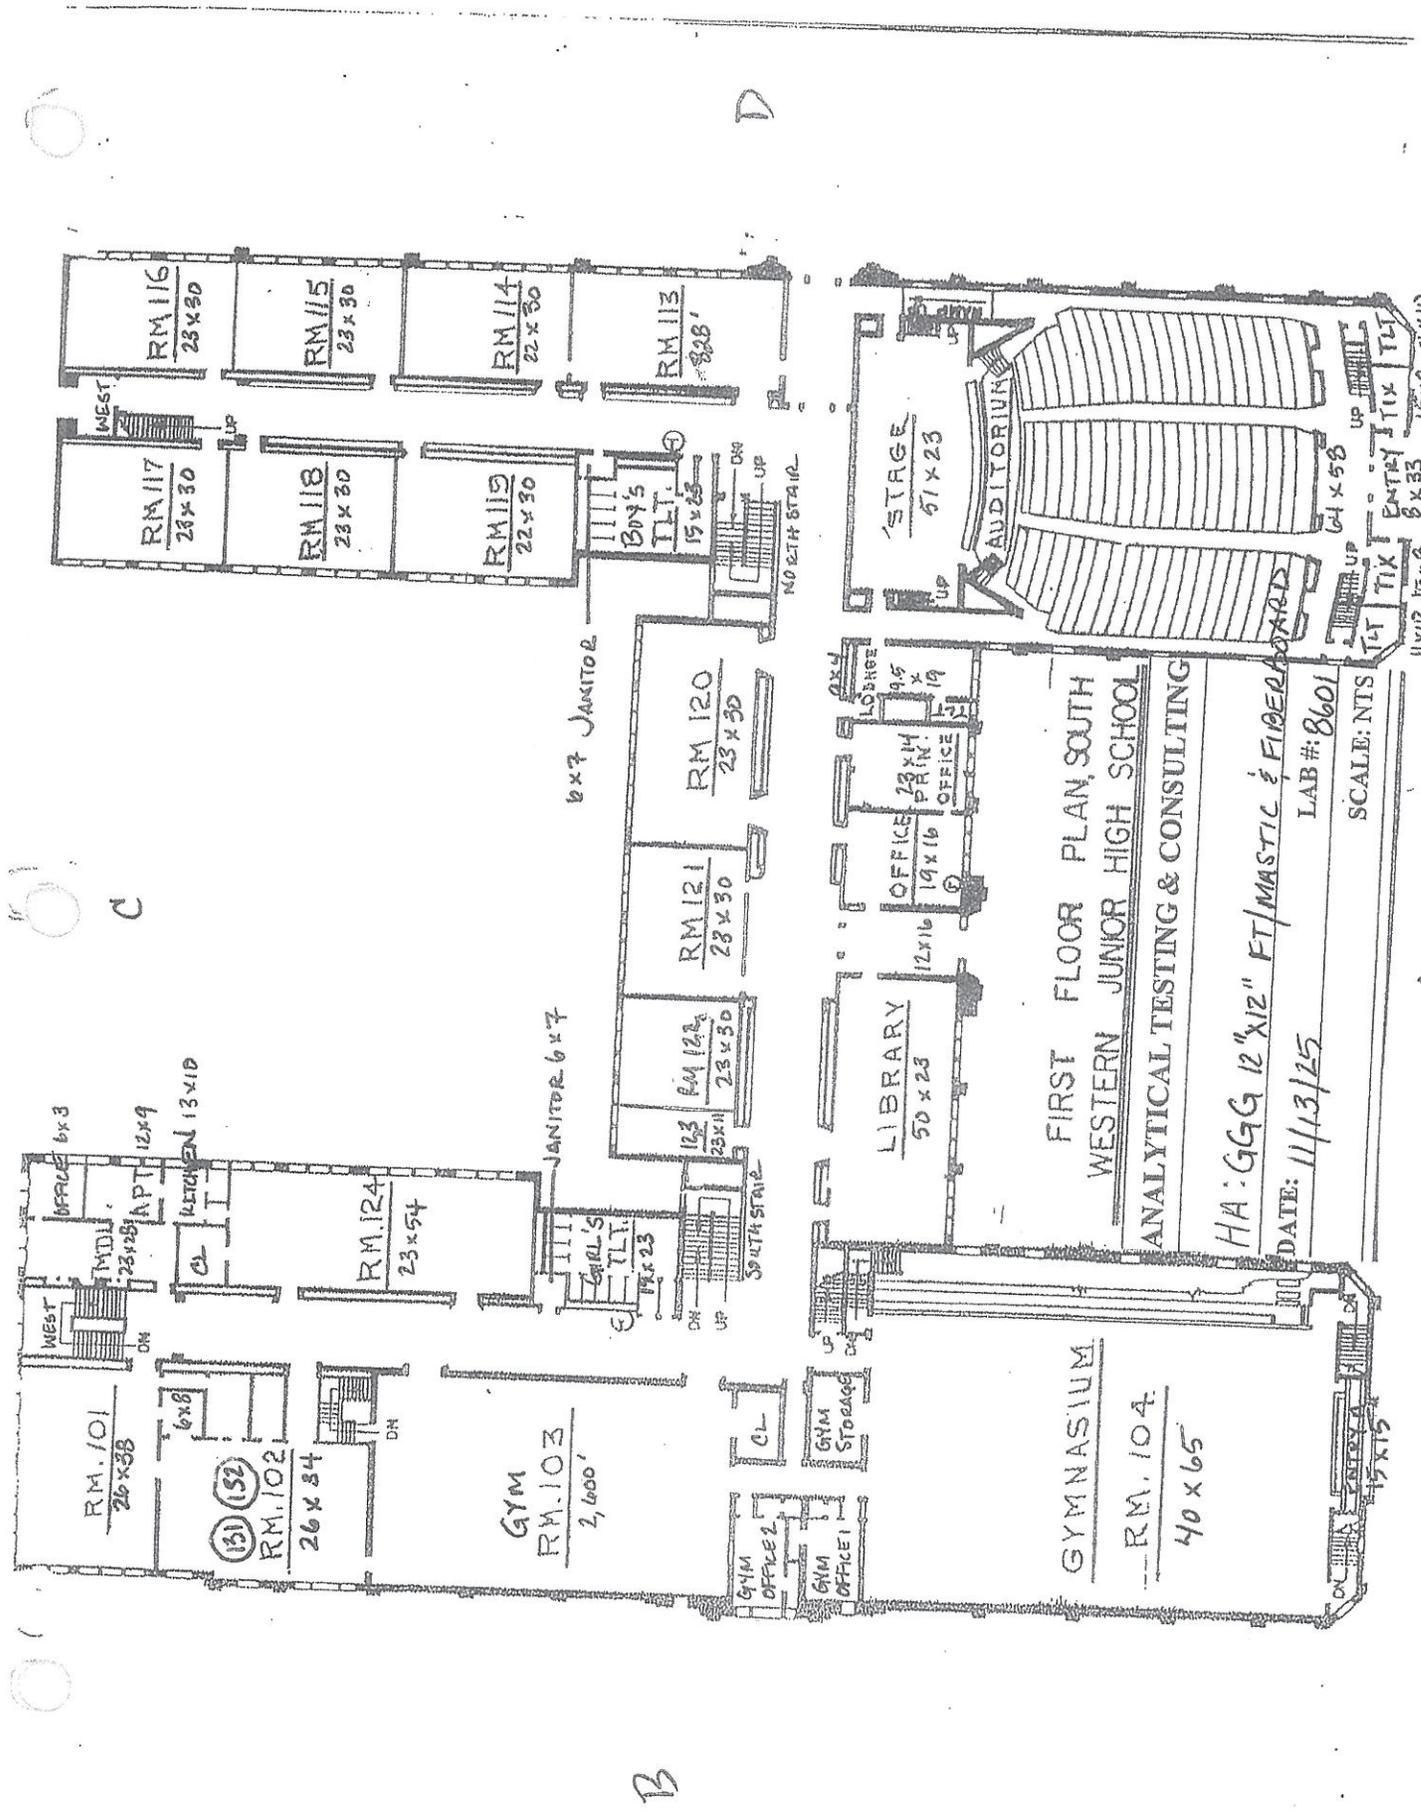
FIRST FLOOR PLAN, SOUTH
 WESTERN JUNIOR HIGH SCHOOL
 ANALYTICAL TESTING & CONSULTING
 HA: GGG 12" X 12" FT/MASTIC & FIBERGLASS
 DATE: 11/13/25
 LAB #: 8601
 SCALE: NTS

HA DESCRIPTION: 12"x12" Floor Tile/ Mastic with Fiberboard

HA LOCATION	Type SM/TSI/MM	Friability F/NF	Physical Condition	Size SF/LF/MF
Room 102	MM	NF	7	~858 SF
TOTAL				~858 SF

Sample No.	Description and Location	Results (%)
8601-131	Sample of floor tile/ mastic with fiberboard from center	Layer 1 – None Detected Layer 2 – None Detected
8601-132	Sample of floor tile/ mastic with fiberboard from center	Layer 1 – None Detected Layer 2 – None Detected
*Note: All samples were collected in a statistically random manner representative of Homogeneous Area in accordance with 40 CFR 763.86.

Location	Recommendations
HA-GGG	Non Asbestos

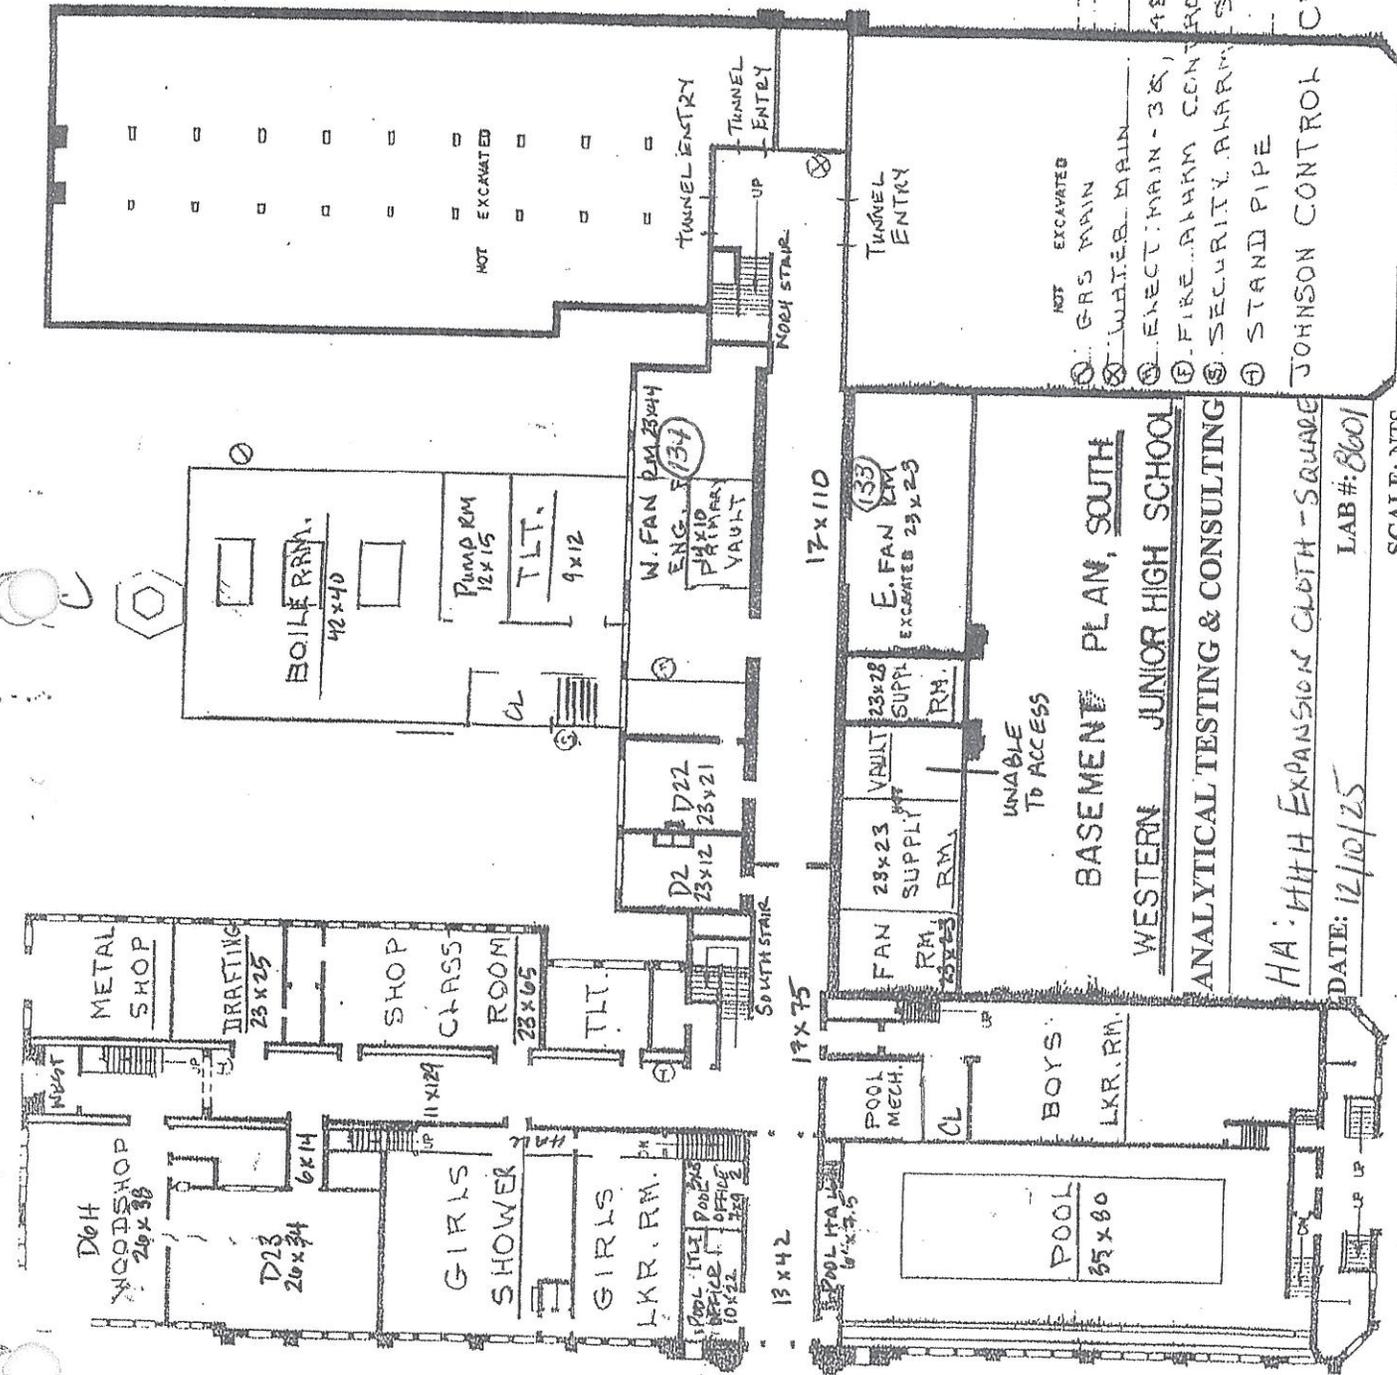
HA: HHH EXPANSION CLOTH - SQUARE

HA DESCRIPTION: Expansion Cloth – Square

HA LOCATION	Type SM/TSI/MM	Friability F/NF	Physical Condition	Size SF/LF/MF
East Fan Room	MM	F	7	~15 LF / ~2.5 SF
West Fan Room	MM	F	7	~20 LF / ~9 SF
TOTAL				~35 LF / ~12 SF

Sample No.	Description and Location	Results (%)
8601-133	Sample of expansion cloth from east fan room	None Detected
8601-134	Sample of expansion cloth from west fan room	None Detected
*Note: All samples were collected in a statistically random manner representative of Homogeneous Area in accordance with 40 CFR 763.86.

Location	Recommendations
HA-HHH	Non Asbestos

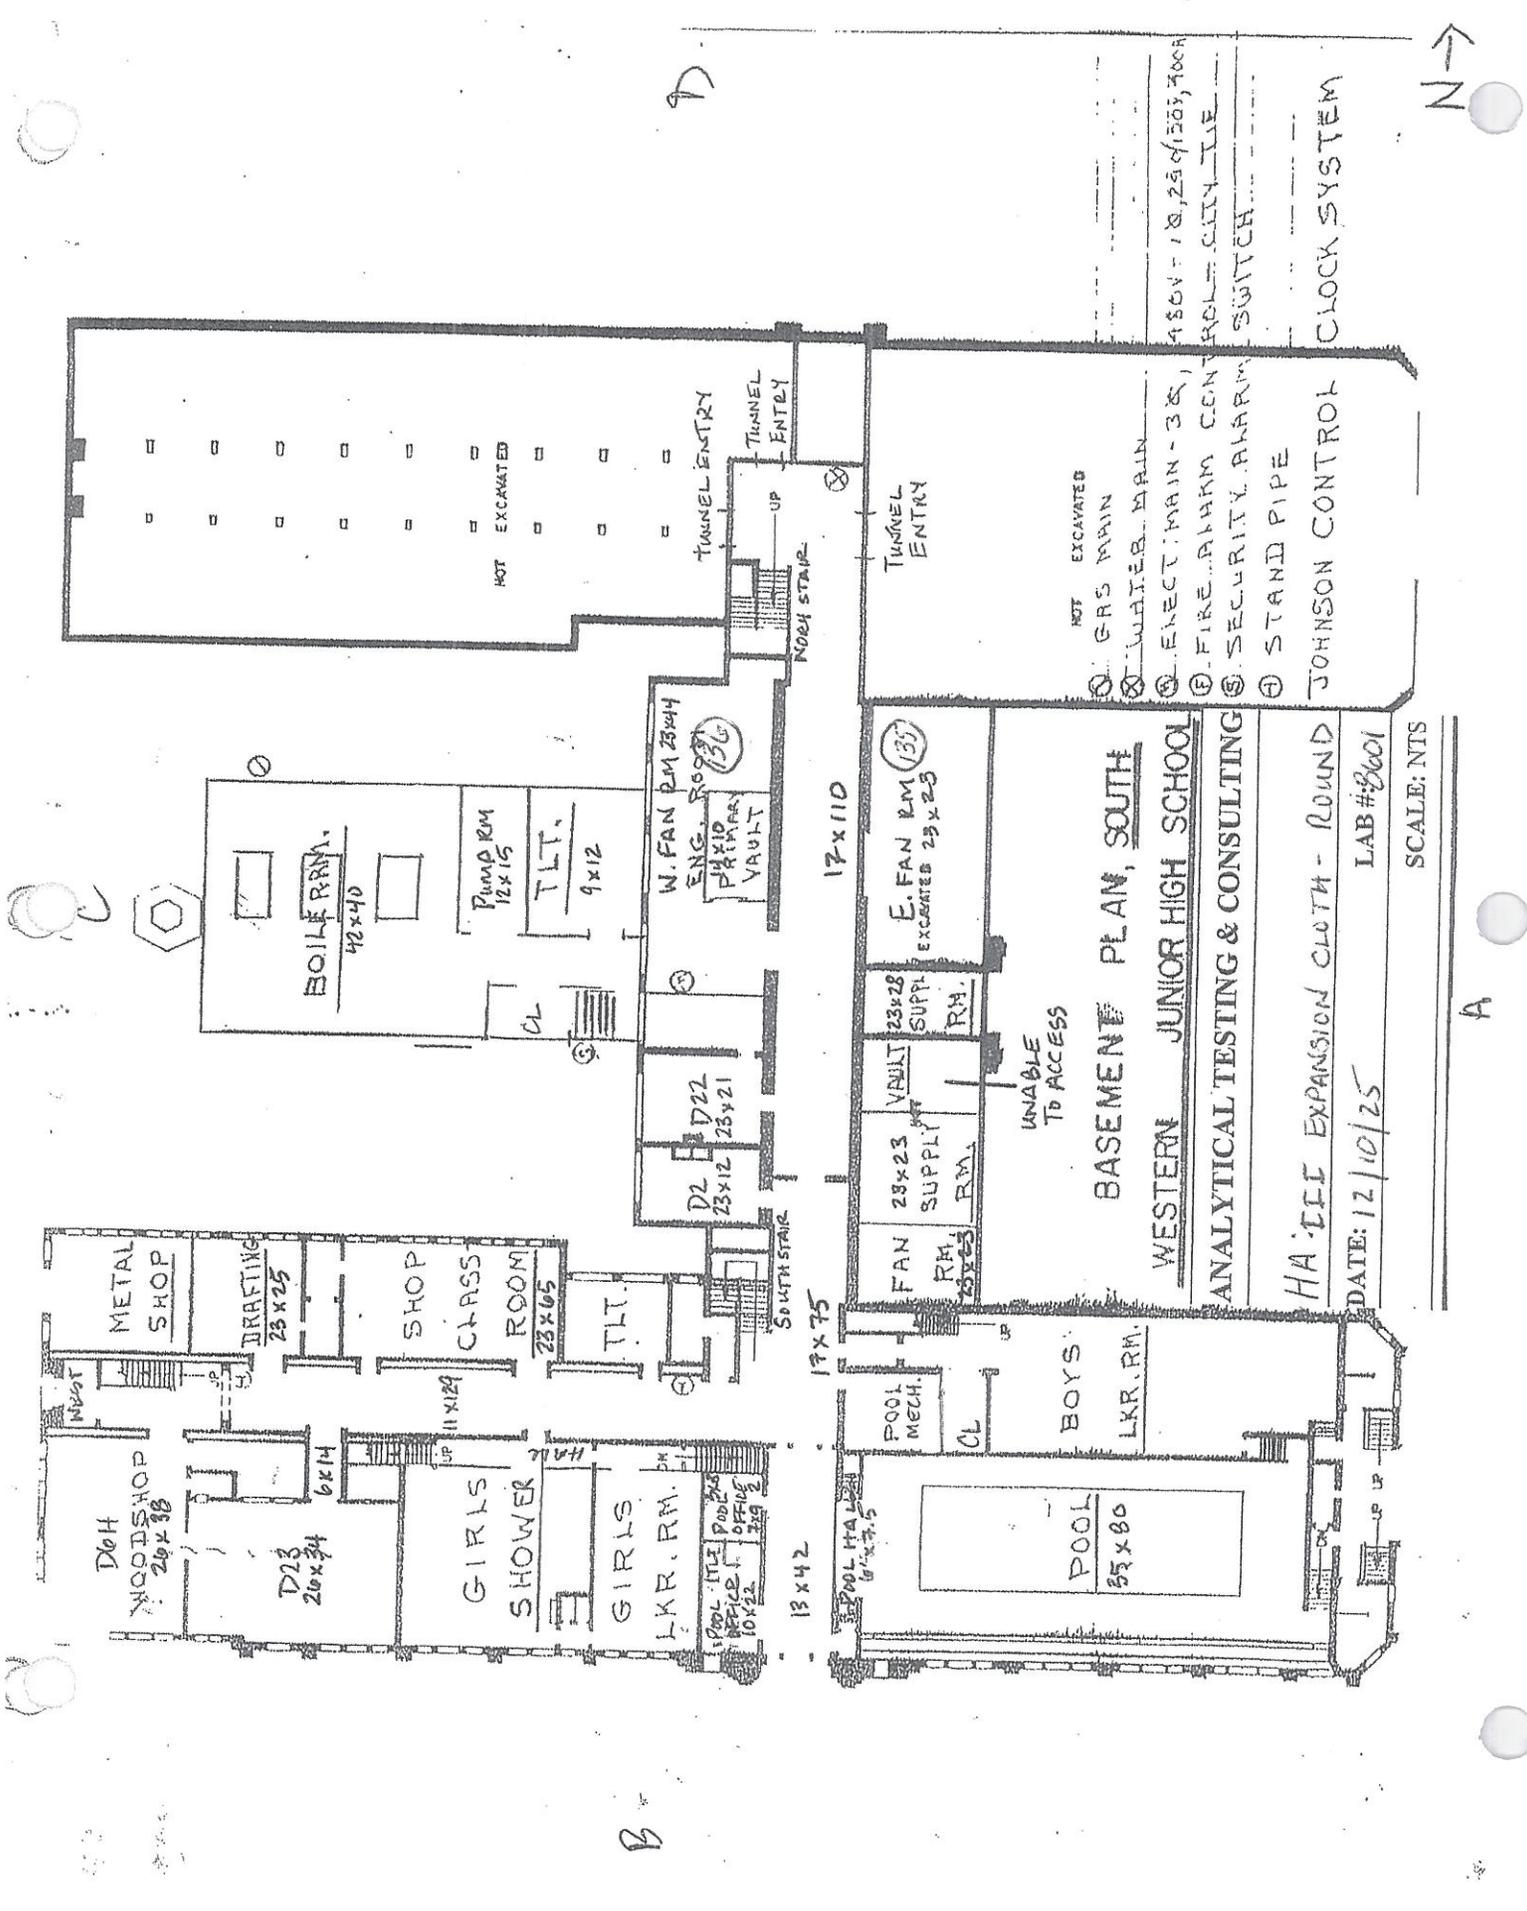
BASEMENT PLAN, SOUTH
 WESTERN JUNIOR HIGH SCHOOL
 ANALYTICAL TESTING & CONSULTING
 HA-III EXPANSION CLOTH - ROUND
 DATE: 12/10/25
 LAB #8601
 SCALE: NTS

HA DESCRIPTION: Expansion Cloth – Round

HA LOCATION	Type SM/TSI/MM	Friability F/NF	Physical Condition	Size SF/LF/MF
West Fan Room	MM	F	7	~20 LF / ~9 SF
East Fan Room	MM	F	7	~10 LF / ~5 SF
TOTAL				~30 LF / ~14 SF

Sample No.	Description and Location	Results (%)
8601-135	Sample of expansion cloth from East Fan Room	None Detected
8601-136	Sample of expansion cloth from West Fan Room	None Detected
*Note: All samples were collected in a statistically random manner representative of Homogeneous Area in accordance with 40 CFR 763.86.

Location	Recommendations
HA-III	Non Asbestos

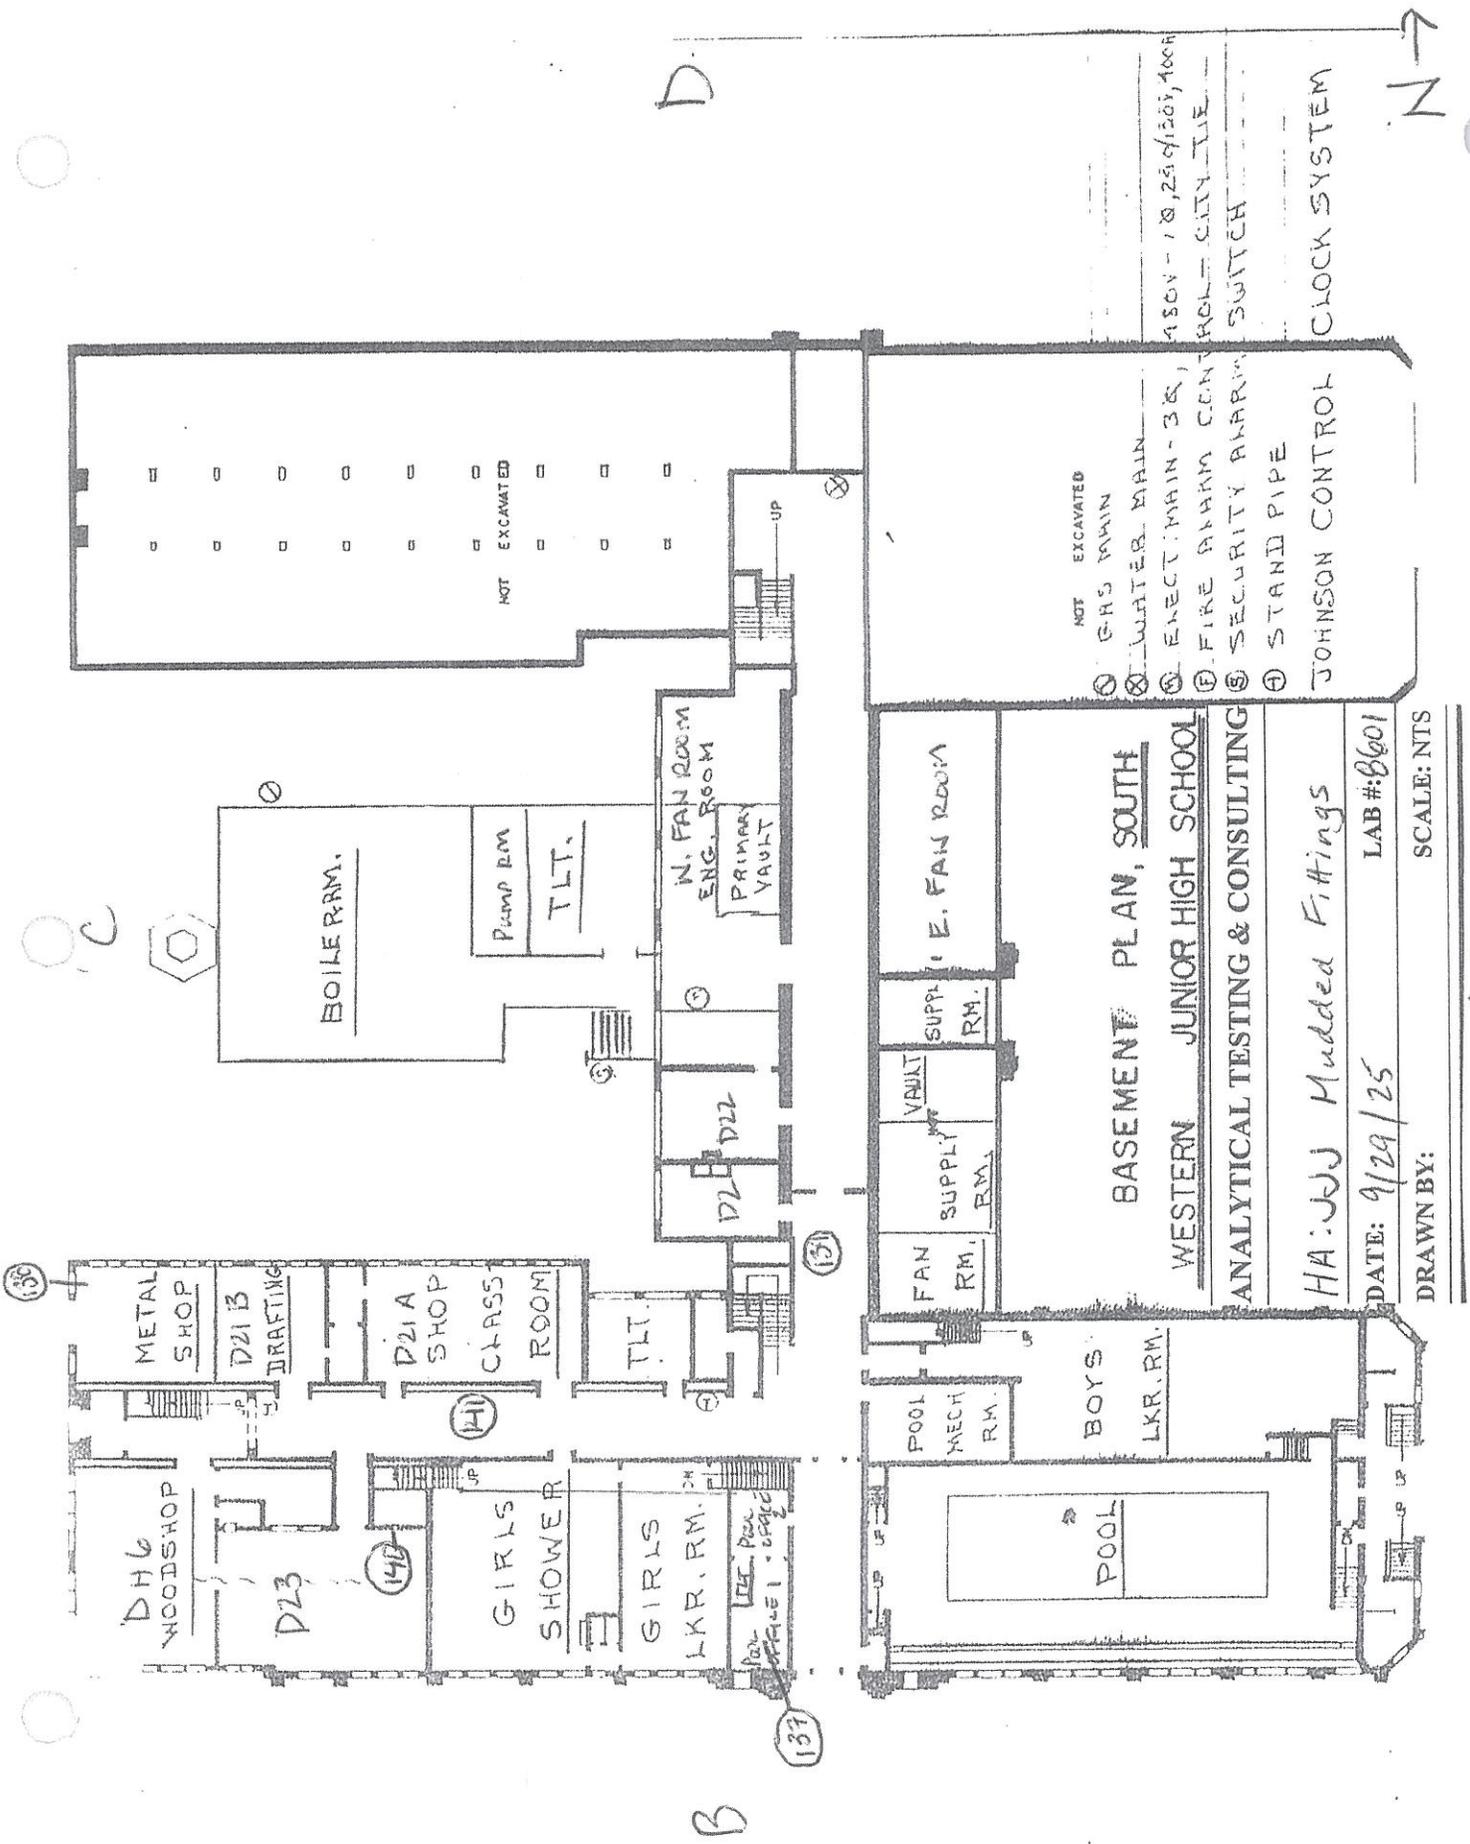
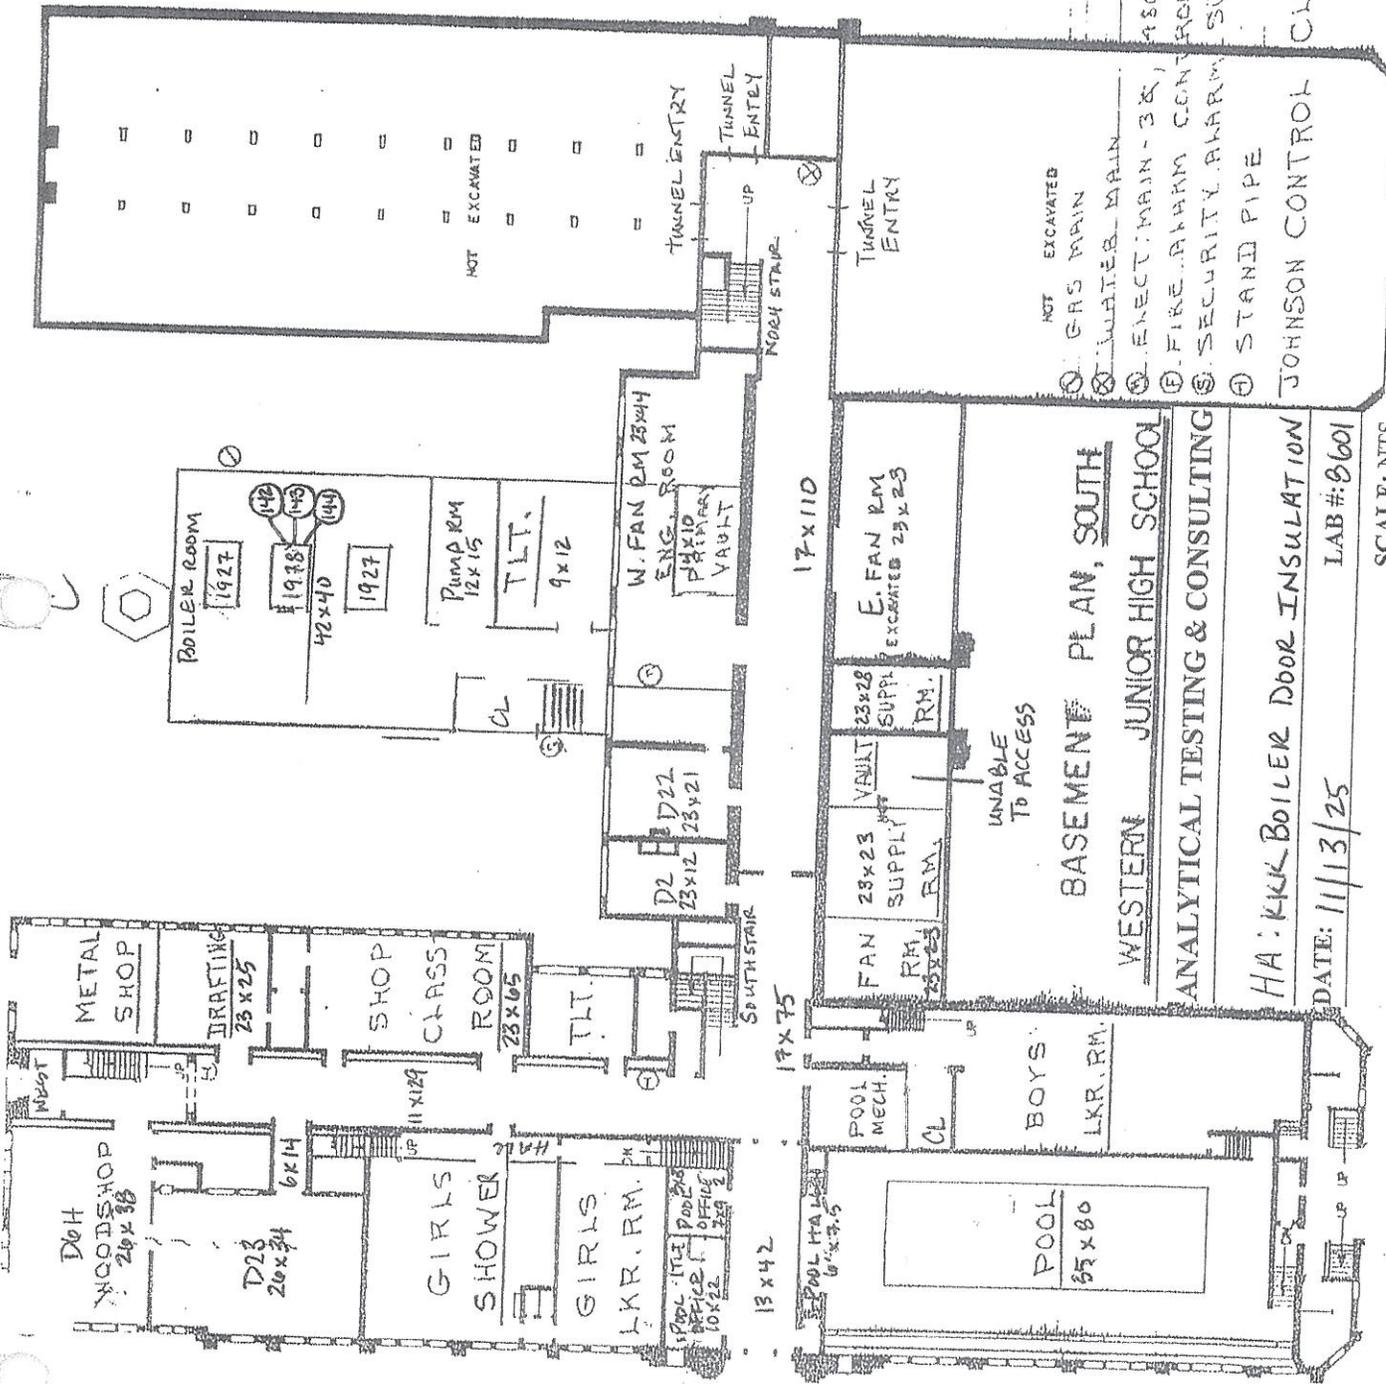
HA DESCRIPTION: Mudded Fittings on TSI Pipe Wrap

HA LOCATION	Type SM/TSI/MM	Friability F/NF	Physical Condition	Size SF/LF/MF
Lower level – TSI Total in HA: ZZZ	TSI	F	4 / 7	TSI Total in HA: ZZZ
TOTAL

Sample No.	Description and Location	Results (%)
8601-137	Sample of mudded fitting from Pool Office 1 Side B	70% Chrysotile
8601-138	Sample of mudded fitting from metal shop from Side C	70% Chrysotile
8601-139	Sample of mudded fitting from basement hall Side center	70% Chrysotile
8601-140	Sample of mudded fitting from Room D23 by Side D wall front right side of room	45% Chrysotile
8601-141	Sample of mudded fitting from hallway by Room D21A Side D of hall	45% Chrysotile
*Note: All samples were collected in a statistically random manner representative of Homogeneous Area in accordance with 40 CFR 763.86.

Location	Recommendations
HA-JJJ	Remove Asbestos Prior to Demolition/ Renovation

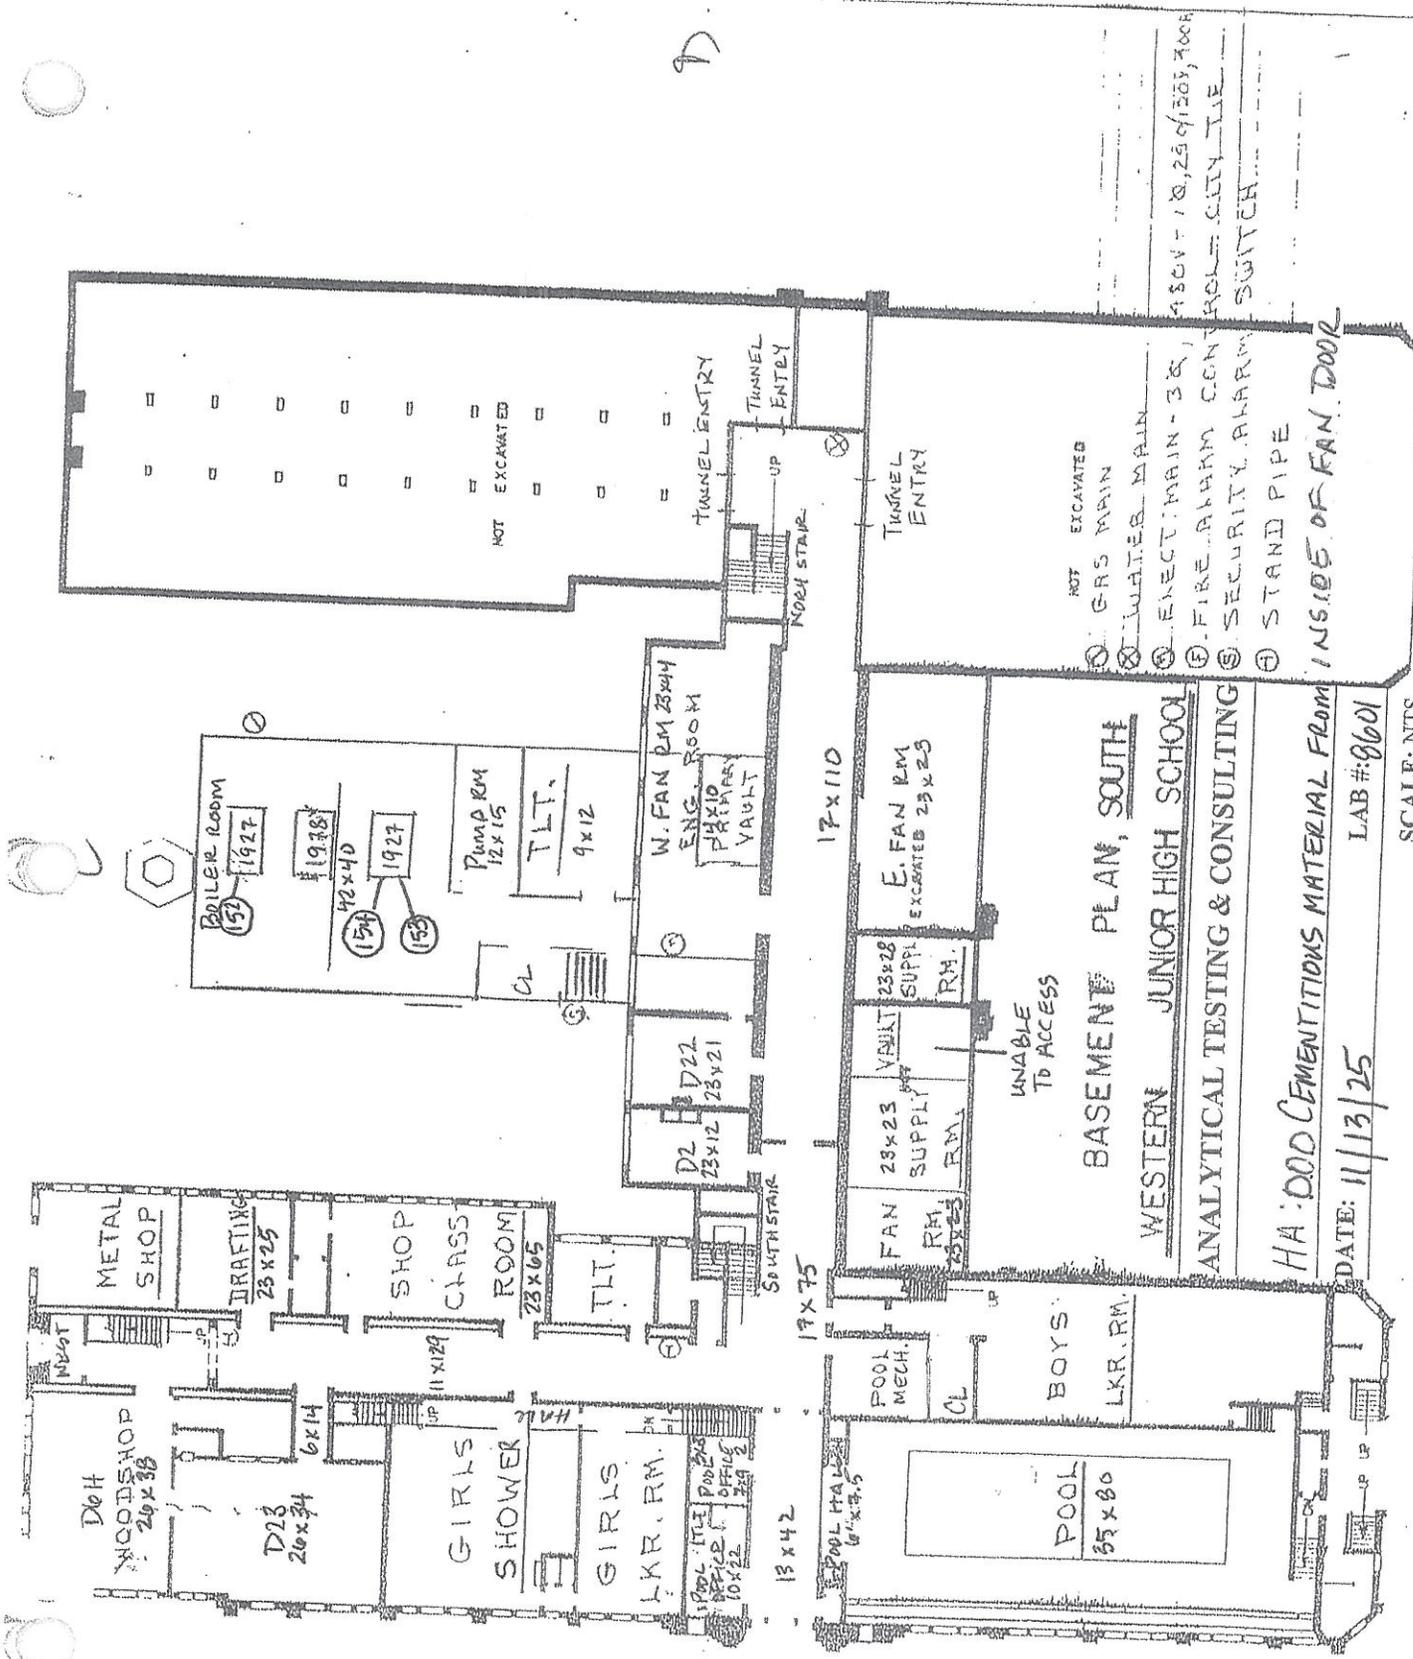
HA: DOD CEMENTITIONS MATERIAL FROM

HA DESCRIPTION: Cementitious Material from Inside of Fan Door

HA LOCATION	Type SM/TSI/MM	Friability F/NF	Physical Condition	Size SF/LF/MF
1927 boilers (2)	TSI	F	7	~80 SF
TOTAL				~80 SF

Sample No.	Description and Location	Results (%)
8601-152	Sample of cementitious material from inside fan door closest to stack	None Detected
8601-153	Sample of cementitious material from inside fan door closest to stairs	None Detected
8601-154	Sample of cementitious material from inside fan door closest to stairs	None Detected
*Note: All samples were collected in a statistically random manner representative of Homogeneous Area in accordance with 40 CFR 763.86.

Location	Recommendations
HA-000	Non Asbestos

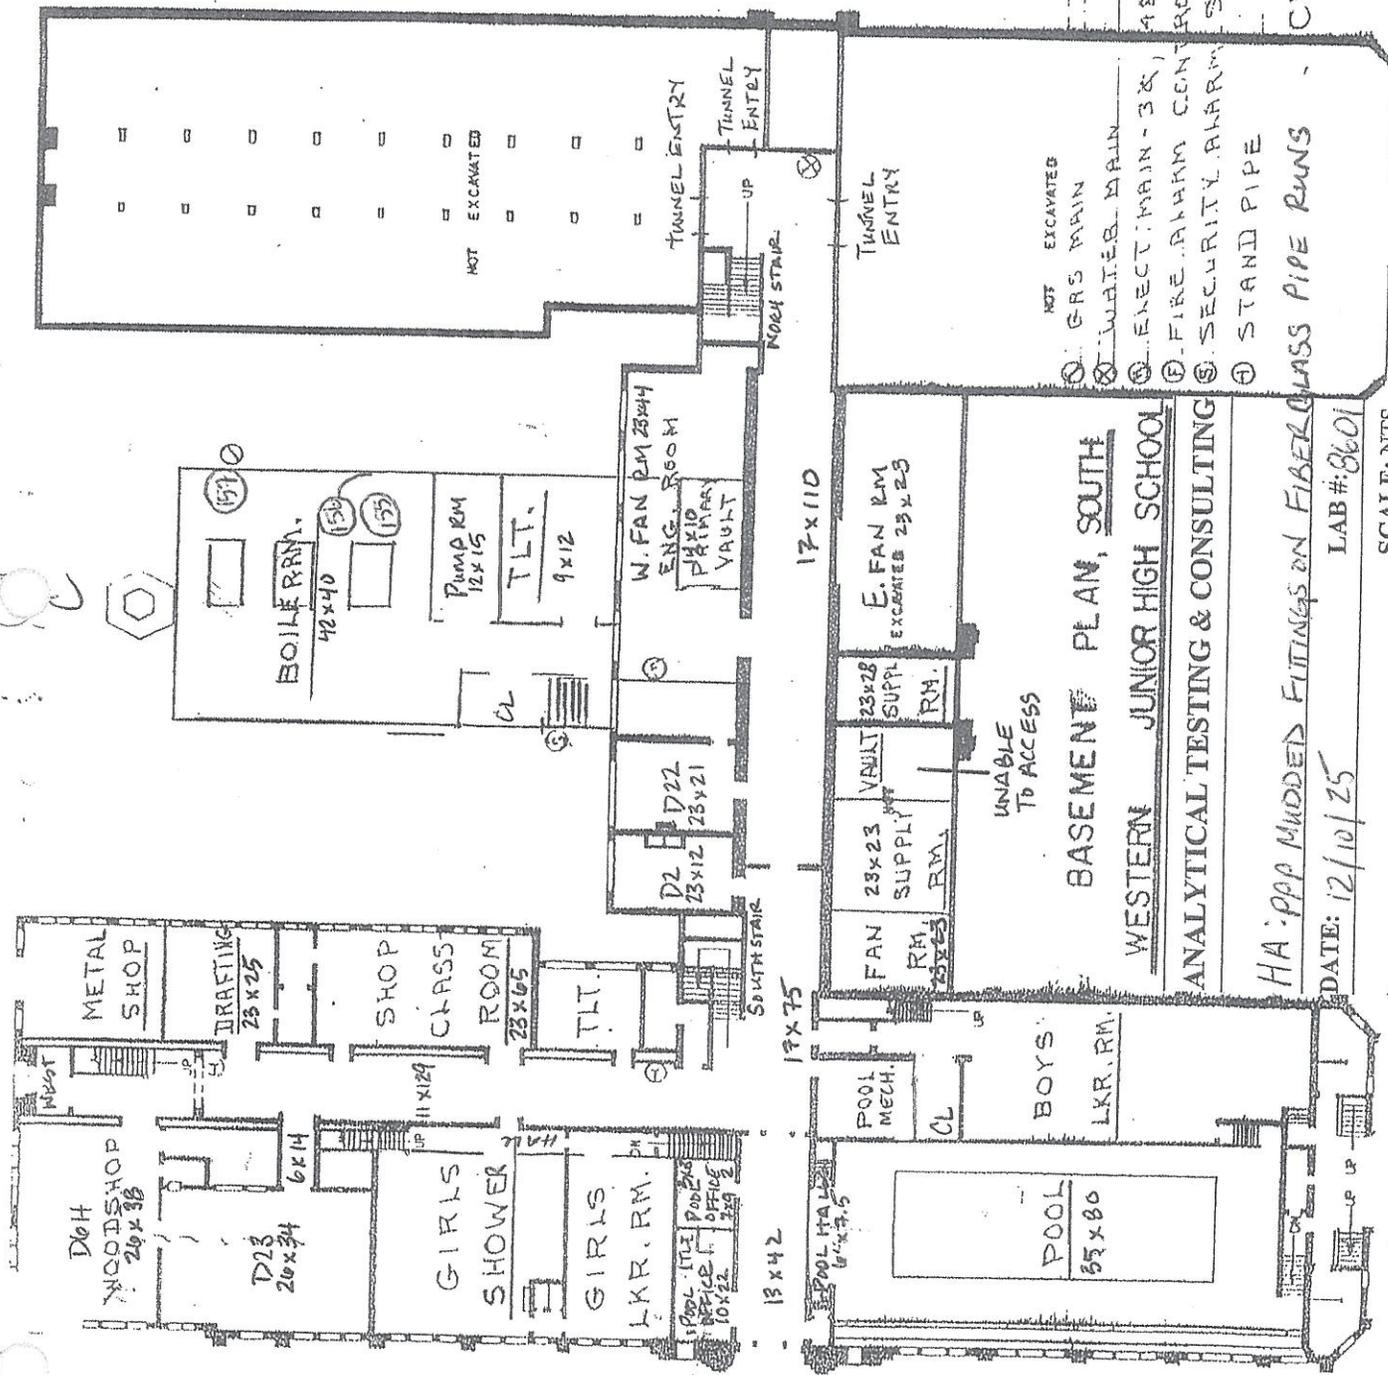
HA: PPP MUDDER FITTINGS ON FIBERGLASS PIPE RUNS
 DATE: 12/10/25
 LAB #: 8601

HA DESCRIPTION: Mudded Fittings on Fiberglass Pipe Runs

HA LOCATION	Type SM/TSI/MM	Friability F/NF	Physical Condition	Size SF/LF/MF
Boiler Room (*material on the ground as well)	TSI	F	7	~100 MF
TOTAL				~100 MF

Sample No.	Description and Location	Results (%)
8601-155	Sample of mudded fitting from below north tank	None Detected
8601-156	Sample of mudded fitting from below north tank	None Detected
8601-157	Sample of mudded fitting from below north tank side pipe run	None Detected
*Note: All samples were collected in a statistically random manner representative of Homogeneous Area in accordance with 40 CFR 763.86.

Location	Recommendations
HA-PPP	Non Asbestos

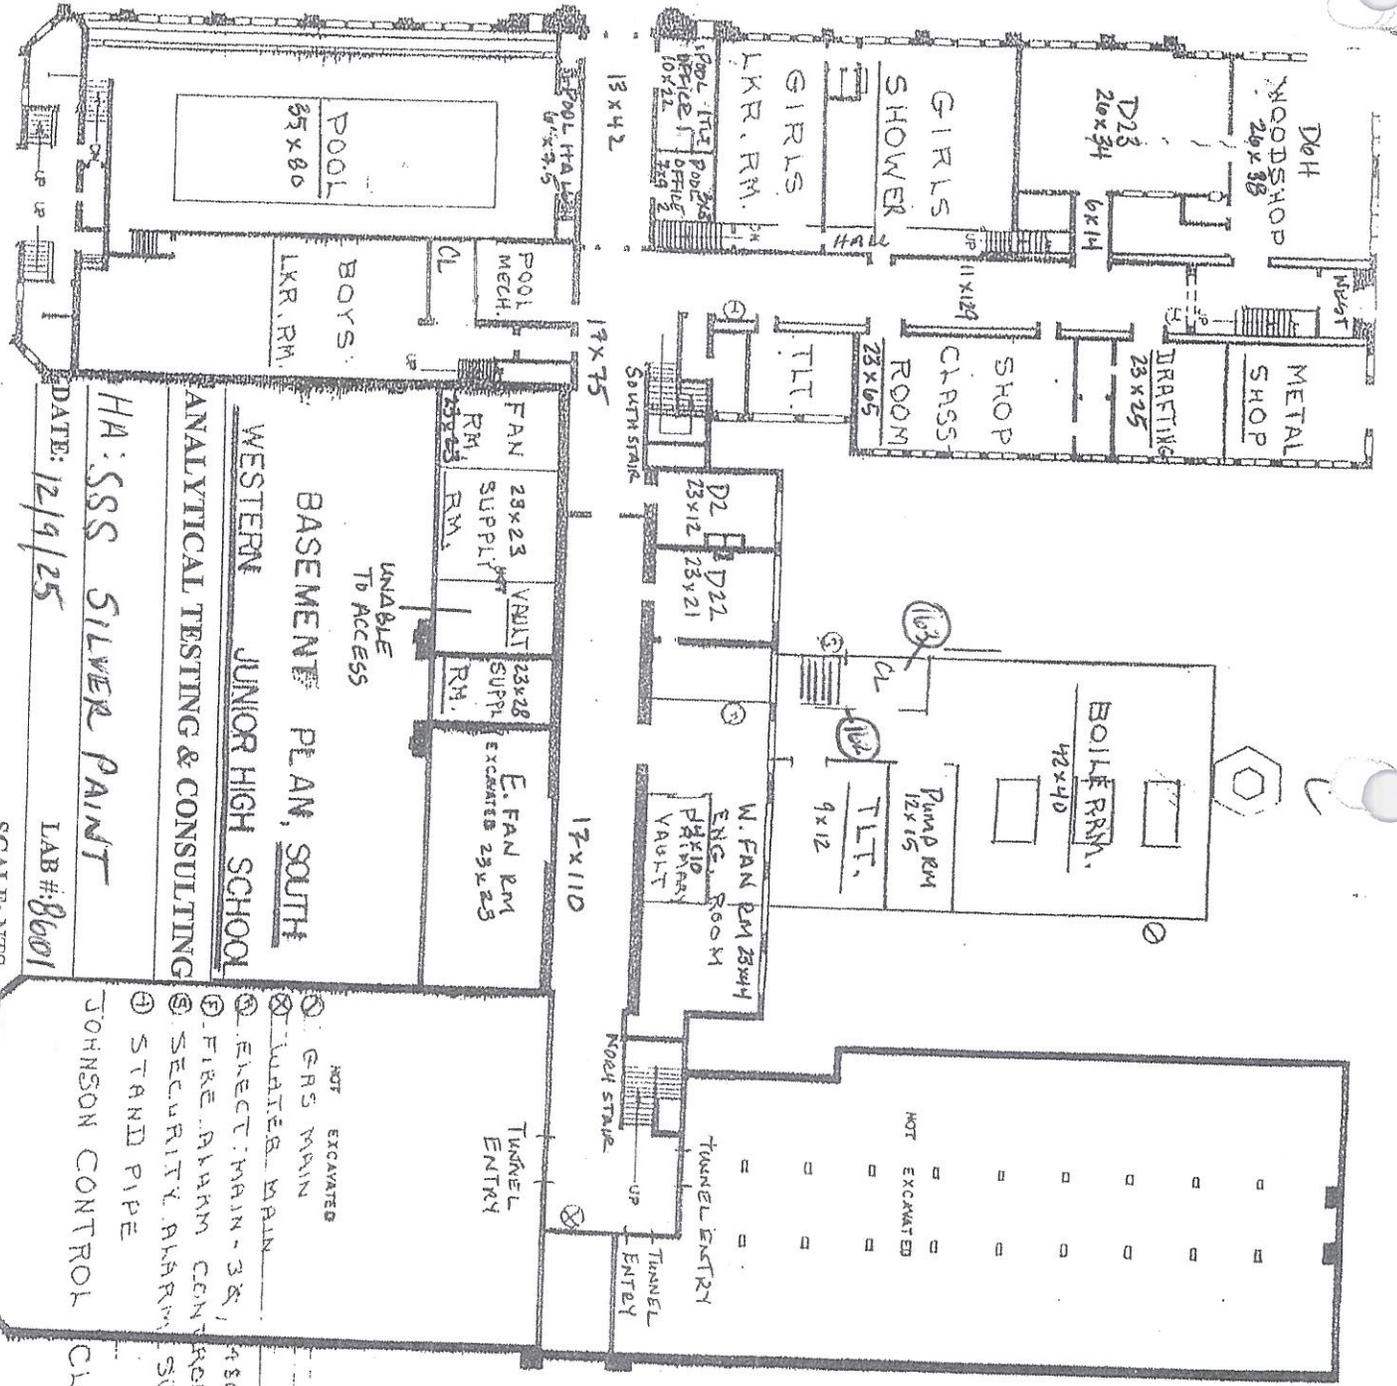
HA: SSS SILVER PAINT
 DATE: 12/9/25
 LAB #: 8601
 SCALE: NTS

HA DESCRIPTION: Silver Paint

HA LOCATION	Type SM/TSI/MM	Friability F/NF	Physical Condition	Size SF/LF/MF
Boiler Room walls	MM	NF	2	~1,968 SF
Pump Room walls	MM	NF	2	~810 SF
Pump Room closet walls	MM	NF	2	~400 SF
Pump Room stairwell walls	MM	NF	2	~200 SF
TOTAL				~3,378 SF

Sample No.	Description and Location	Results (%)
8601-162	Sample of silver paint from Pump Room stairwell Side B	None Detected
8601-163	Sample of silver paint from pump roof closet wall Side B	None Detected

Location	Recommendations
HA-SSS	Non Asbestos
