ASBESTOS SURVEY DATA FORM

LOCATION: Southwestern Junior High School

ADDRESS: 390 S. Washington, Battle Creek, Michigan 49017

DATE: Sept/Oct/Nov/Dec 2025

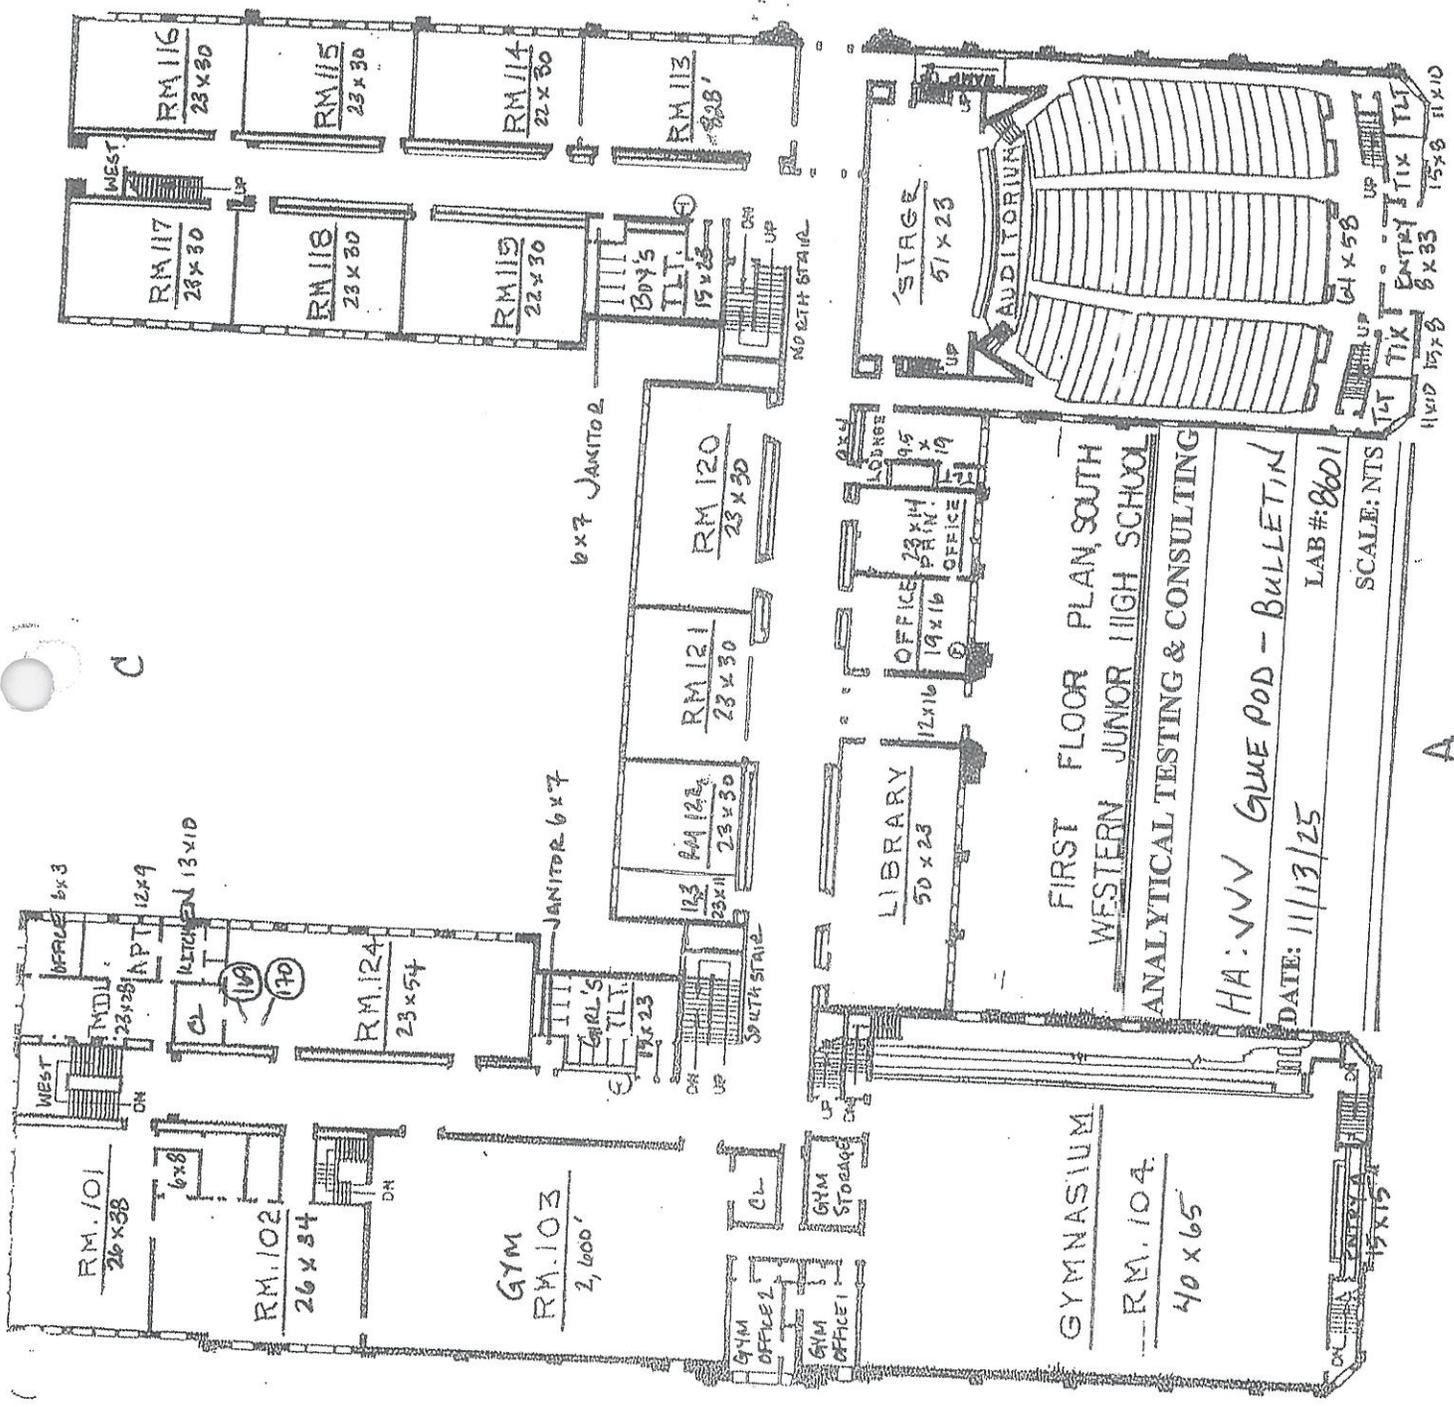
FIRST FLOOR PLAN, SOUTH
 WESTERN JUNIOR HIGH SCHOOL
 ANALYTICAL TESTING & CONSULTING
 HA: VVV GUME POD - BULLETIN
 DATE: 11/13/25
 LAB #: 8601
 SCALE: NTS

HA DESCRIPTION: Glue Pod – Bulletin

HA LOCATION	Type SM/TSI/MM	Friability F/NF	Physical Condition	Size SF/LF/MF
Room 124 bulletin board	MM	NF	1	~25 SF
TOTAL				~25 SF

Sample No.	Description and Location	Results (%)
8601-169	Sample of glue pod from Room 124 Side B	None Detected
8601-170	Sample of glue pod from Room 124 Side B	None Detected
<p><i>*Note: All samples were collected in a statistically random manner representative of Homogeneous Area in accordance with 40 CFR 763.86.</i></p>

Location	Recommendations
HA-VVV	Non Asbestos

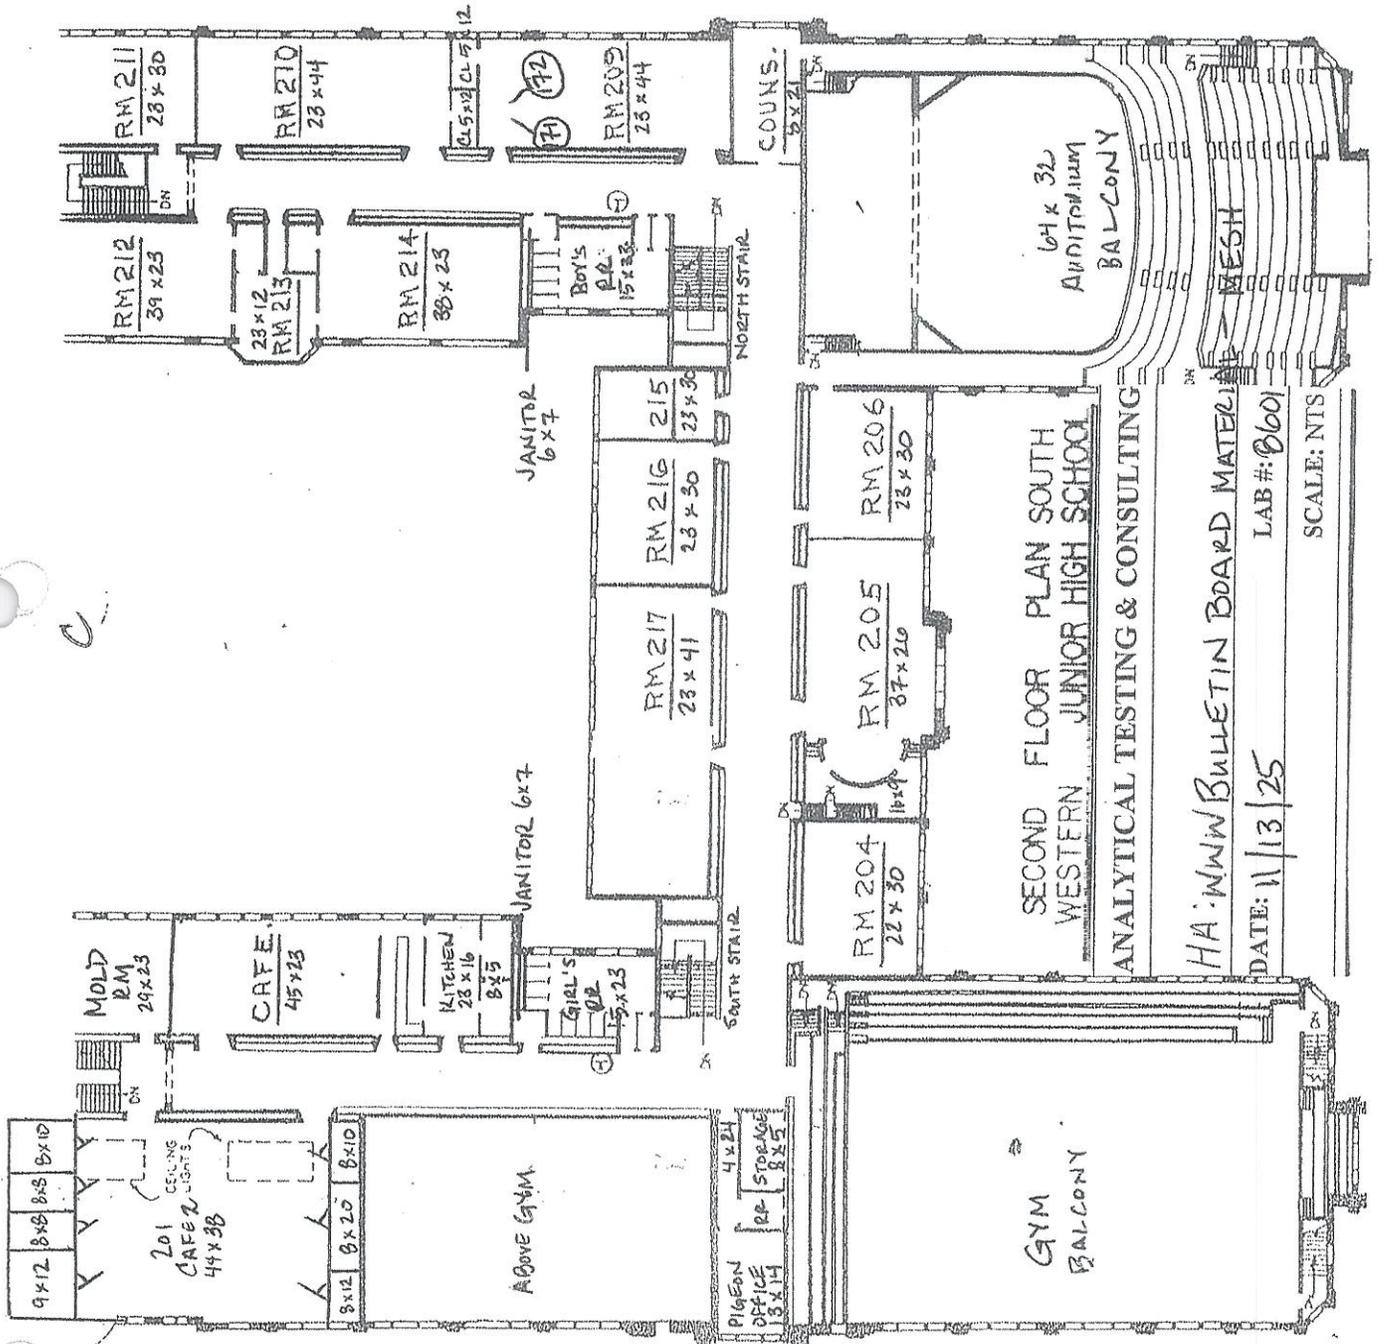
HA: WNW BULLETIN BOARD MATERIAL

HA DESCRIPTION: Bulletin Board – Material – Mesh

HA LOCATION	Type SM/TSI/MM	Friability F/NF	Physical Condition	Size SF/LF/MF
Room 209	MM	NF	4	~50 SF
TOTAL				~50 SF

Sample No.	Description and Location	Results (%)
8601-171	Sample of bulletin board material from Room 209	Layer 1 – None Detected Layer 2 – None Detected
8601-172	Sample of bulletin board material from Room 209	Layer 1 – None Detected Layer 2 – None Detected
<p><i>*Note: All samples were collected in a statistically random manner representative of Homogeneous Area in accordance with 40 CFR 763.86.</i></p>

Location	Recommendations
HA-WWW	Non Asbestos

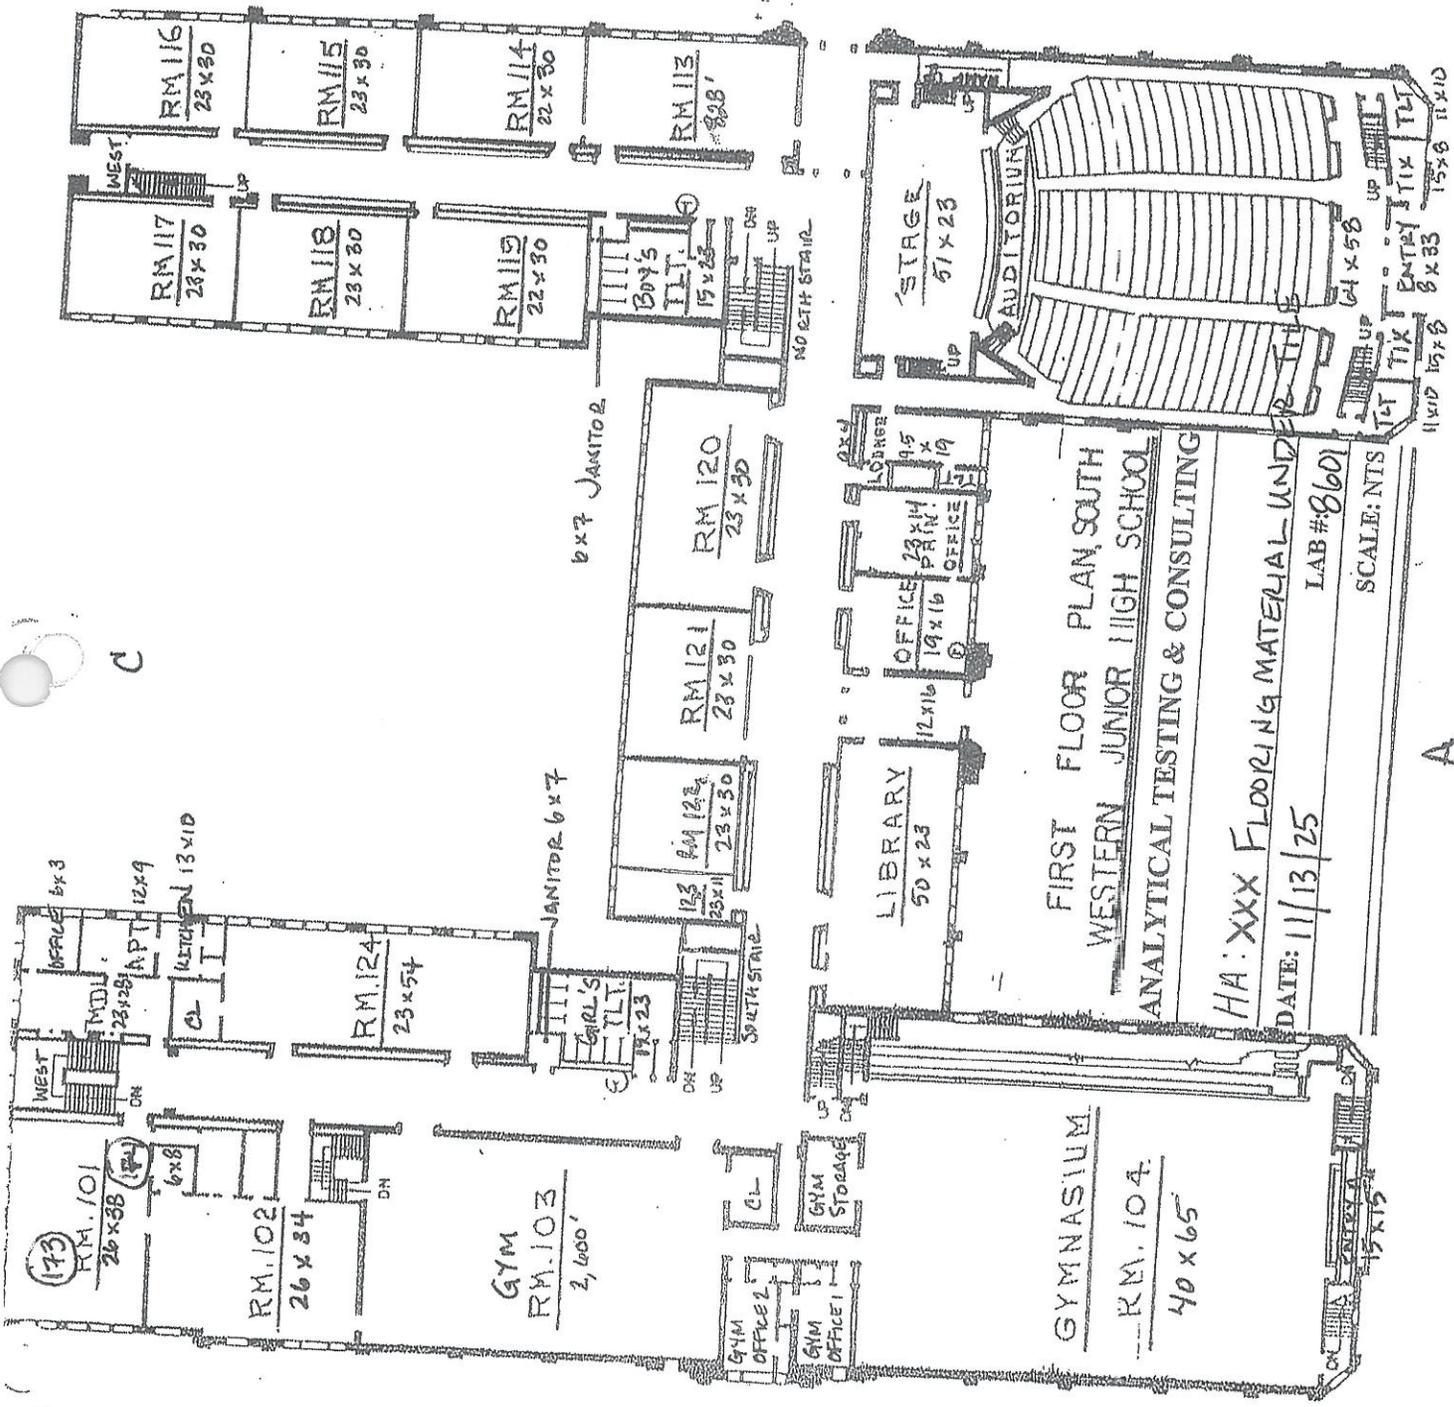
HA DESCRIPTION: Flooring Material under Tile

HA LOCATION	Type SM/TSI/MM	Friability F/NF	Physical Condition	Size SF/LF/MF
Room 101 – under tile	MM	NF	7	~1,054 SF
TOTAL				~1,054 SF

Sample No.	Description and Location	Results (%)
8601-173	Sample of flooring material under tile Room 101	Layer 1 – None Detected Layer 2 – None Detected
8601-174	Sample of flooring material under tile Room 101	None Detected
<p><i>*Note: All samples were collected in a statistically random manner representative of Homogeneous Area in accordance with 40 CFR 763.86.</i></p>

Location	Recommendations
HA-XXX	Non Asbestos

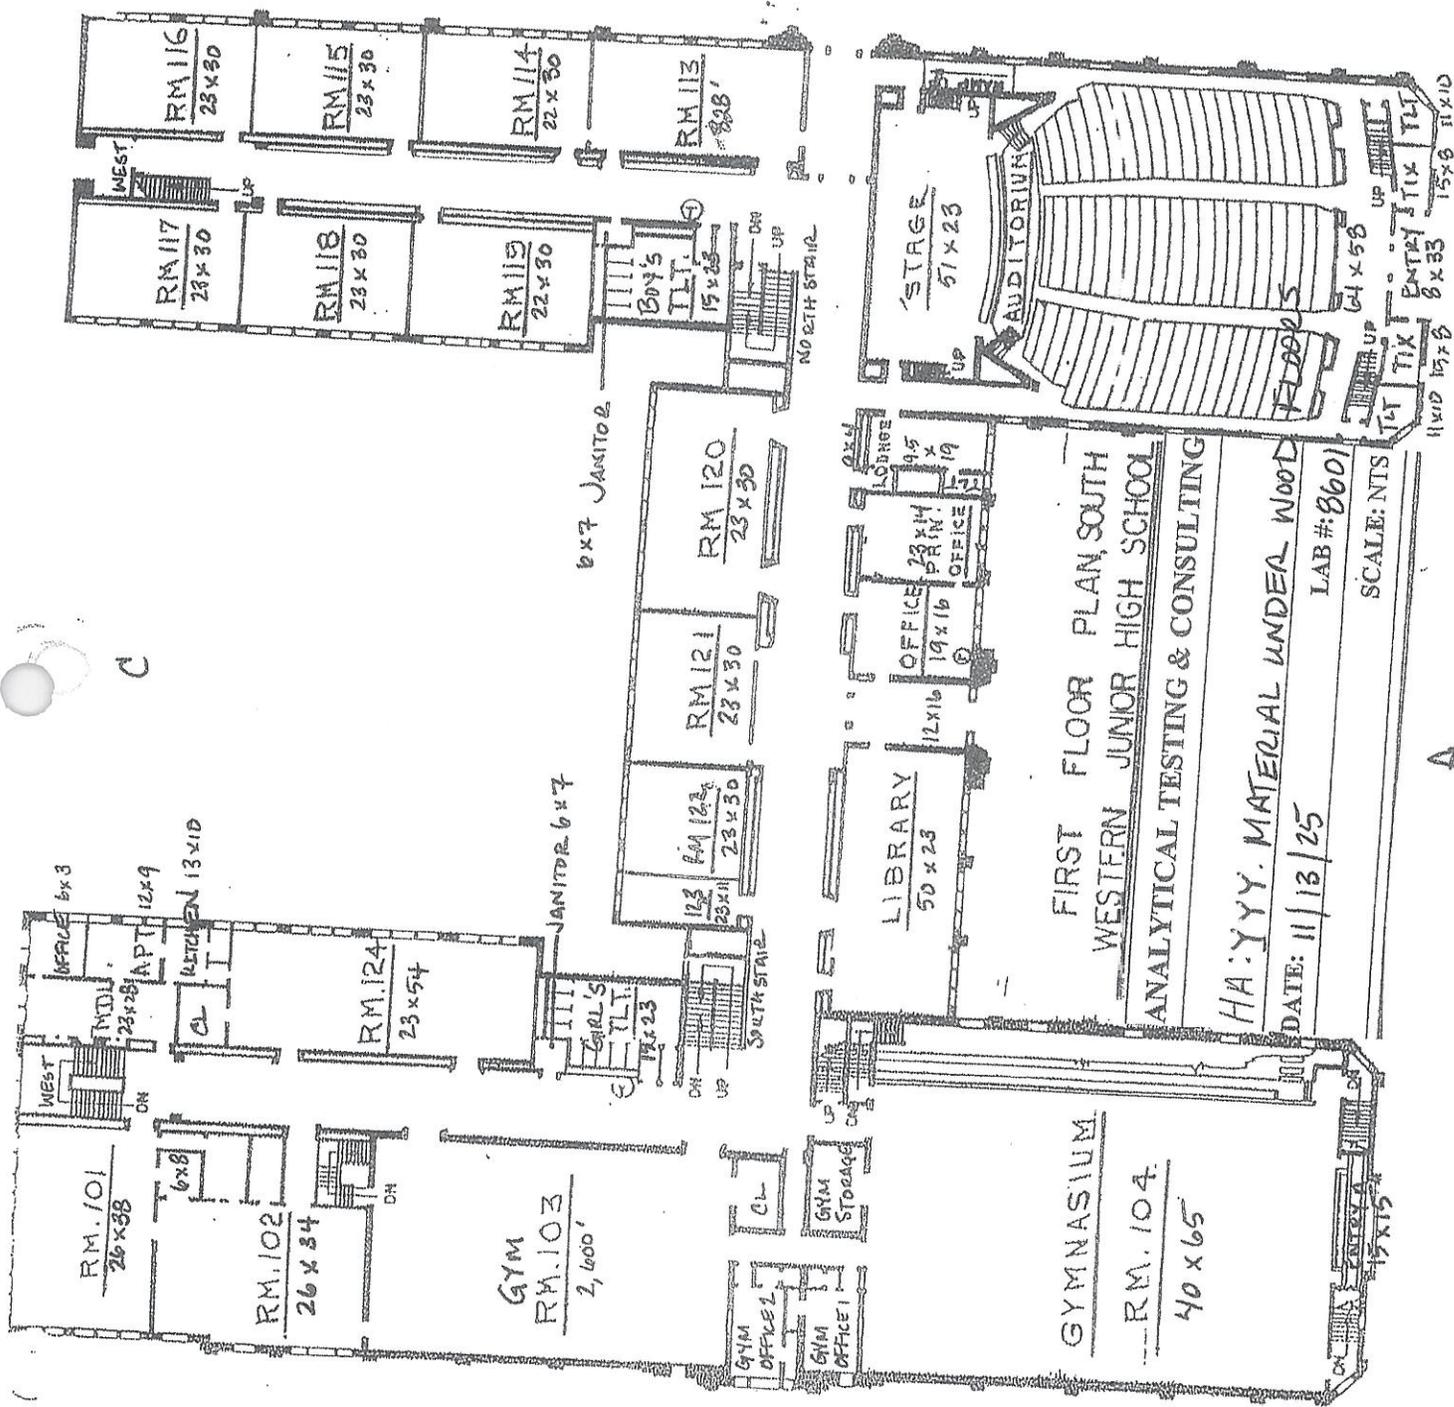
HA:YYY. MATERIAL UNDER WOOD
 LAB #: 8601
 DATE: 11/13/25

HA DESCRIPTION: Material under Wood Floor

HA LOCATION	Type SM/TSI/MM	Friability F/NF	Physical Condition	Size SF/LF/MF
1 st and 2 nd Floors - slag	MM	NF	7	~80,000 SF
TOTAL				~80,000 SF

Sample No.	Description and Location	Results (%)
8601-175	Sample of flooring material from Room 204	None Detected
*Note: All samples were collected in a statistically random manner representative of Homogeneous Area in accordance with 40 CFR 763.86.

Location	Recommendations
HA-YYY	Non Asbestos

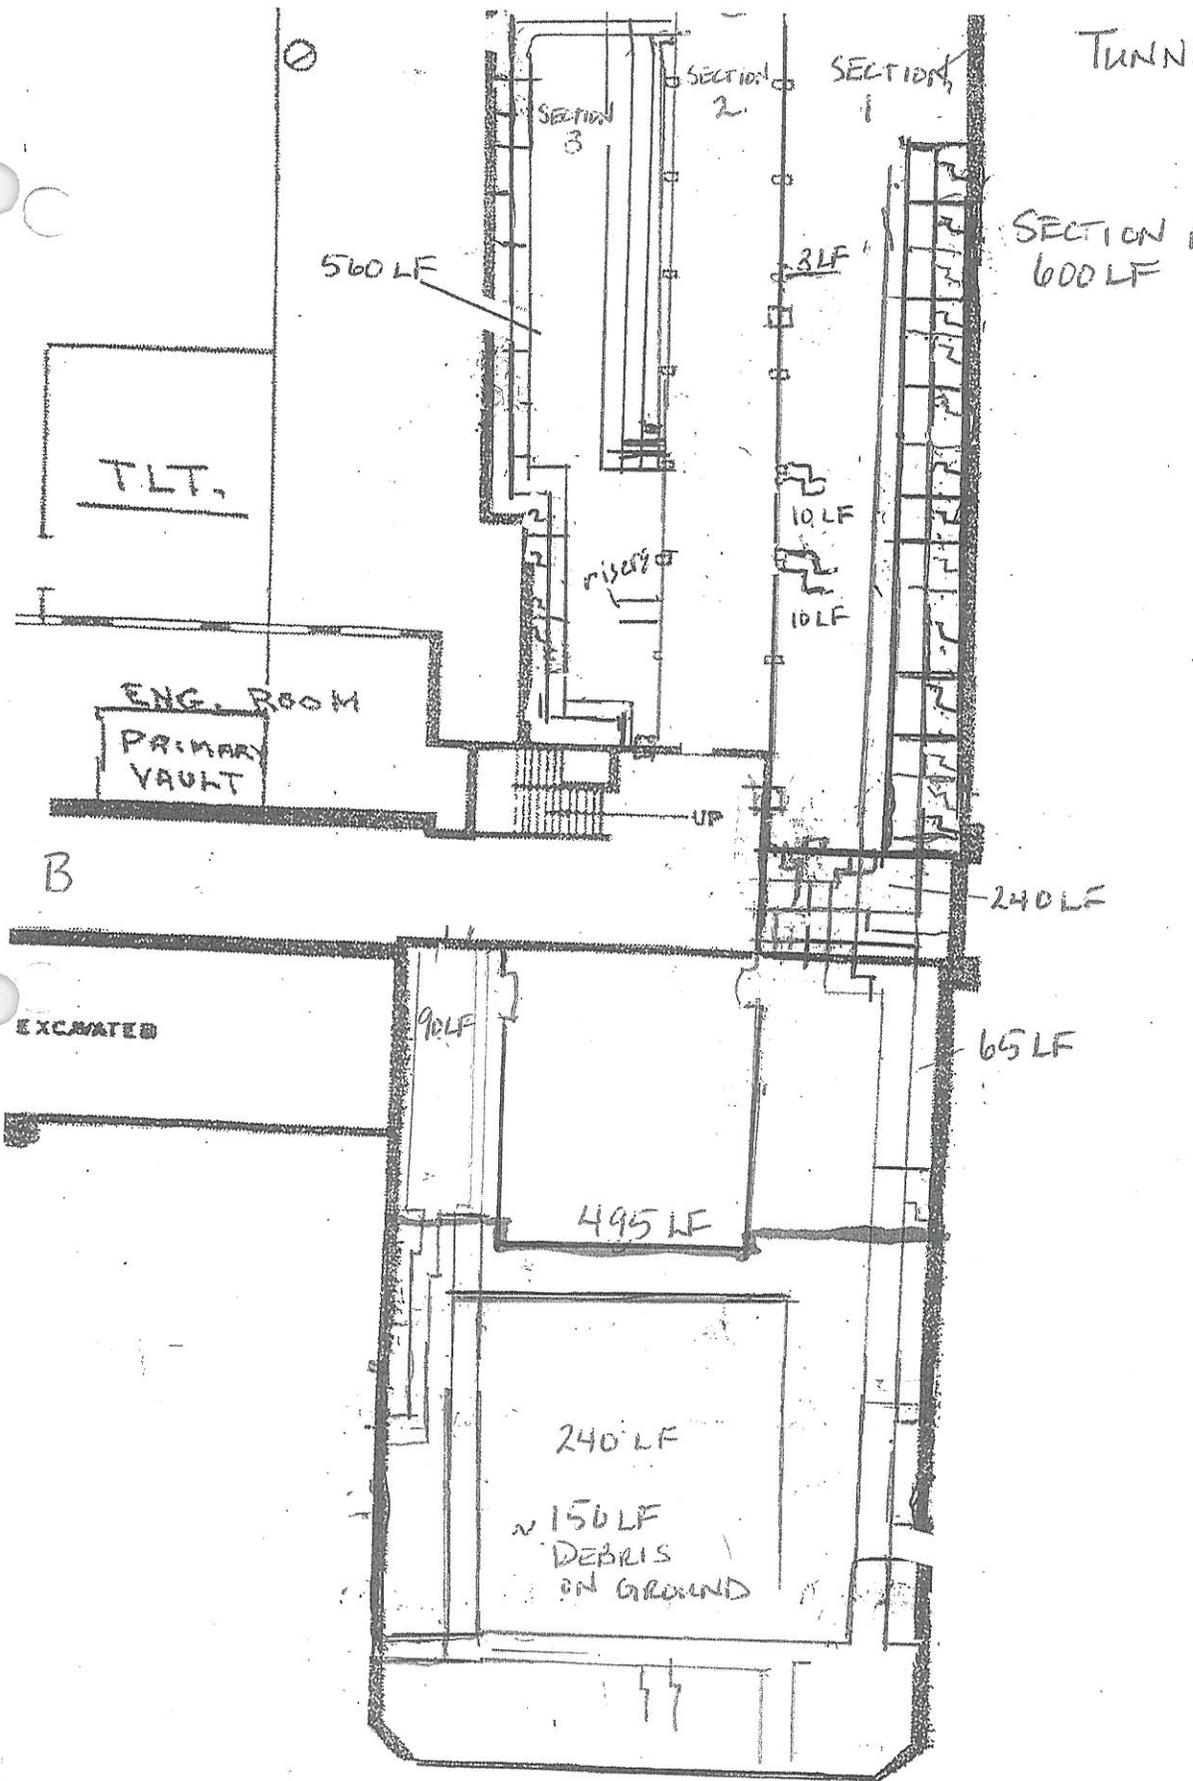
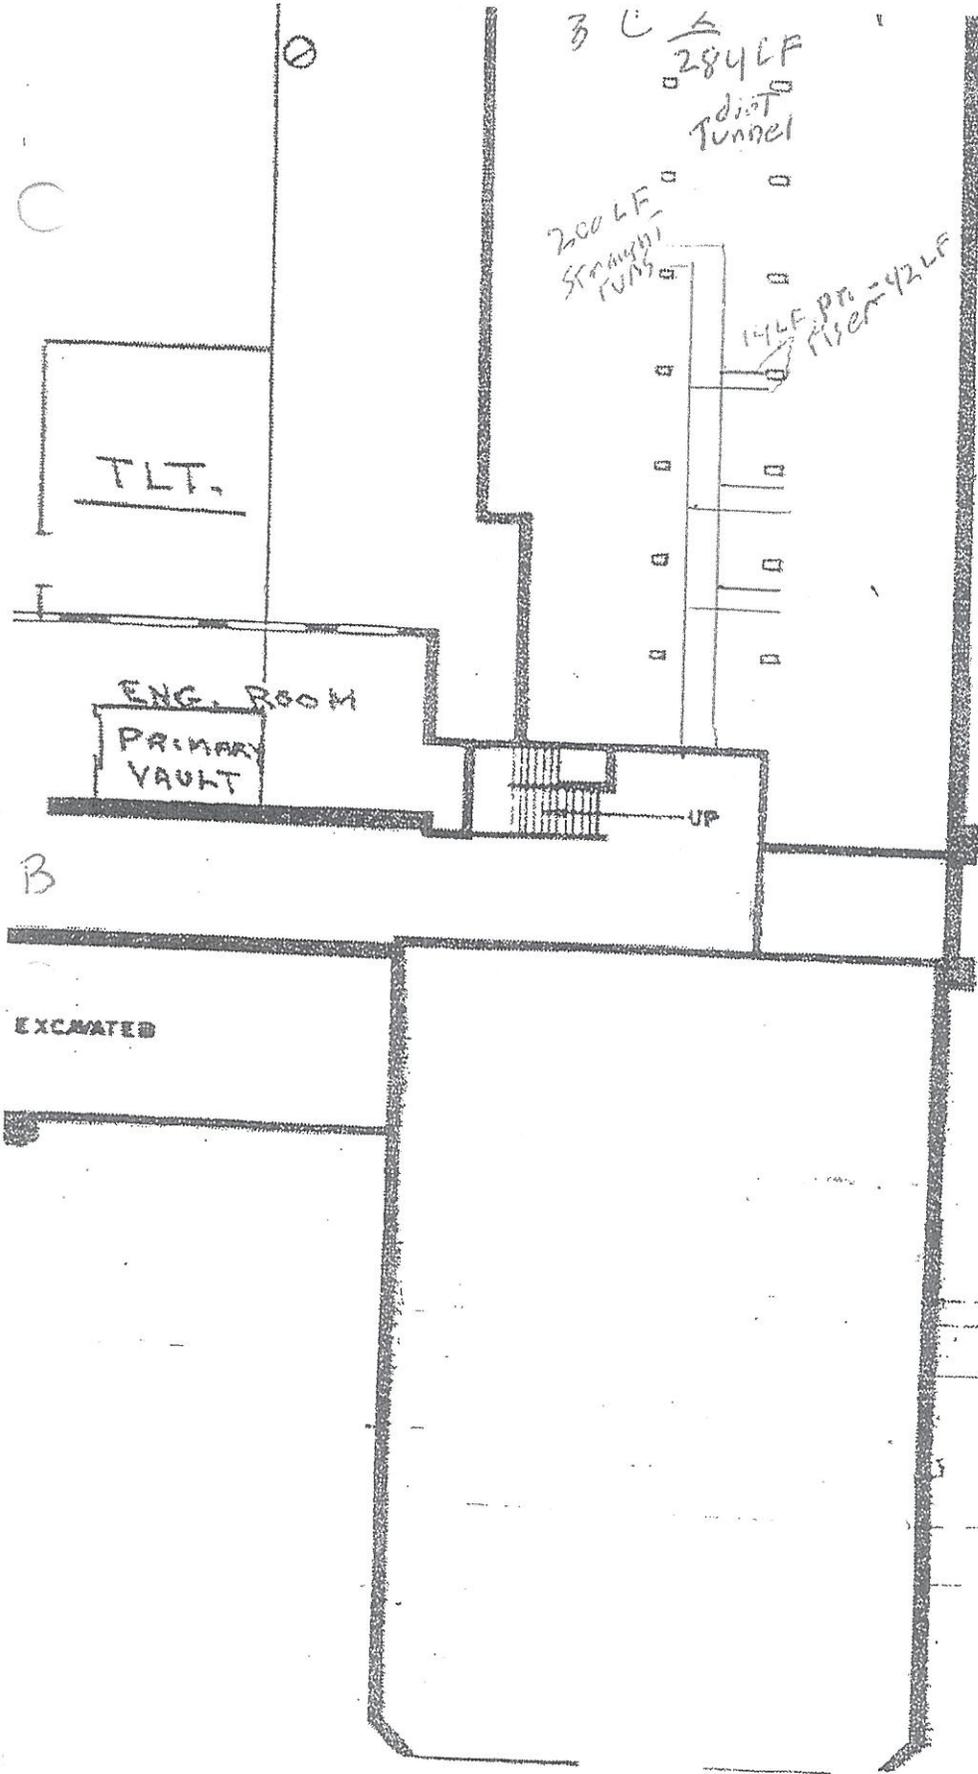
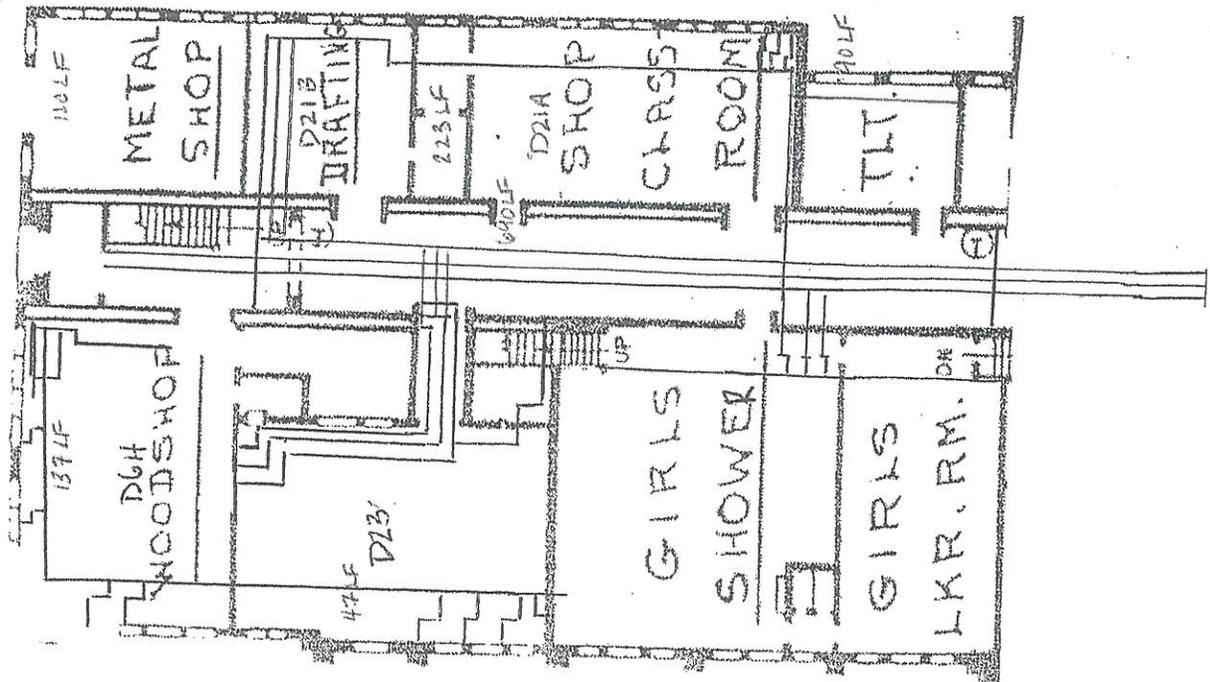
ANALYTICAL TESTING & CONSULTING
HA: 222 TGI PIPE WRAP
DATE: 12/23/25
LAB #: 8601
SCALE: NTS

HA DESCRIPTION: TSI Pipe Wrap

HA LOCATION	Type SM/TSI/MM	Friability F/NF	Physical Condition	Size SF/LF/MF
Tunnels and debris on the ground	TSI	F	1	~3,000 LF
Auditorium vent at entry	TSI	F	1	~7 LF
2 nd floor Janitor Closet – south side	TSI	F	1	~70 LF
Pipe chase 1 st floor – toilet south side	TSI	F	1	~15 LF
Principal Office	TSI	F	1	~30 LF
Basement hall	TSI	F	1	~1,700 LF
D6H Wood Shop	TSI	F	1	~140 LF
D23	TSI	F	1	~226 LF
Girl's locker room closet	TSI	F	1	~25 LF
Pool office 1 and pool office 2	TSI	F	1	~100 LF
Pool	TSI	F	1	~60 LF
Boy's locker room closet	TSI	F	1	~30 LF
Supply room and small room near non excavation	TSI	F	1	~15 LF
D2	TSI	F	1	~60 LF
High voltage near primary vault	TSI	F	1	~85 LF
Metal shop	TSI	F	1	~120 LF
D21A and D21B – Drafting/Shop	TSI	F	1	~223 LF
Air plenum between basement and first floor	TSI	F	1	~410 LF
TOTAL				~6,316 LF

Sample No.	Description and Location	Results (%)
As per the 1988 AHERA Survey, the TSI was sampled and determined positive.		
*Note: All samples were collected in a statistically random manner representative of Homogeneous Area in accordance with 40 CFR 763.86.

Location	Recommendations
HA-ZZZ	Remove Asbestos Prior to Demolition/ Renovation
