FIRST FLOOR PLAN, SOUTH
WESTERN JUNIOR HIGH SCHOOL
ANALYTICAL TESTING & CONSULTING

ASBESTOS SURVEY DATA FORM

LOCATION: Southwestern Junior High School

ADDRESS: 390 S. Washington, Battle Creek, Michigan 49017

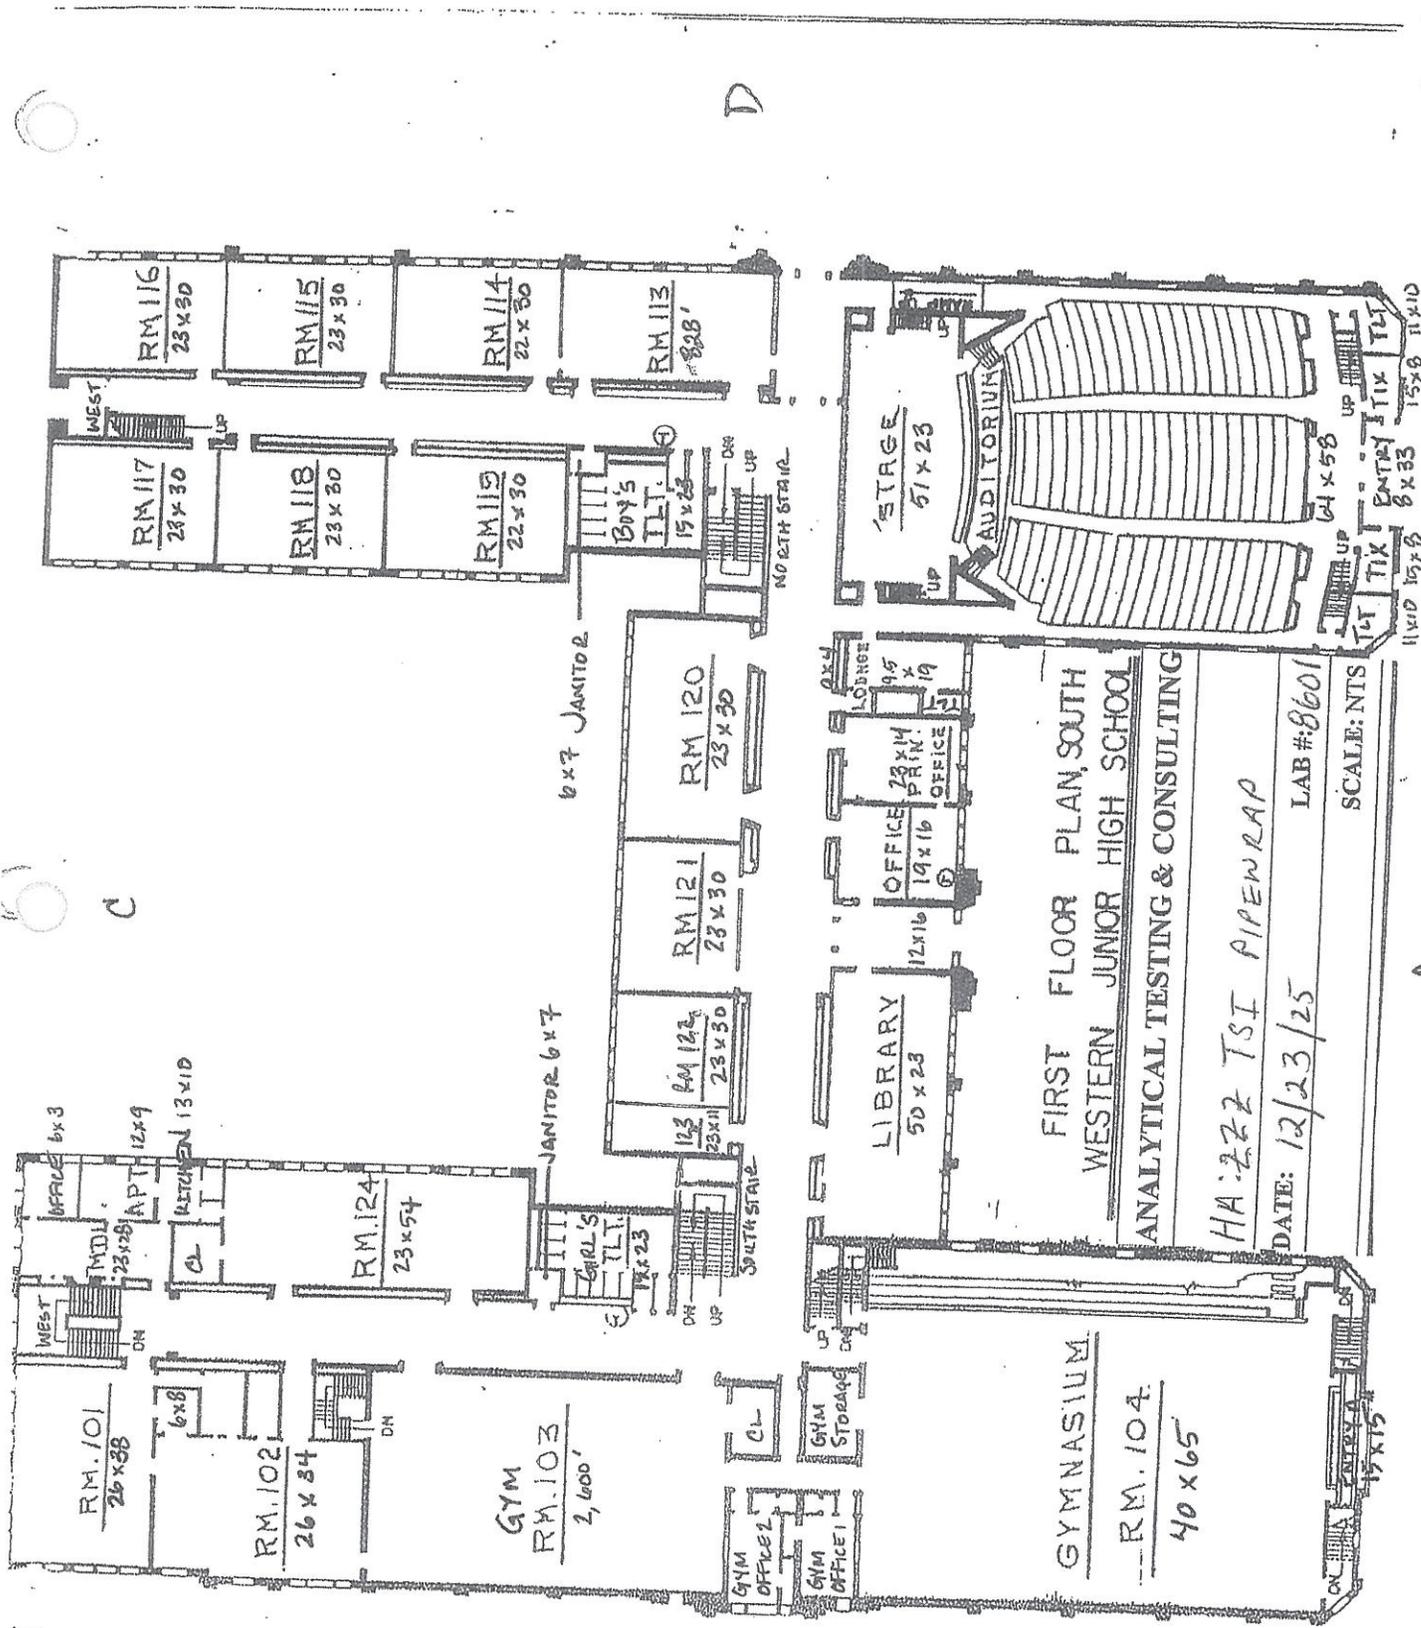
HA: 222 TSI PIPEWRAP

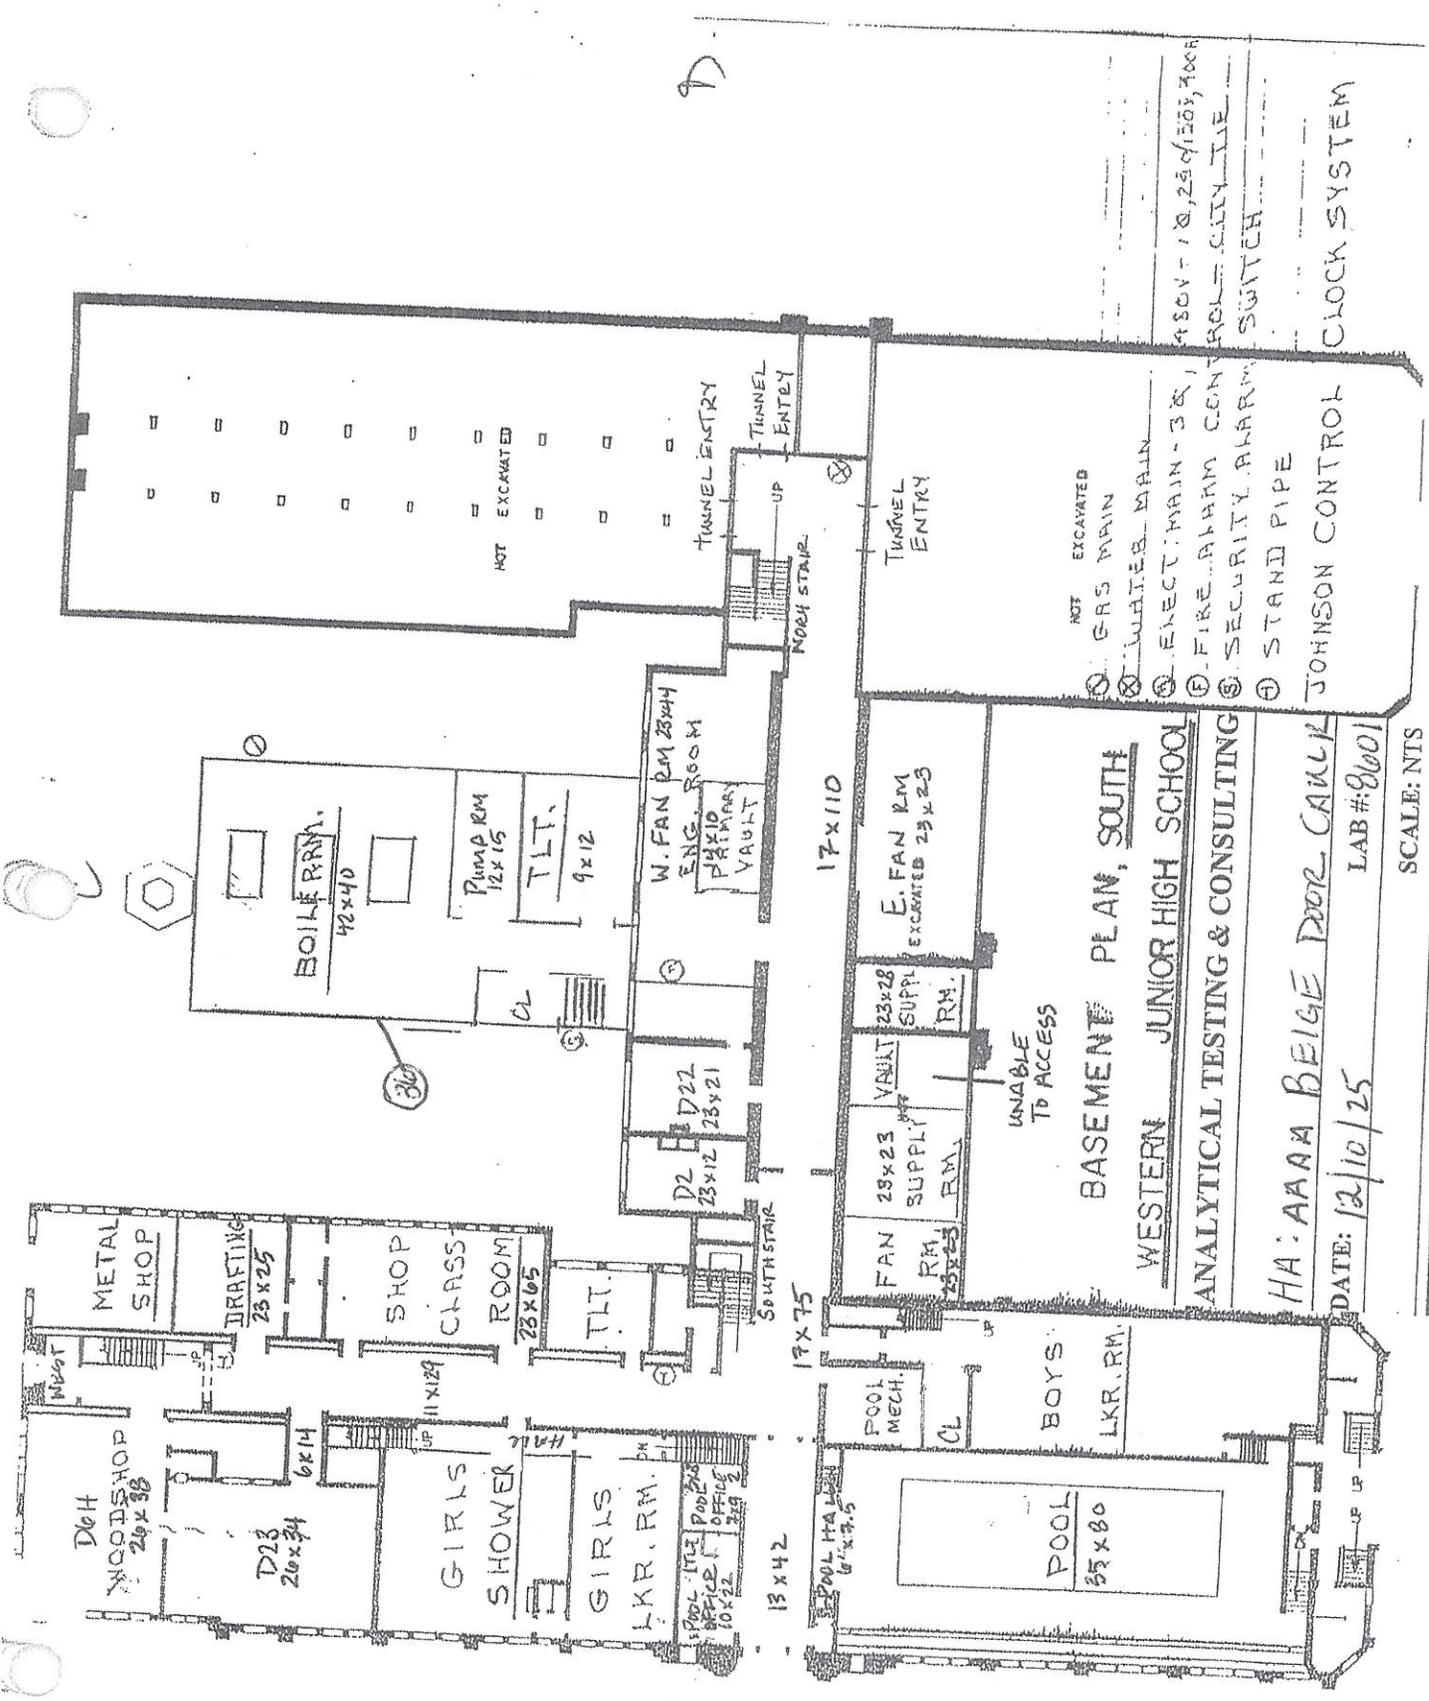
BASEMENT PLAN, SOUTH
WESTERN JUNIOR HIGH SCHOOL
ANALYTICAL TESTING & CONSULTING

HA DESCRIPTION: Beige Door Caulk

HA LOCATION	Type SM/TSI/MM	Friability F/NF	Physical Condition	Size SF/LF/MF
Main entry	MM	NF	4	~35 LF / ~1.5 SF
Gym entry	MM	NF	4	~35 LF / ~1.5 SF
Auditorium entry	MM	NF	4	~35 LF / ~1.5 SF
Pool office entry	MM	NF	4	~35 LF / ~1.5 SF
Lower level entries Side C	MM	NF	4	~72 LF / ~3 SF
Boiler doors and vents	MM	NF	4	~86 LF / ~4 SF
Entry Side D	MM	NF	4	~35 LF / ~1.5 SF
Bell Tower	MM	NF	4	~13 LF / ~.5 SF
TOTAL				~346 LF / ~15 SF

HA: AAAA BEIGE DOOR CALL
DATE: 12/10/25
LAB #: 8001

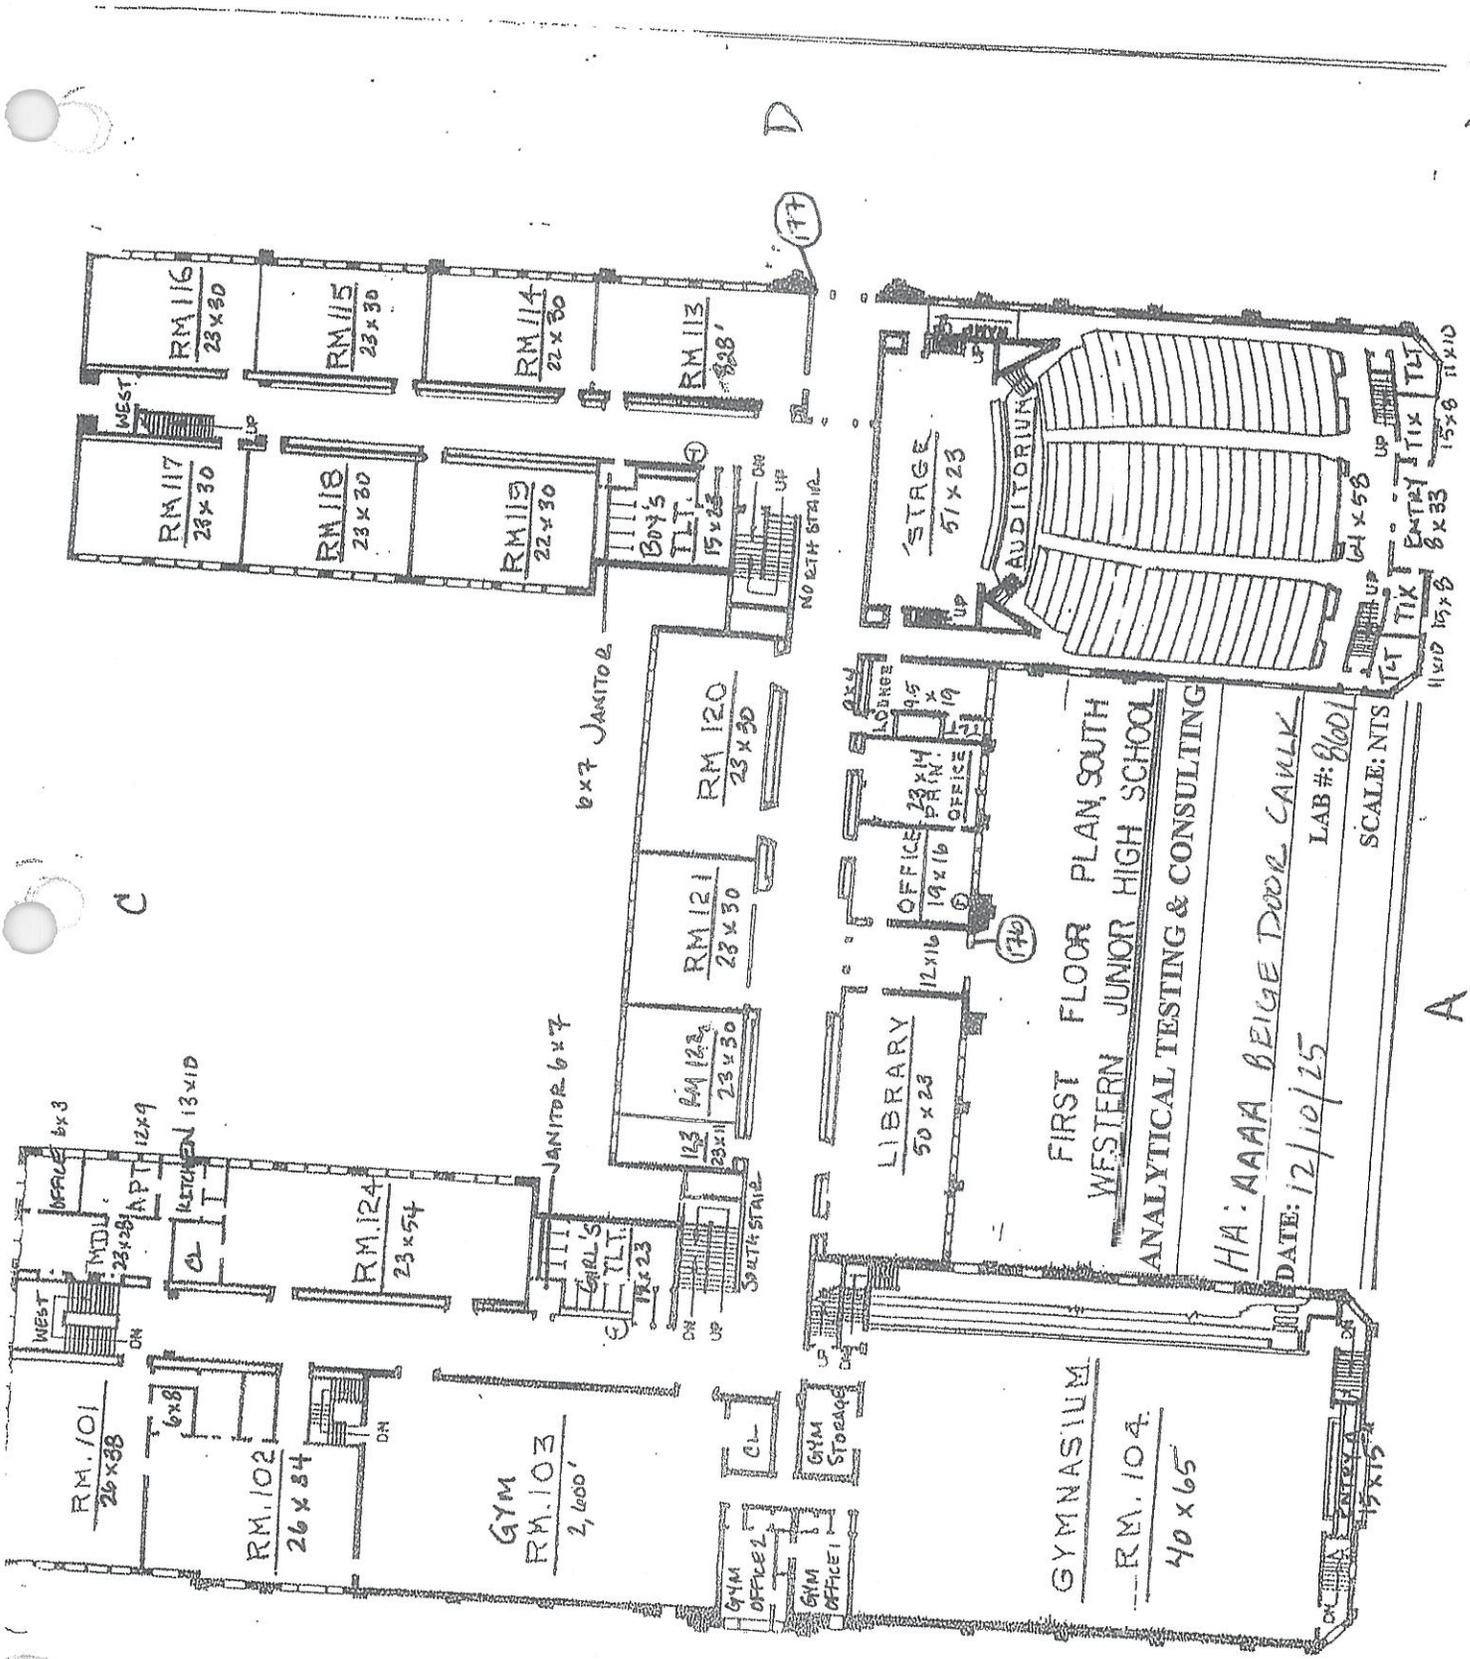
FIRST FLOOR PLAN, SOUTH
WESTERN JUNIOR HIGH SCHOOL
ANALYTICAL TESTING & CONSULTING

HA: AAAA BEIGE DOOR CALLK
DATE: 12/10/25
LAB #: 8601
SCALE: NTS

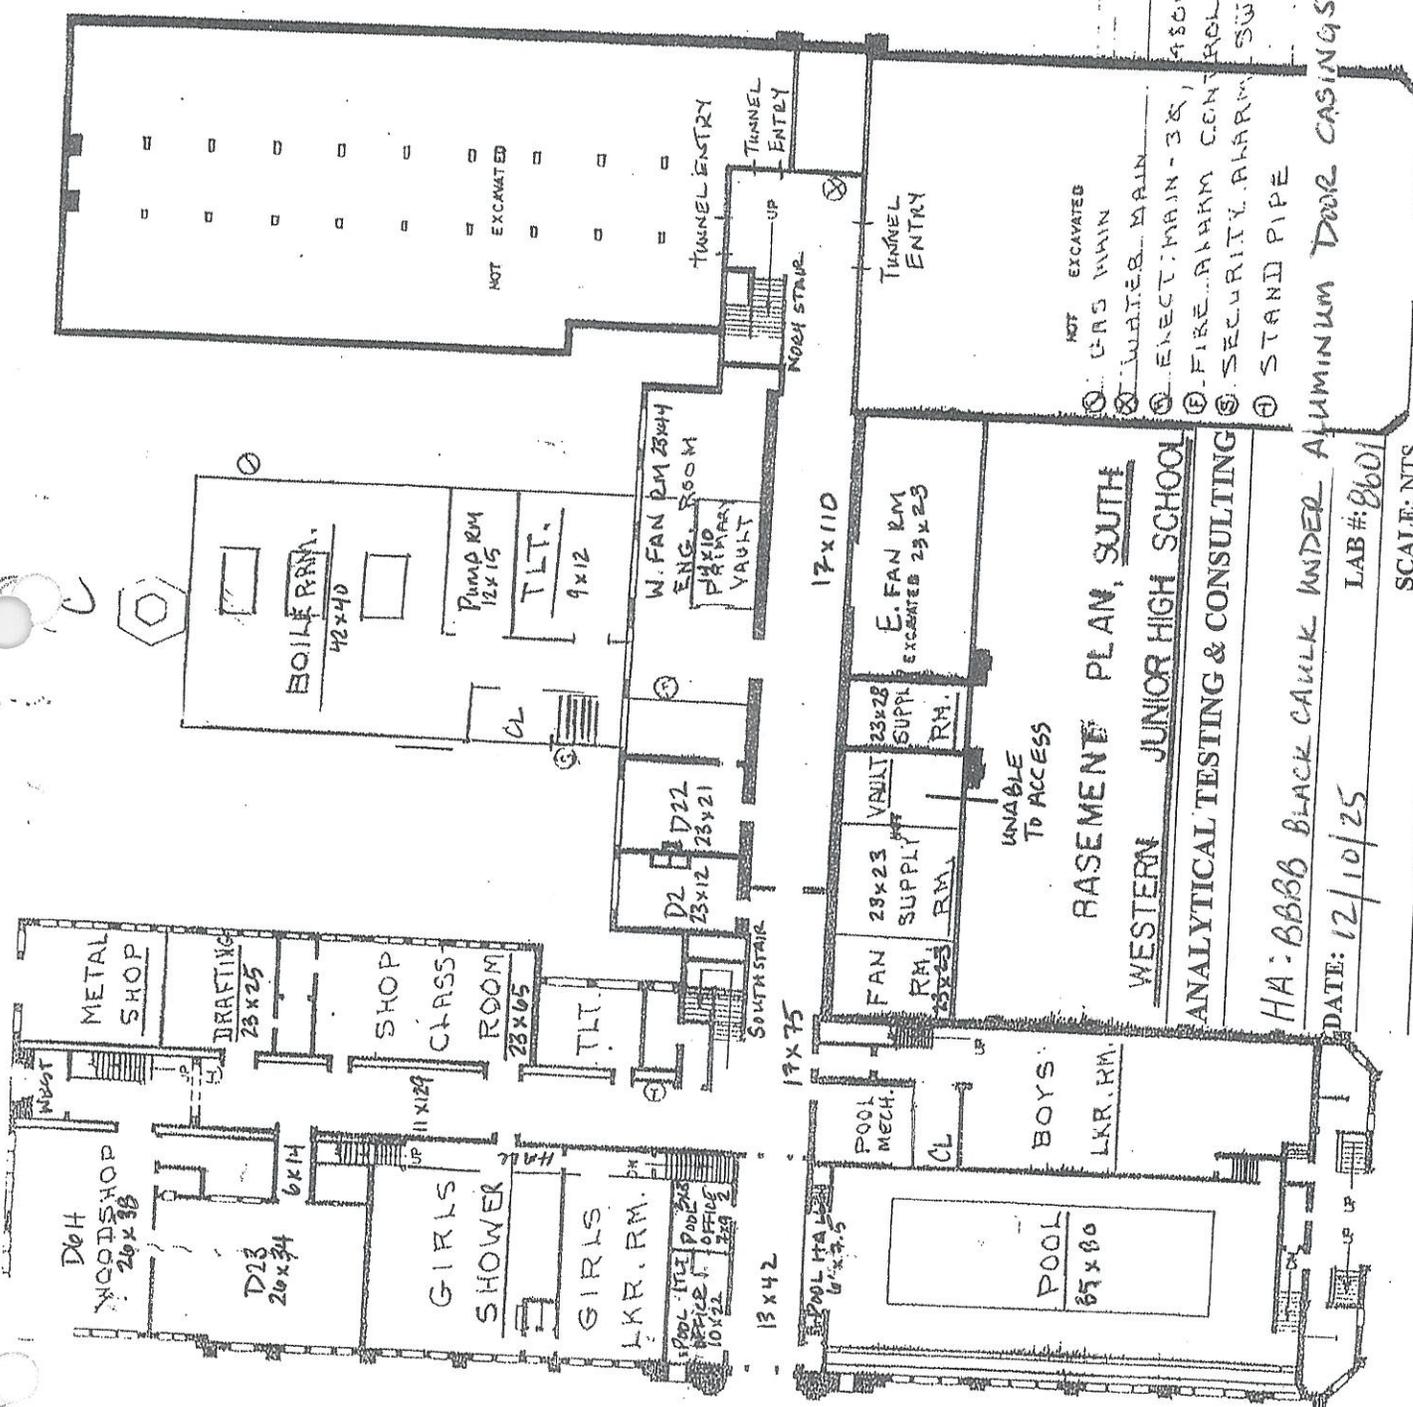
BASEMENT PLAN, SOUTH
 WESTERN JUNIOR HIGH SCHOOL
 ANALYTICAL TESTING & CONSULTING

HA DESCRIPTION: Black Caulk under Aluminum Door Casings

HA LOCATION	Type SM/TSI/MM	Friability F/NF	Physical Condition	Size SF/LF/MF
Under aluminum door casings exterior doors	MM	NF	4	~175 LF / ~30 SF
TOTAL				~175 LF / ~30 SF

Sample No.	Description and Location	Results (%)
8601-178	Sample of black caulk from main entry Side A	None Detected
8601-179	Sample of black caulk from Side D entry	None Detected
*Note: All samples were collected in a statistically random manner representative of Homogeneous Area in accordance with 40 CFR 763.86.

HA: 8886 BLACK CAULK UNDER ALUMINUM DOOR CASINGS
 DATE: 12/10/25
 LAB #: 8601
 SCALE: NTS

Location	Recommendations
HA-BBBB	Non Asbestos

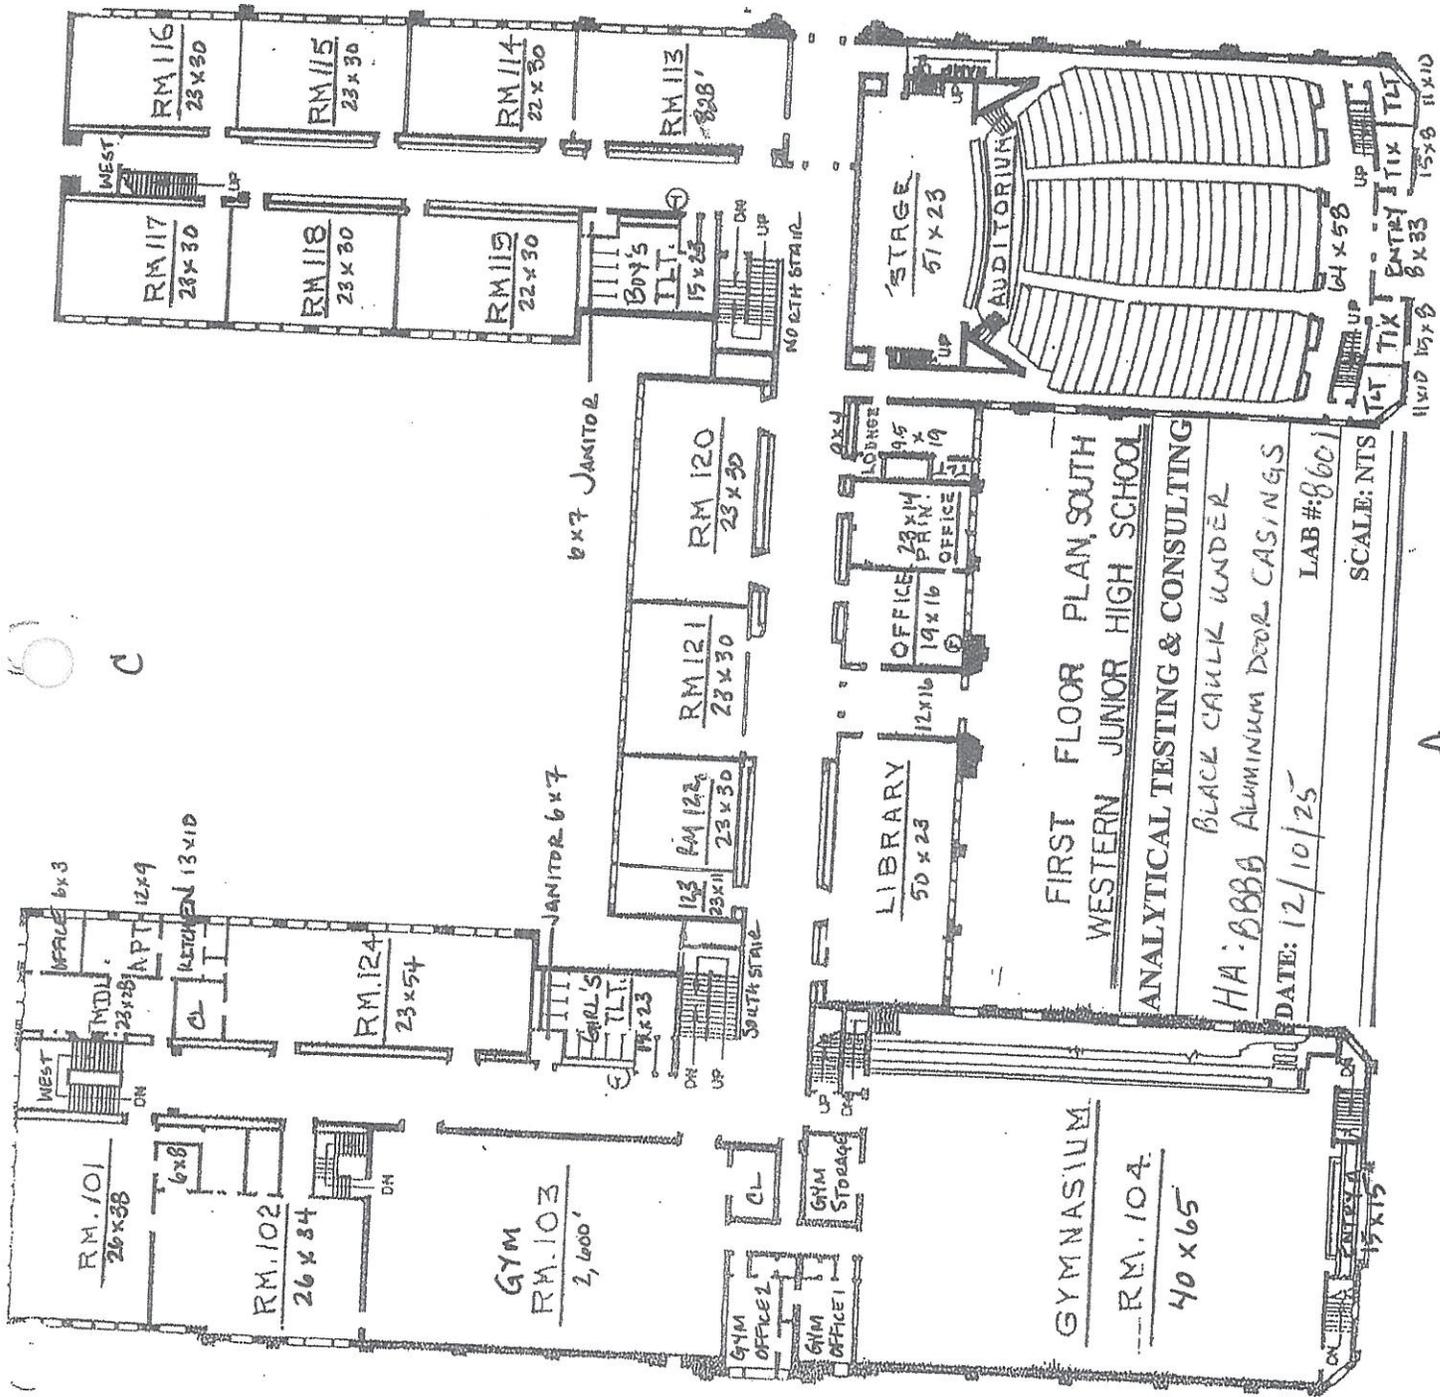
FIRST FLOOR PLAN, SOUTH
 WESTERN JUNIOR HIGH SCHOOL
 ANALYTICAL TESTING & CONSULTING
 BLACK CAULK UNDER
 HA: 8888 ALUMINUM DOOR CASINGS
 DATE: 12/10/25
 LAB #: 8601
 SCALE: NTS

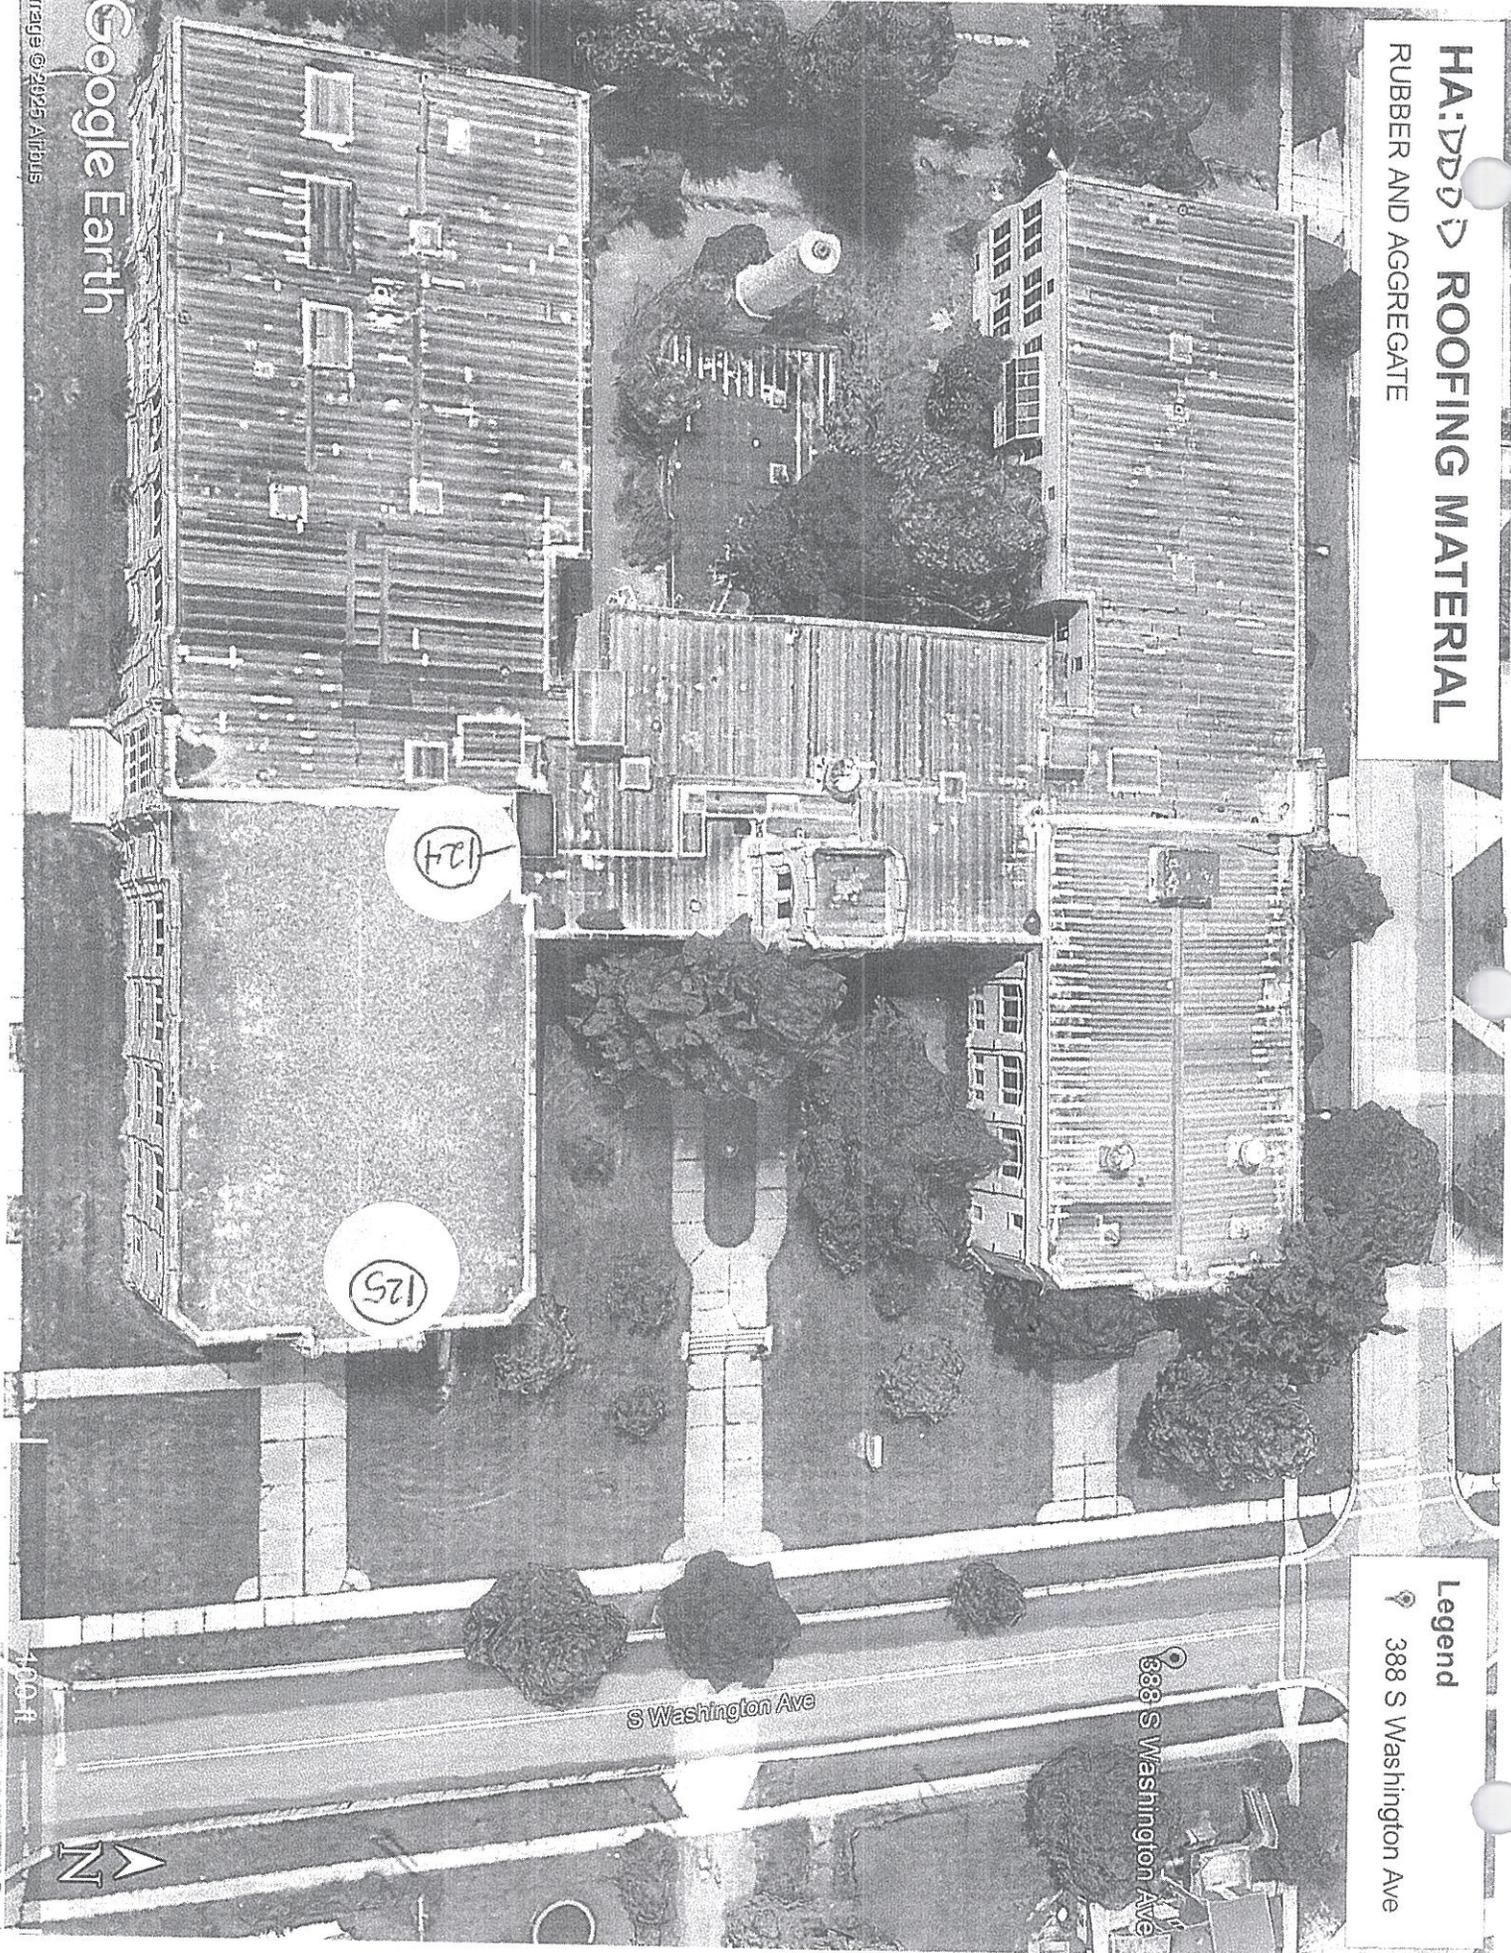
HA DESCRIPTION: Roofing Material – Rubber and Aggregate

HA LOCATION	Type SM/TSI/MM	Friability F/NF	Physical Condition	Size SF/LF/MF
Gym 104 area	MM	NF	1	~8,000 SF
TOTAL				~8,000 SF

Sample No.	Description and Location	Results (%)
8601-124	Sample of roofing over Gym Room 104 Side D near air handler	Layer 1 – None Detected Layer 2 – None Detected
8601-125	Sample of roofing Side A over Gym Room 104	Layer 1 – None Detected Layer 2 – None Detected

HA:DDDD ROOFING MATERIAL RUBBER AND AGGREGATE

Location	Recommendations
HA-DDDD	Non Asbestos

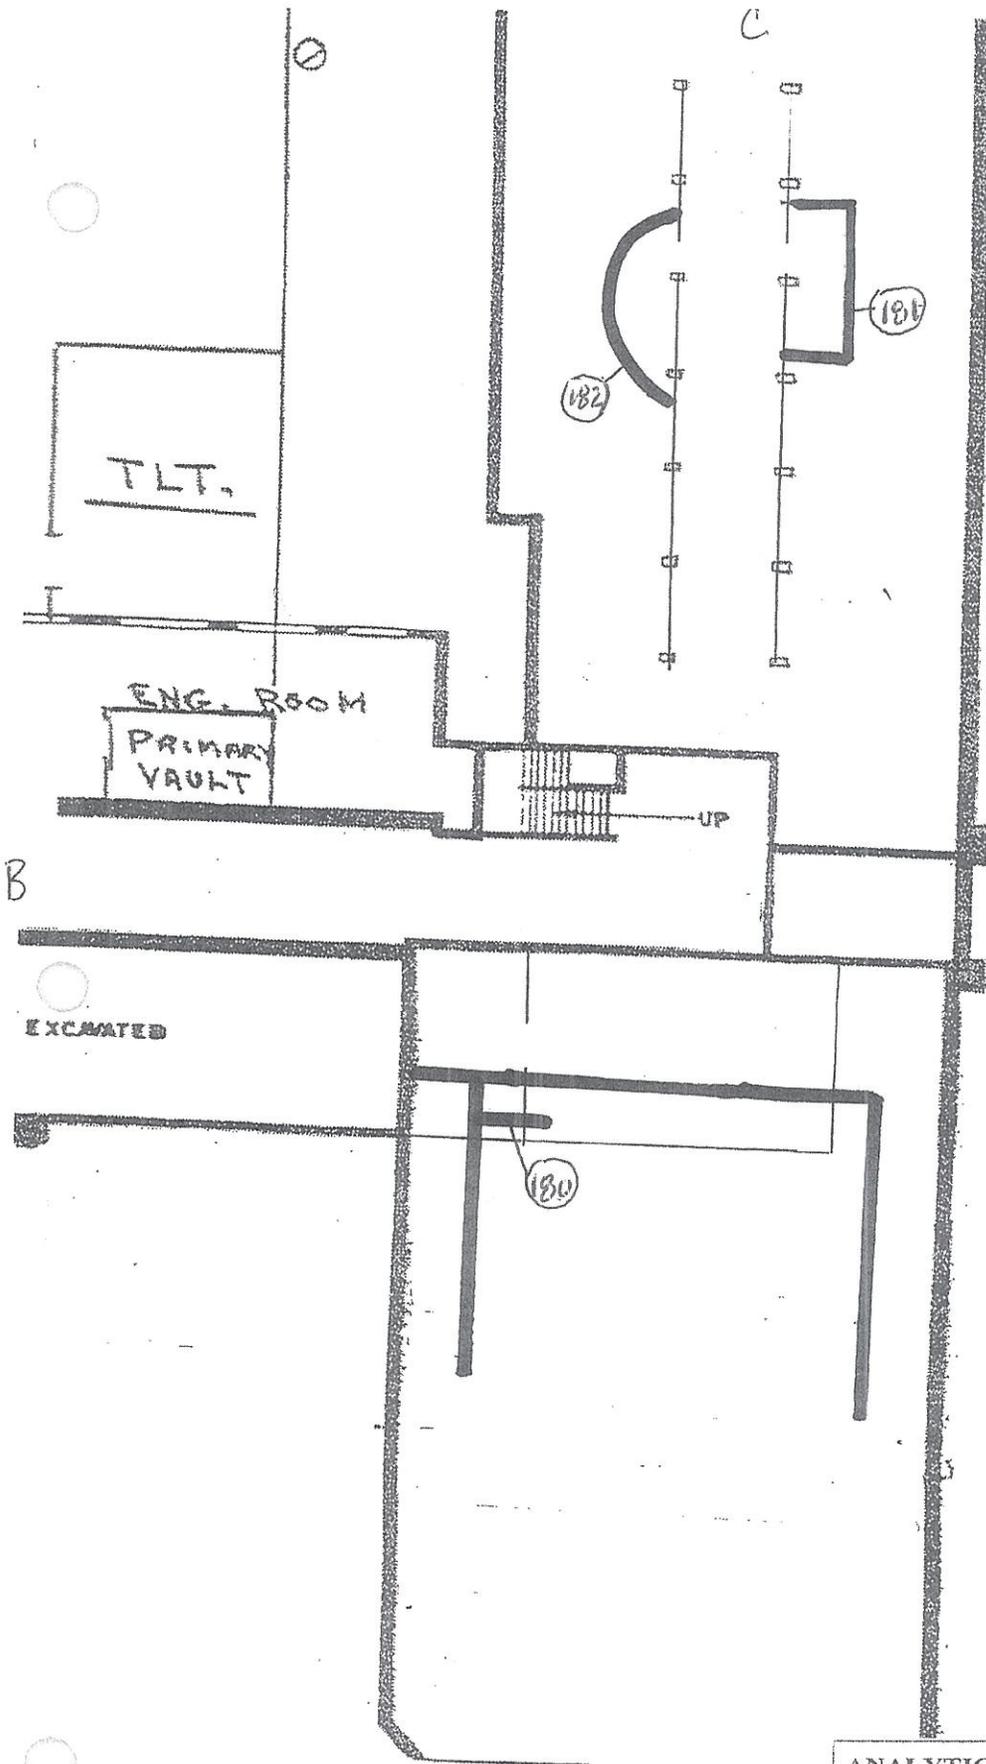
HA DESCRIPTION: Duct Wrap

HA LOCATION	Type SM/TSI/MM	Friability F/NF	Physical Condition	Size SF/LF/MF
Air duct wrap in tunnels / crawlspace under auditorium south section	TSI	F	7	~2,614 SF
Air duct wrap in tunnels / crawlspace – north section non excavated area	TSI	F	7	~406 SF
TOTAL				~3,020 SF

Sample No.	Description and Location	Results (%)
8601-180	Duct wrap tunnel area south section under auditorium	80% Chrysotile
8601-181	Duct wrap tunnel area north section in non excavated area	80% Chrysotile
8601-182	Duct wrap tunnel area north section in non excavated area	80% Chrysotile
*Note: All samples were collected in a statistically random manner representative of Homogeneous Area in accordance with 40 CFR 763.86.

ANALYTICAL TESTING & CONSULTING	
HA: EEEE DUCTWRAP	
DATE: 12/23/25	LAB #: 8601
SCALE: NTS

Location	Recommendations
HA-EEEE	Remove Asbestos Prior to Demolition/ Renovation

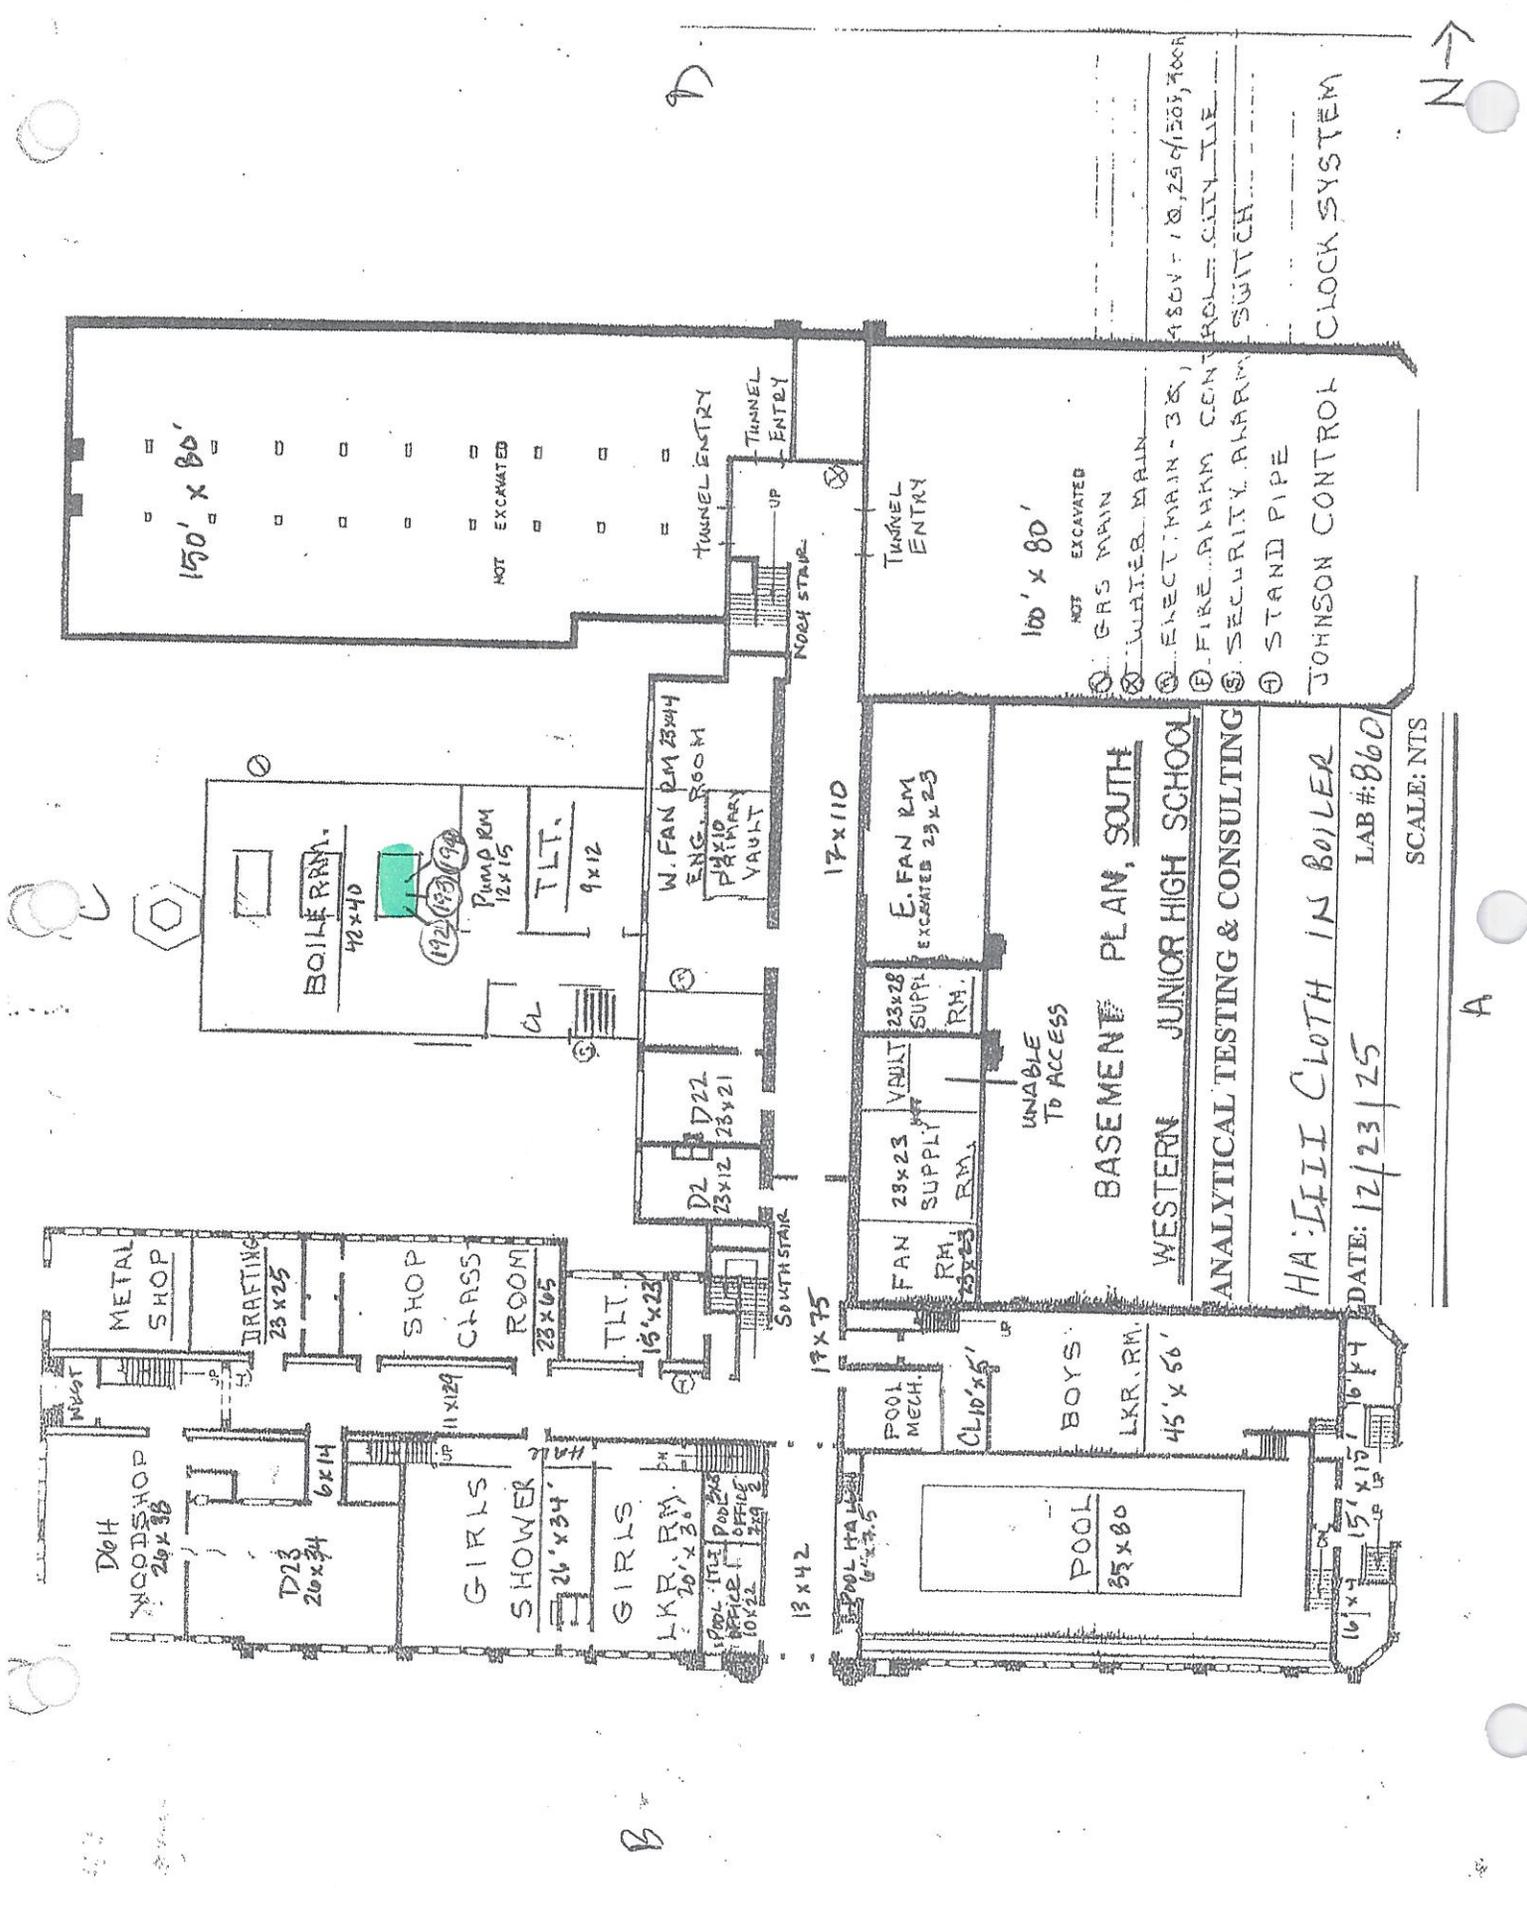
BASEMENT PLAN, SOUTH

HA DESCRIPTION: Cloth in Boiler

HA LOCATION	Type SM/TSI/MM	Friability F/NF	Physical Condition	Size SF/LF/MF
1927 boiler near entrance	TSI	F	7	~10 SF
TOTAL				~10 SF

Sample No.	Description and Location	Results (%)
8601-192	Sample of boiler cloth in 1927 boiler near entrance	70% Chrysotile
8601-193	Sample of boiler cloth in 1927 boiler near entrance	70% Chrysotile
8601-194	Sample of boiler cloth in 1927 boiler near entrance	70% Chrysotile
<p><i>*Note: All samples were collected in a statistically random manner representative of Homogeneous Area in accordance with 40 CFR 763.86.</i></p>

HA: ILLI CLOTH IN BOILER

Location	Recommendations
HA-III	Remove Asbestos Prior to Demolition/ Renovation
