Using Thermal Imaging to detect energy leakage in existing windows

Jodi Burns¹, Dr. Julian Wang²

¹Bakersfield R-IV School District, Bakersfield, MO; ²School of Architectural Engineering, Penn State University

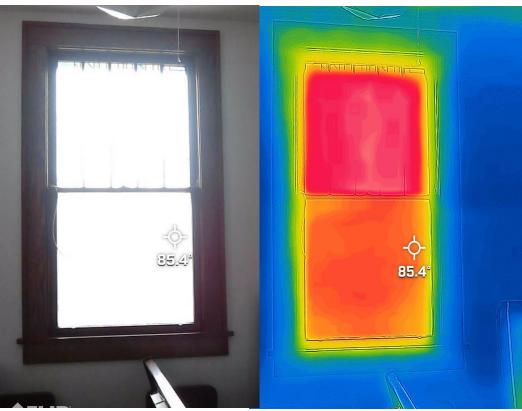
Actual window at church on the left (facing North), when thermally photographed, even pattern shows no indication of energy leaking

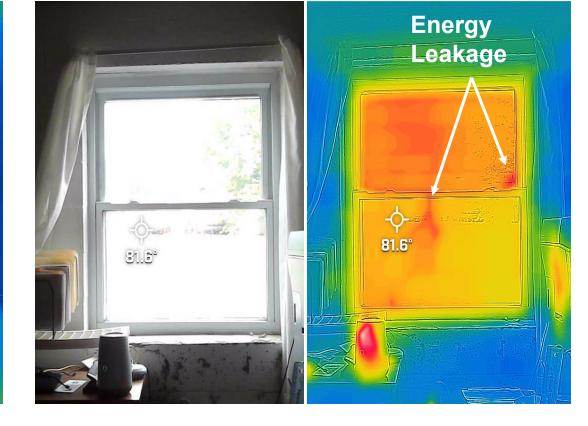
This basement window in the same church (facing North) show warmer areas at corner and center of window frame, therefore indicating energy leakage. (Red object in lower left corner is an electronic appliance.)

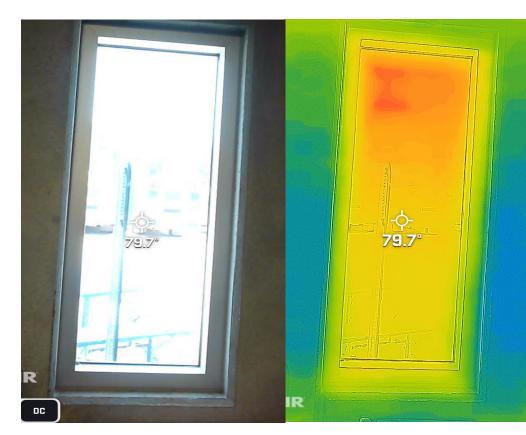
All windows in newly built FEMA building shows even temperature pattern similar to this, revealing no leakage.

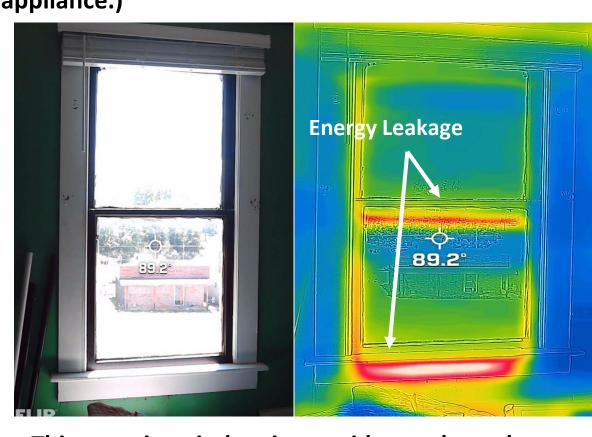
This upstairs window in a residence shows heat infiltration at bottom and top of lower window frame, therefore revealing leakage.

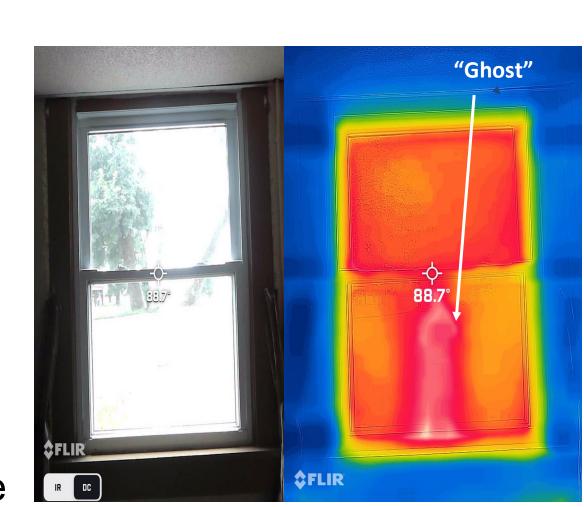
Getting reliable images could be challenging. Roughly 30% of the thermal images of the windows photographed contained "ghosts." These are caused when lower energy infrared bounces off windows and other hard surfaces, onto the photographer, and back to the window. I resolved the problem by taking pictures at about a 60 degree angle. This did not seem to affect the temperature reading on the camera monitor...

same window photographed in infrared with a "ghost."
