**ASBESTOS SURVEY
REPORT FOR**

(Former) Southwestern Junior High School
390 S. Washington Avenue
Battle Creek, Michigan 49037

September 15, 16, 17, 18, 19, 23, 25 & 29, 2025
October 3 & 14, 2025
November 14, 24, 2025
December 23, 2025

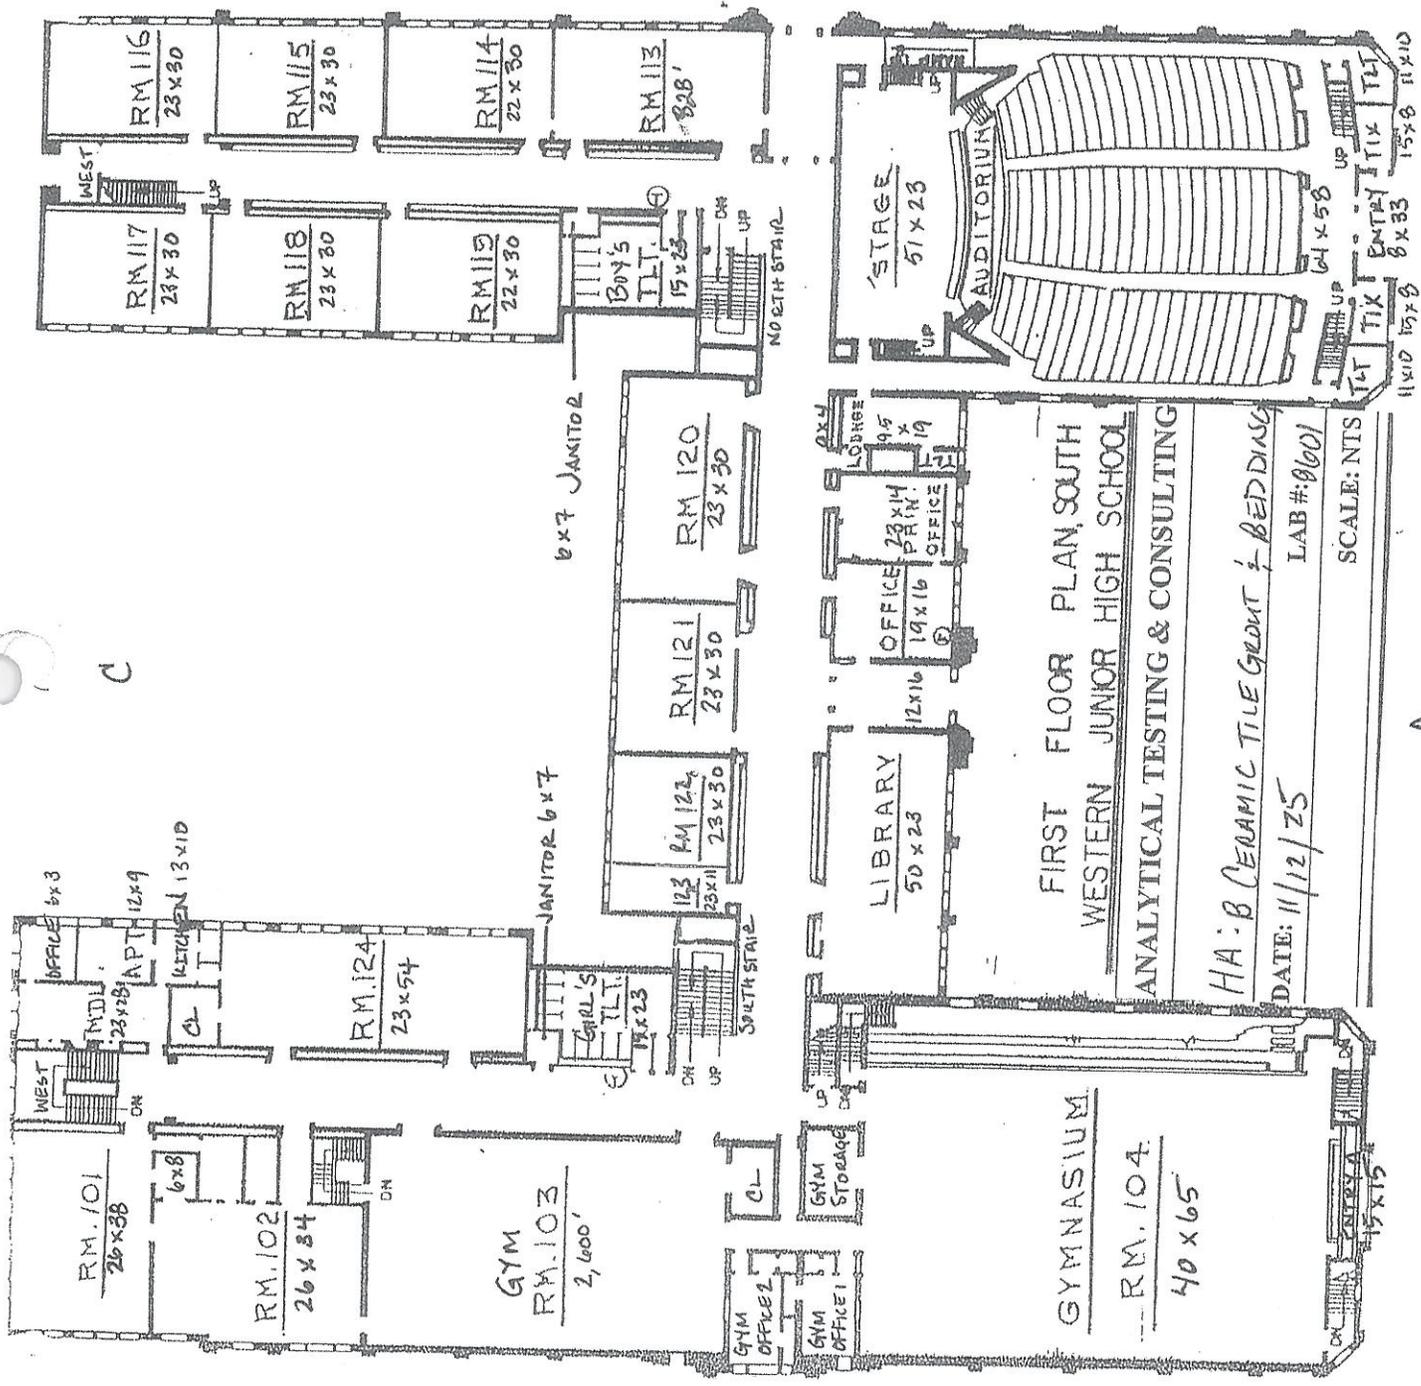
HA LOCATION	Type SM/TSI/MM	Friability F/NF	Physical Condition	Size SF/LF/MF
Pool Hall	MM	NF	7	~45 SF
Pool	MM	NF	7	~2,250 SF
Toilet in pool office 1	MM	NF	7	~20 SF
Entry – near office and library	MM	NF	7	~192 SF
Teacher’s lounge	MM	NF	7	~32 SF
Pigeon office toilet	MM	NF	7	~40 SF
Side A entry to Auditorium	MM	NF	7	~264 SF
1 st and 2 nd floor Boy’s restroom	MM	NF	7	~100 SF
1 st and 2 nd floor Girl’s restroom	MM	NF	7	~100 SF
Lower level classroom hallway walls	MM	NF	7	~1,600 SF
TOTAL				~4,643 SF

Location	Recommendations
HA-B	Non Asbestos

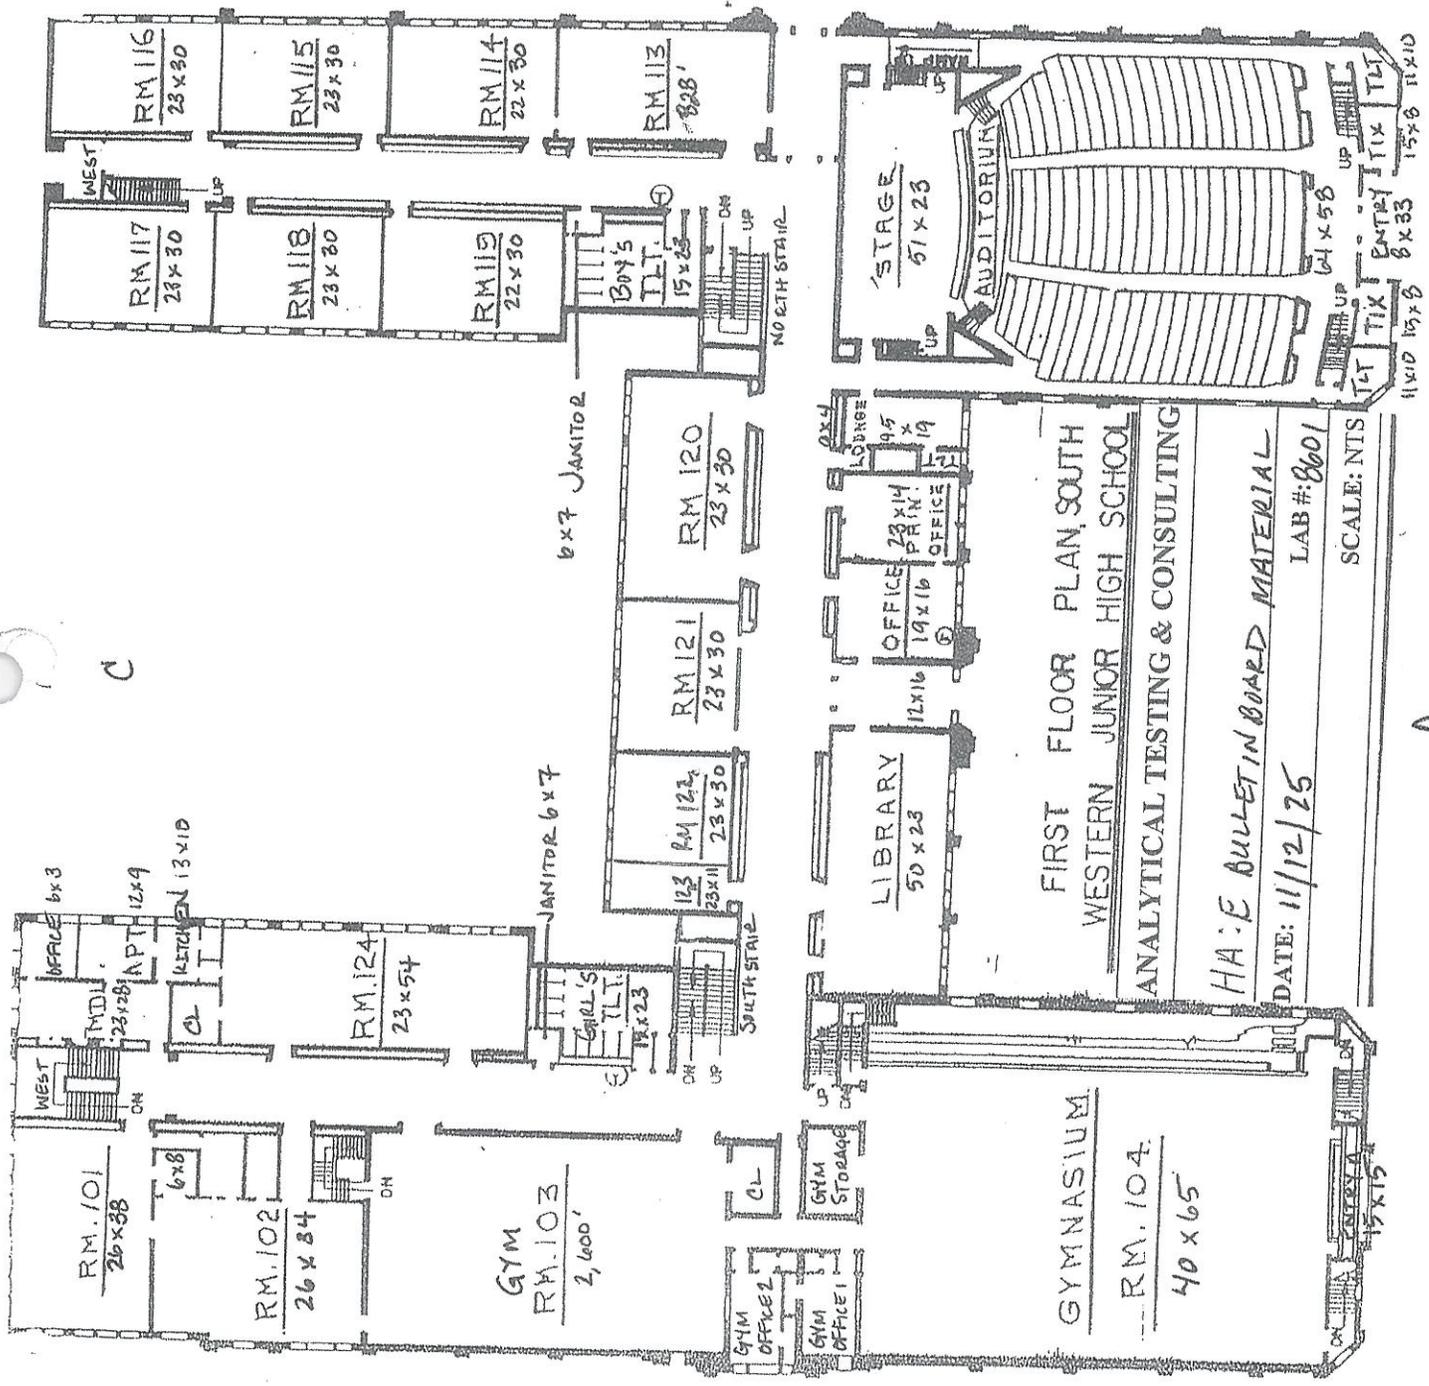
HA LOCATION	Type SM/TSI/MM	Friability F/NF	Physical Condition	Size SF/LF/MF
Gym Entry A on wall	MM	NF	7	~20 SF
TOTAL				~20 SF

Location	Recommendations
HA-E	Non Asbestos

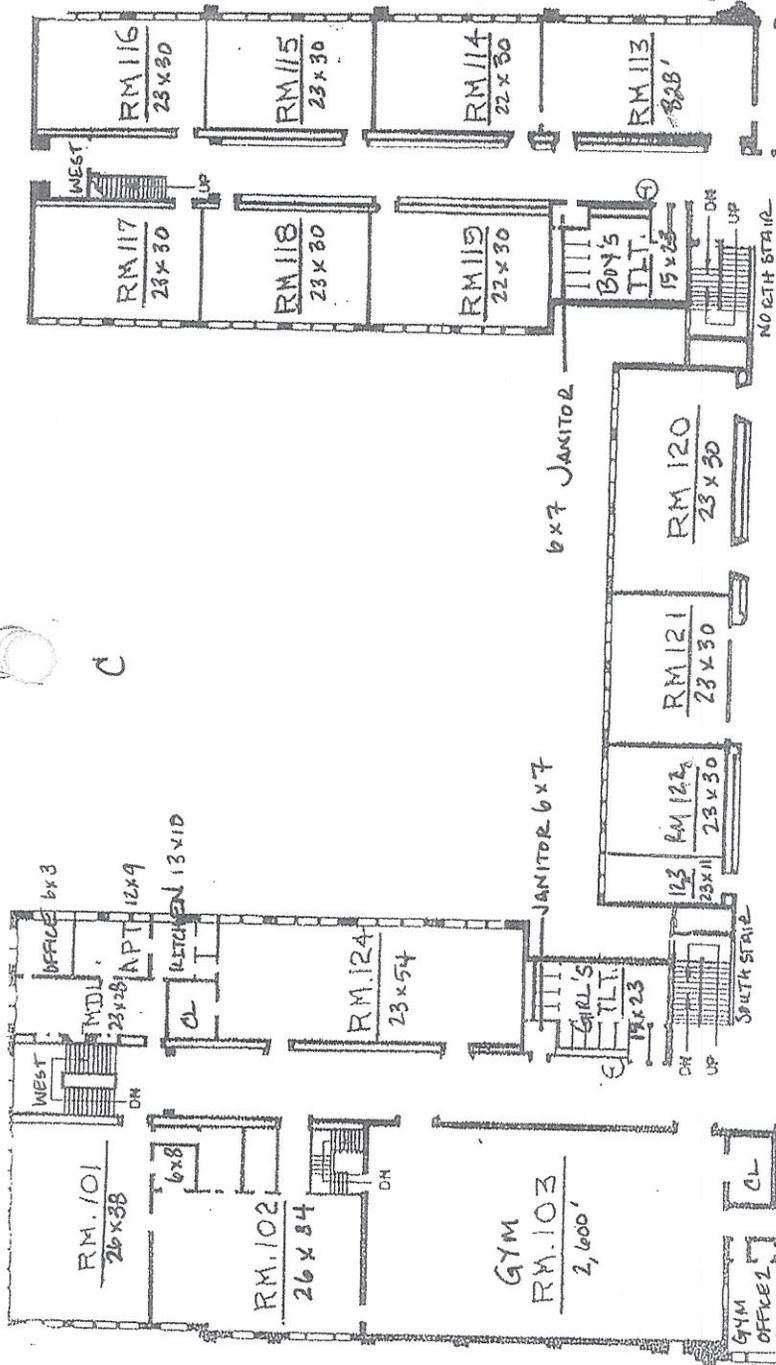
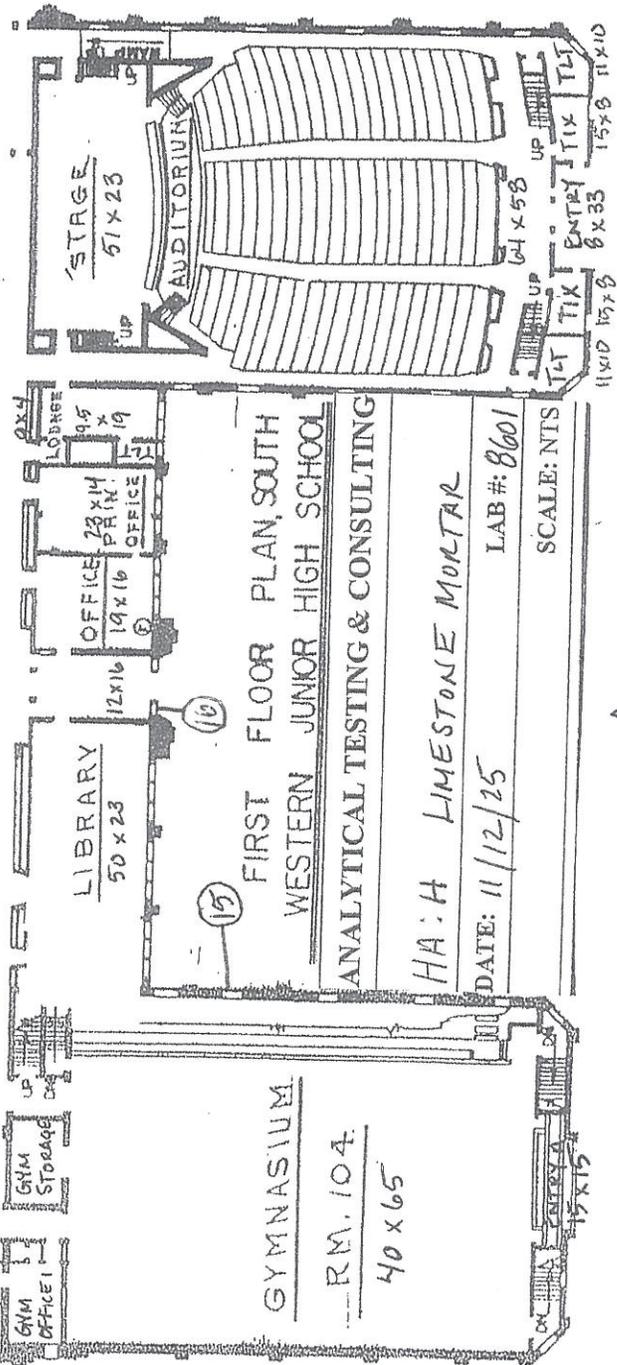
HA LOCATION	Type SM/TSI/MM	Friability F/NF	Physical Condition	Size SF/LF/MF
Base of the exterior of the building	MM	NF	4	~5,160 SF
TOTAL				~5,160 SF

Location	Recommendations
HA-H	Non Asbestos

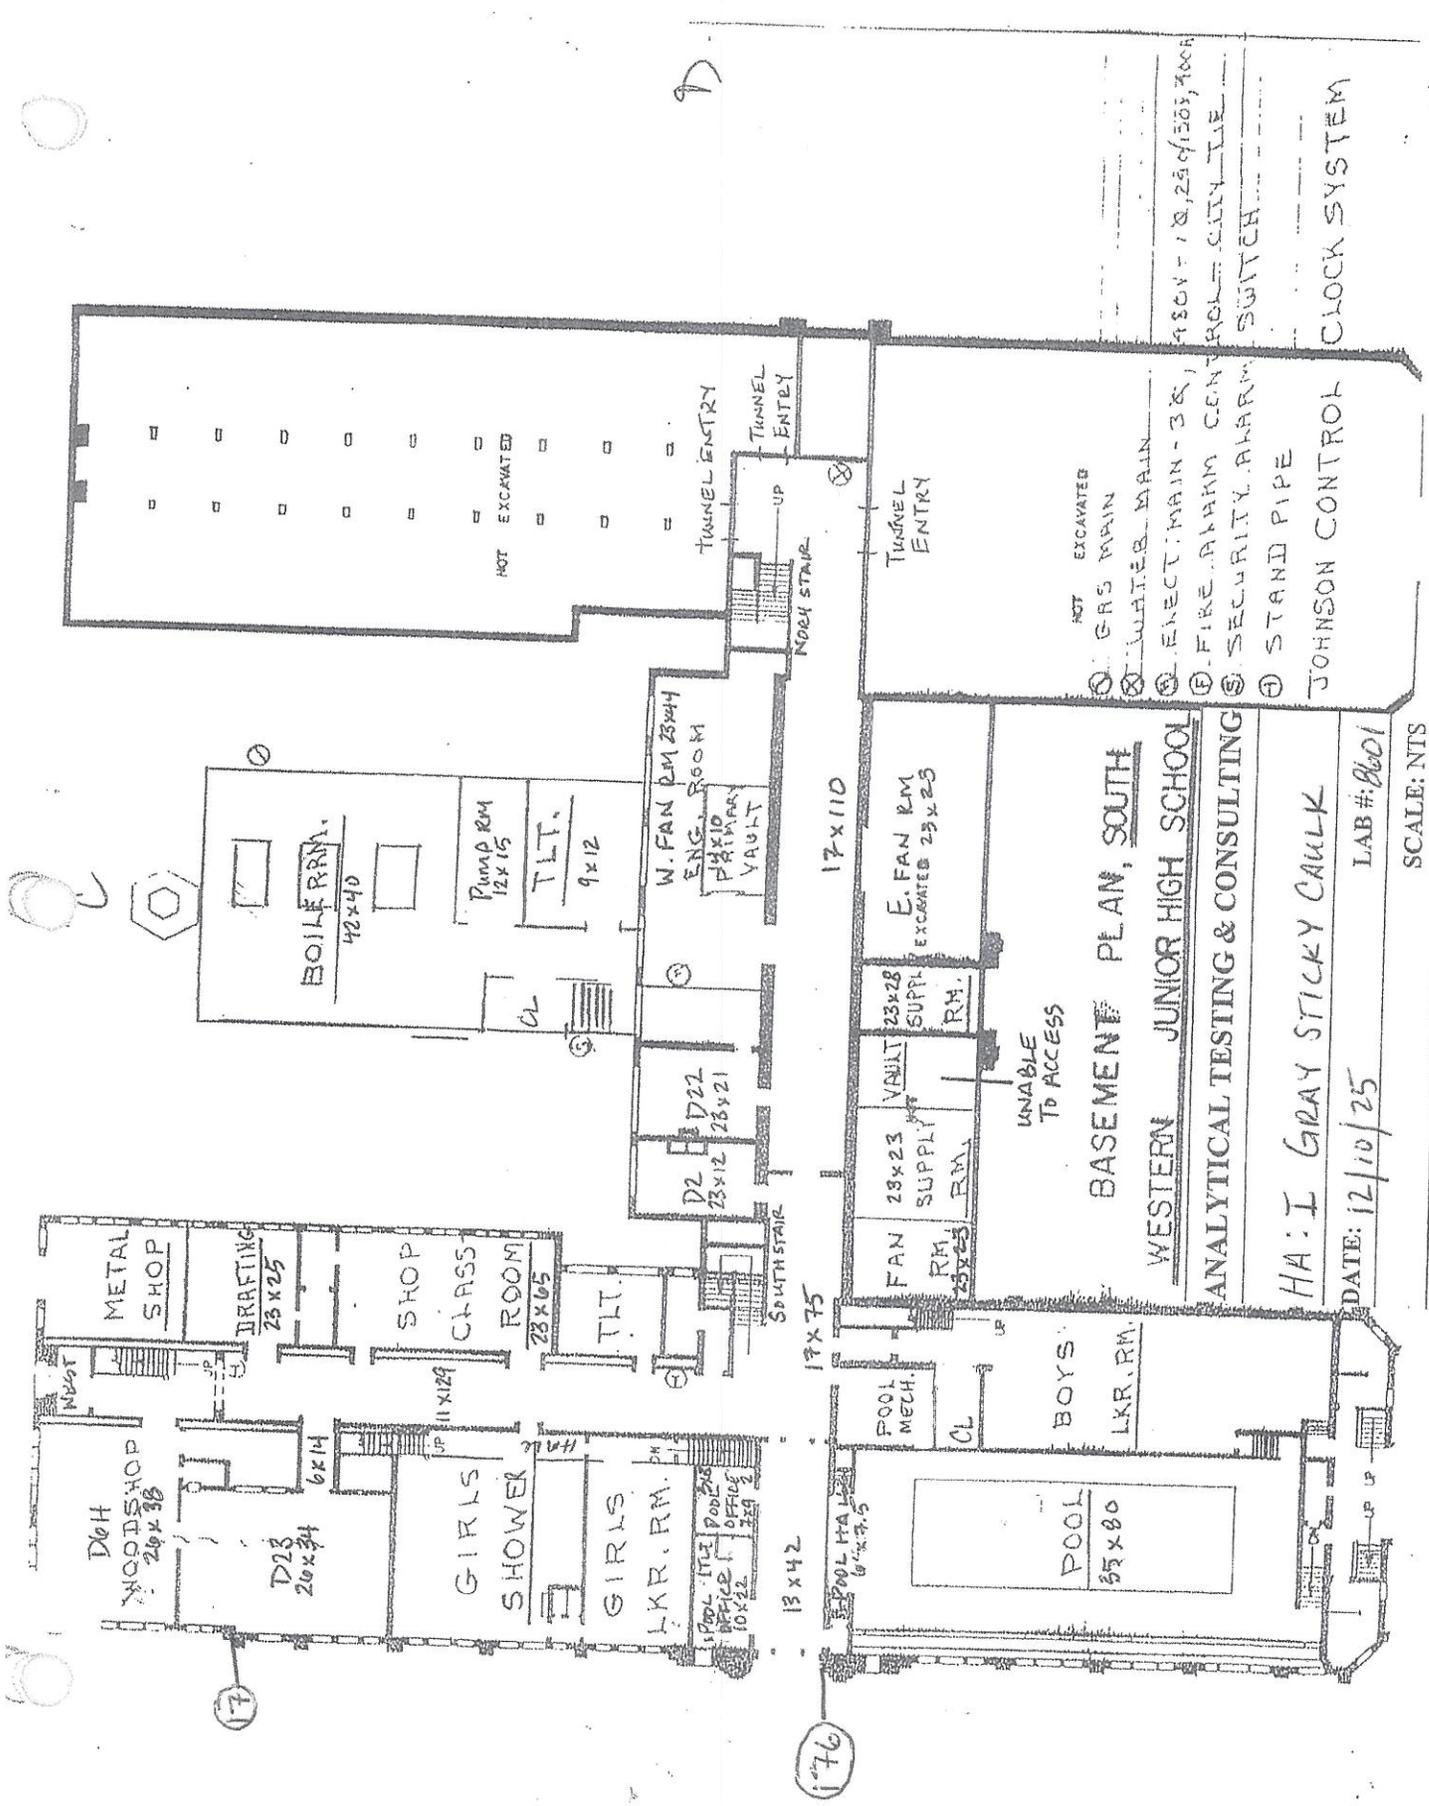
BASEMENT PLAN, SOUTH
WESTERN JUNIOR HIGH SCHOOL
ANALYTICAL TESTING & CONSULTING

HA LOCATION	Type SM/TSI/MM	Friability F/NF	Physical Condition	Size SF/LF/MF
Between brick and aluminum window casings and door casings– top layer (outside around casing)	MM	NF	7	~9,300 LF / ~387 SF
TOTAL				~9,300 LF / ~387 SF

Location	Recommendations
HA-I	Non Asbestos

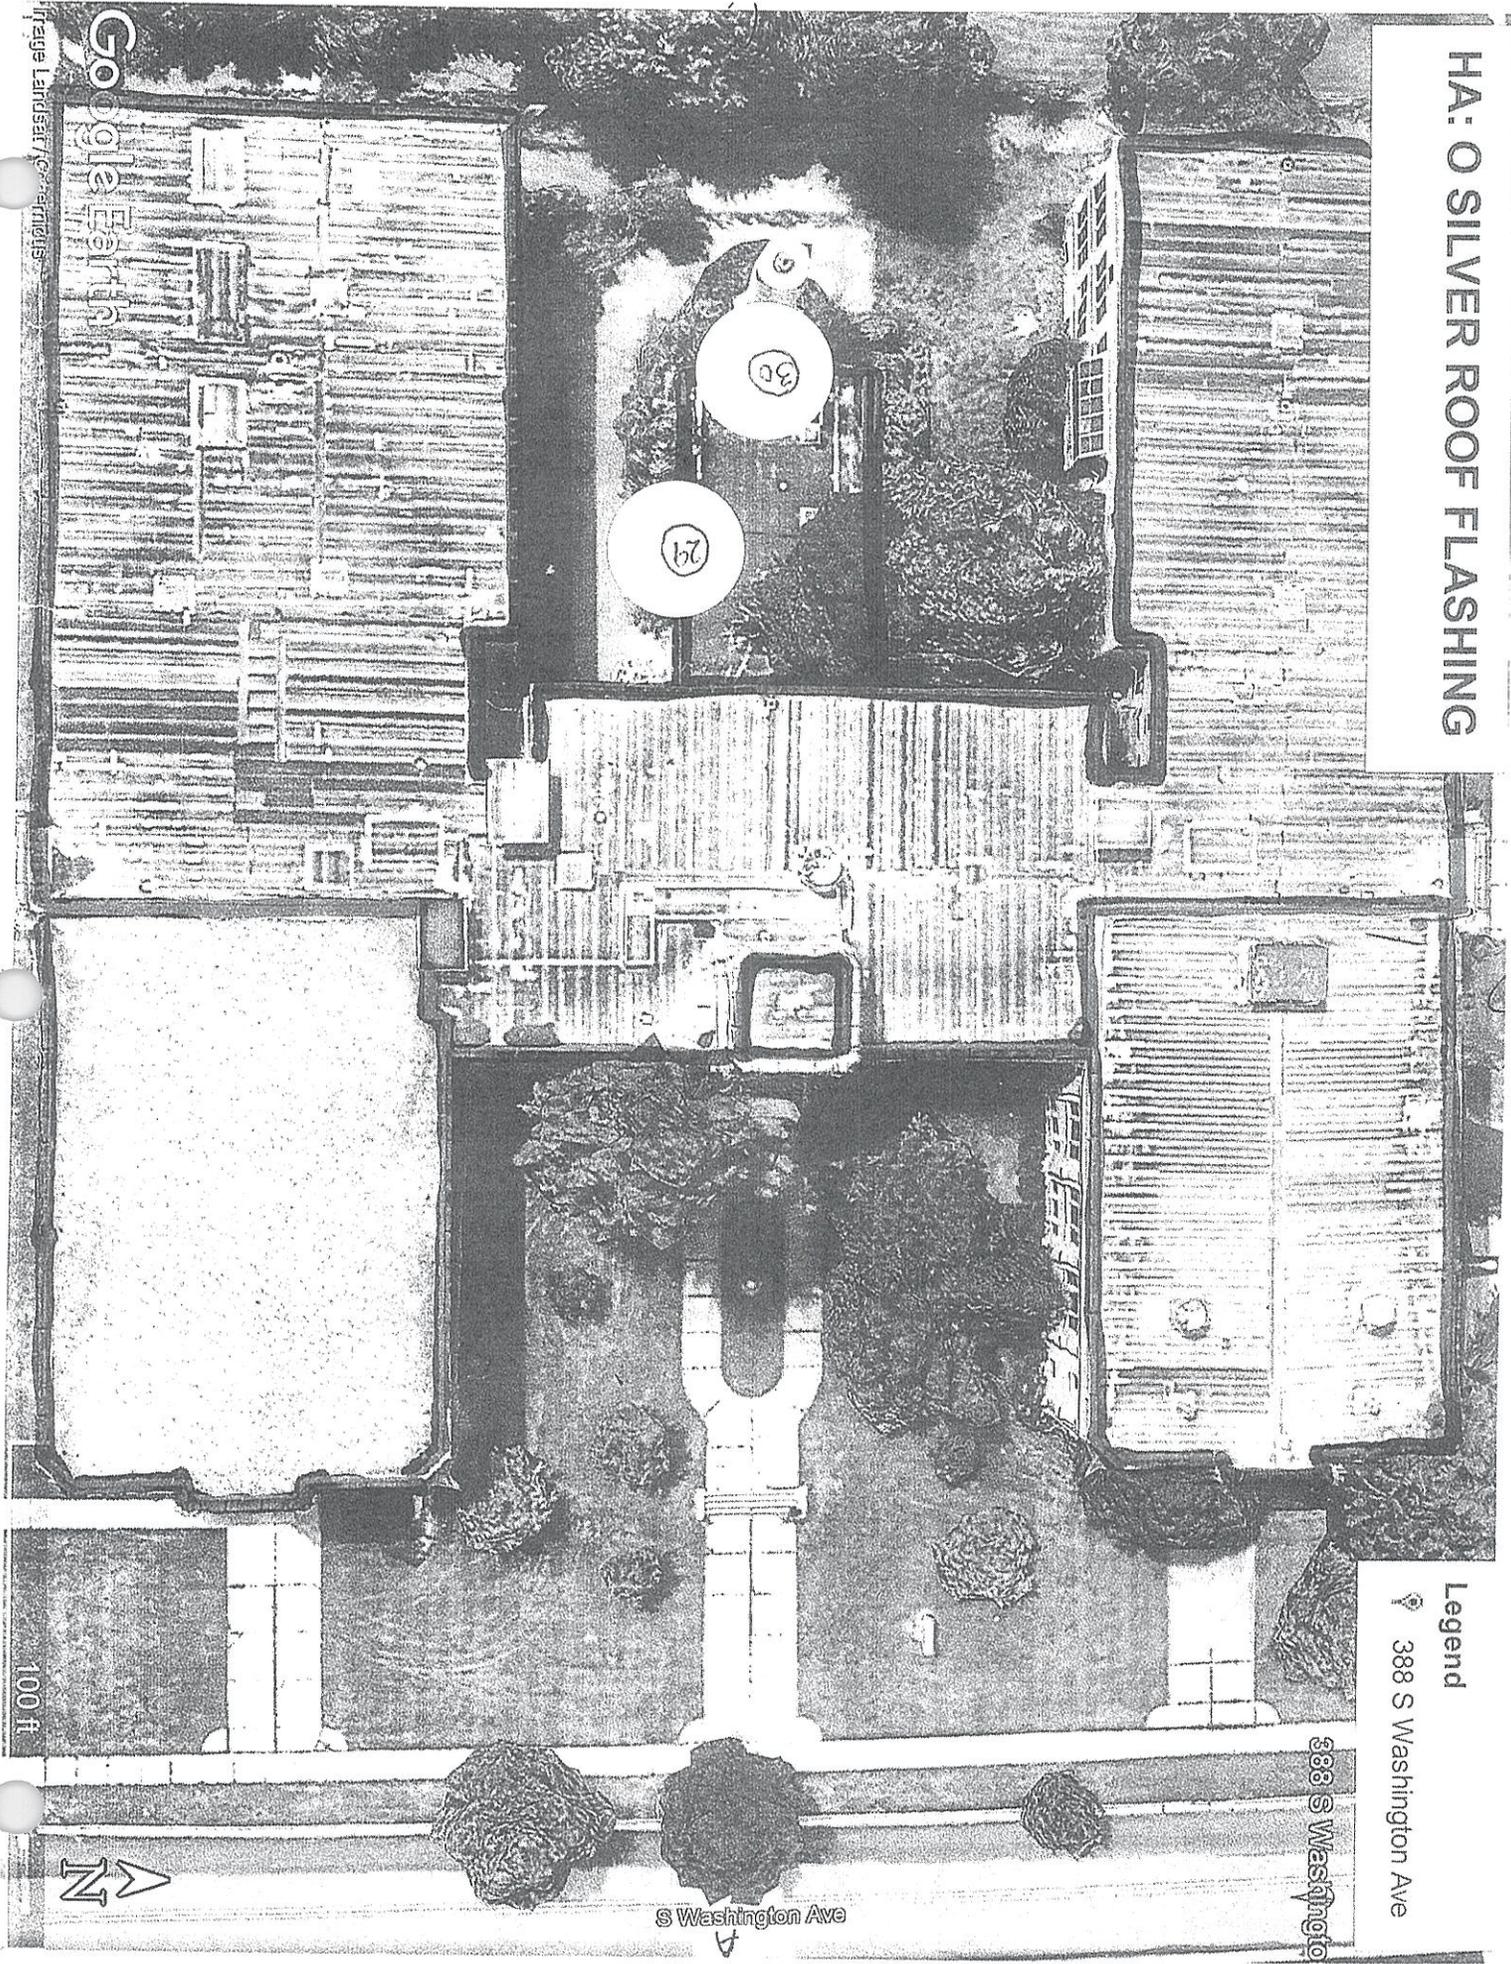
HA: O SILVER ROOF FLASHING

HA LOCATION	Type SM/TSI/MM	Friability F/NF	Physical Condition	Size SF/LF/MF
Boiler Room roof – along the perimeter of the roof	MM	NF	1	~164 LF / ~246 SF
Main building	MM	NF	1	~1,032 LF / ~1,548 SF
TOTAL				~1,196 LF / ~1,794 SF

Location	Recommendations
HA-O	Non Asbestos

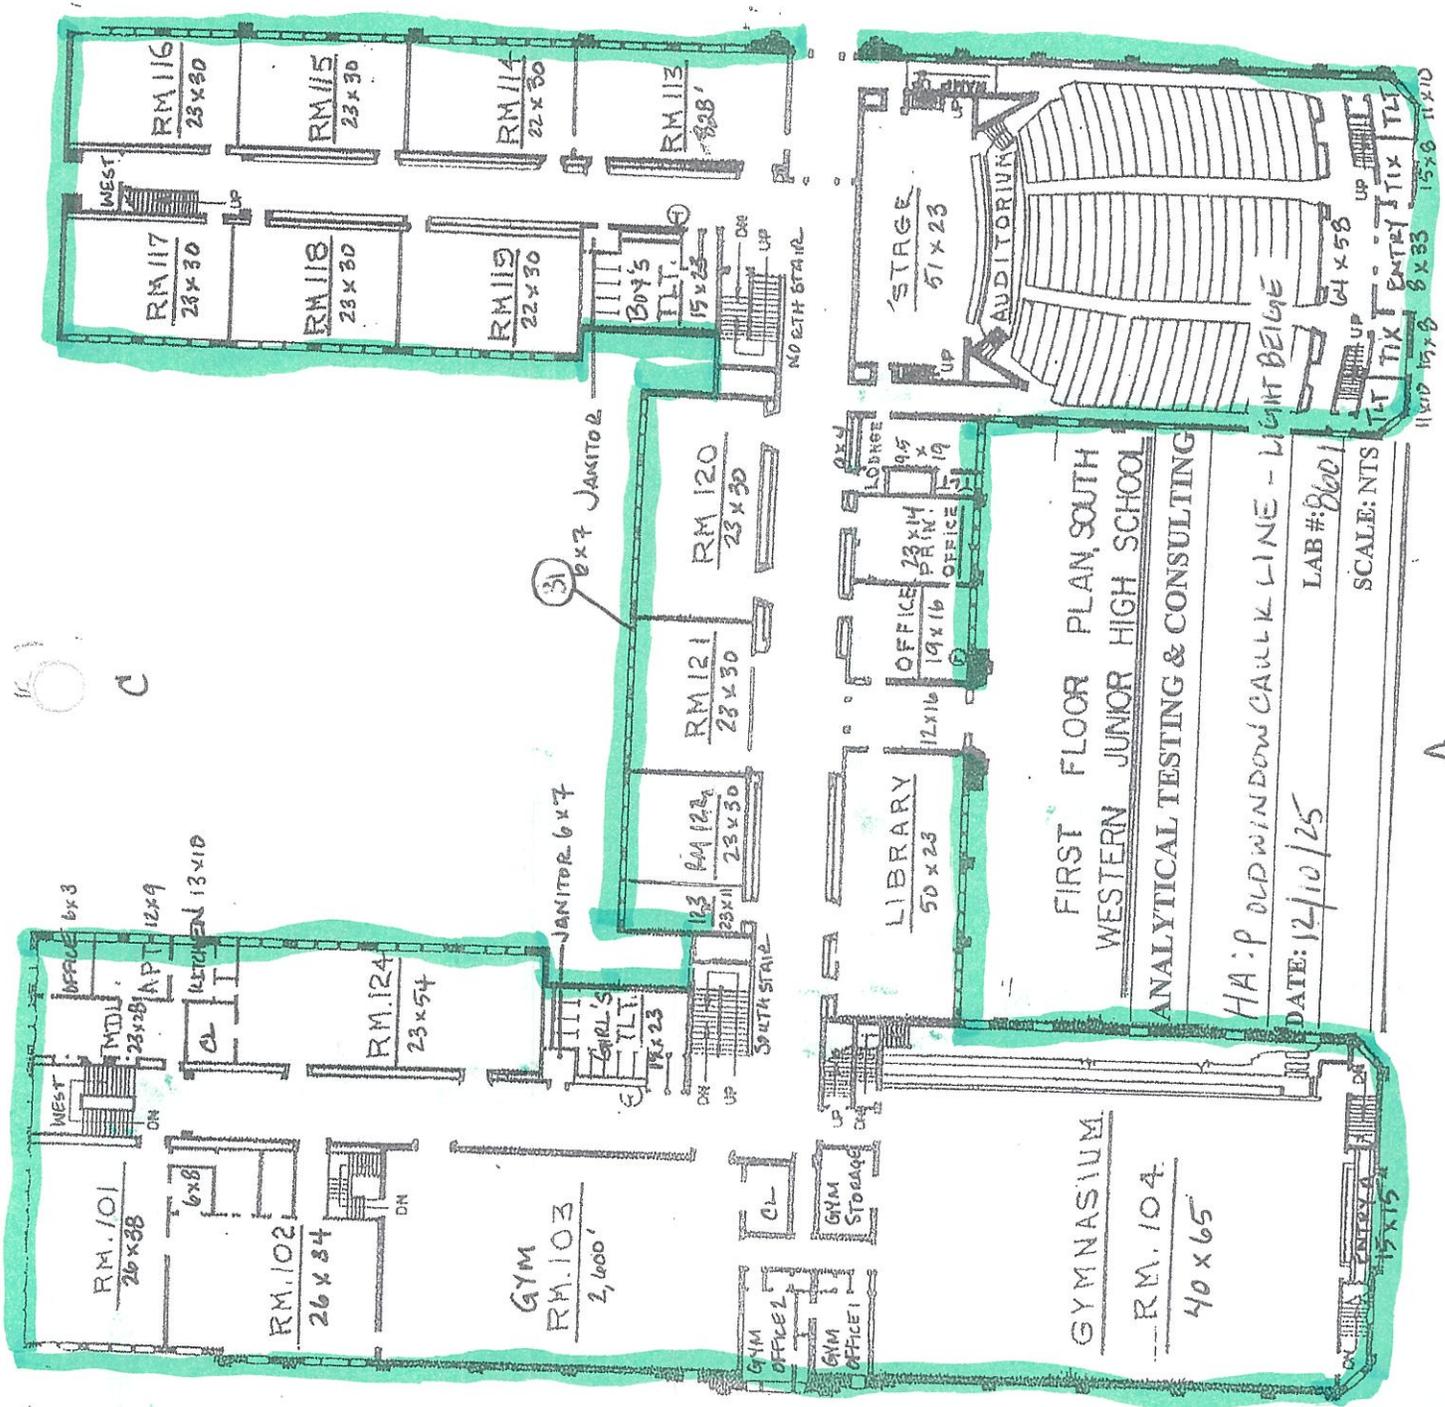
HA LOCATION	Type SM/TSI/MM	Friability F/NF	Physical Condition	Size SF/LF/MF
Under metal window casings – old caulk line from old windows ~261 window openings	MM	NF	5	~7,400 LF / ~309 SF
TOTAL				~7,400 LF / ~309 SF

Location	Recommendations
HA-P	Remove Asbestos Prior to Demolition/ Renovation
