ASBESTOS SURVEY DATA FORM

LOCATION: Southwestern Junior High School

ADDRESS: 390 S. Washington, Battle Creek, Michigan 49017

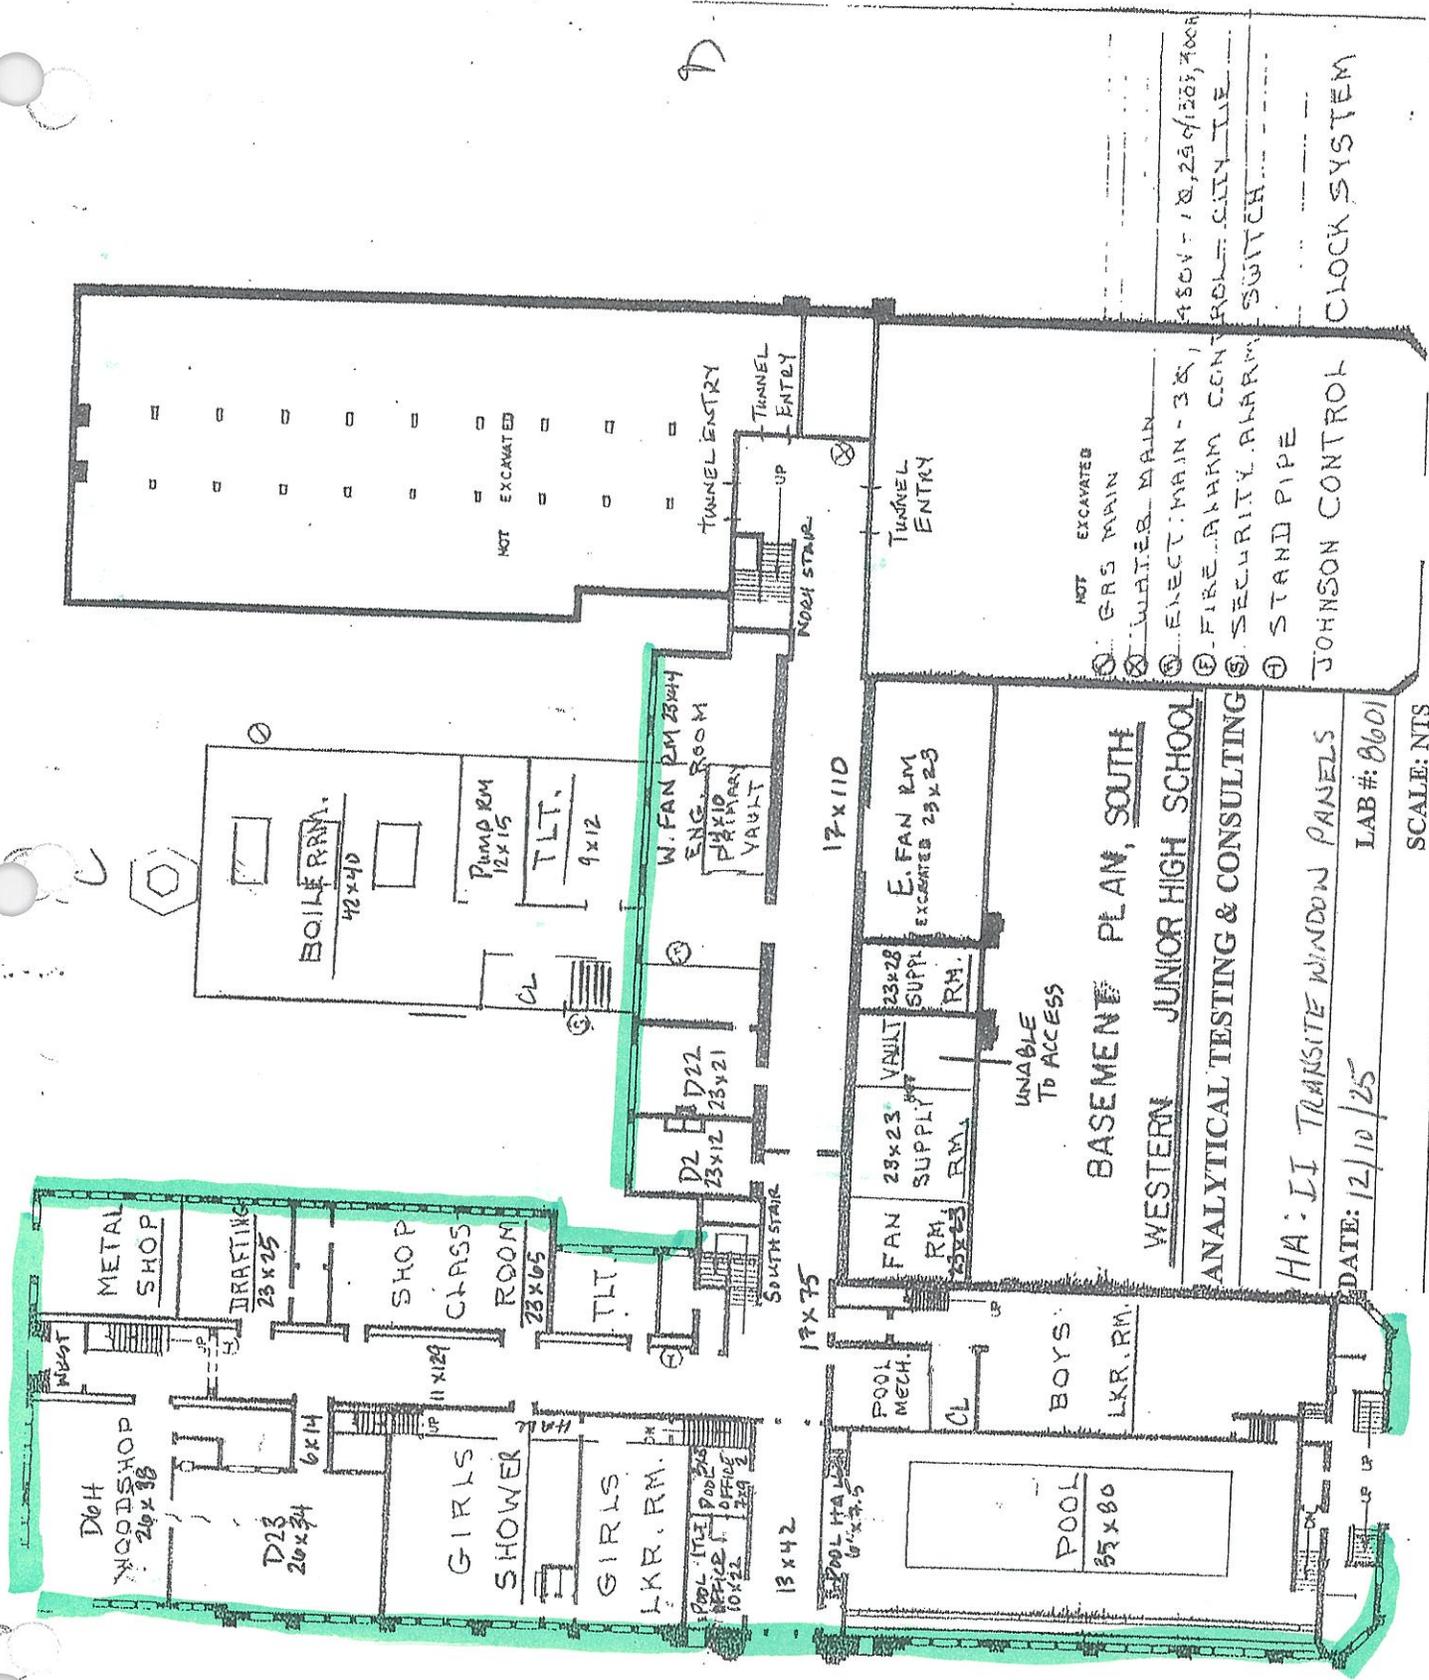
BASEMENT PLAN, SOUTH
WESTERN JUNIOR HIGH SCHOOL
ANALYTICAL TESTING & CONSULTING

HA: JJ TRANSITE WINDOW PANELS
 DATE: 12/10/25
 LAB #: 8601
 SCALE: NTS

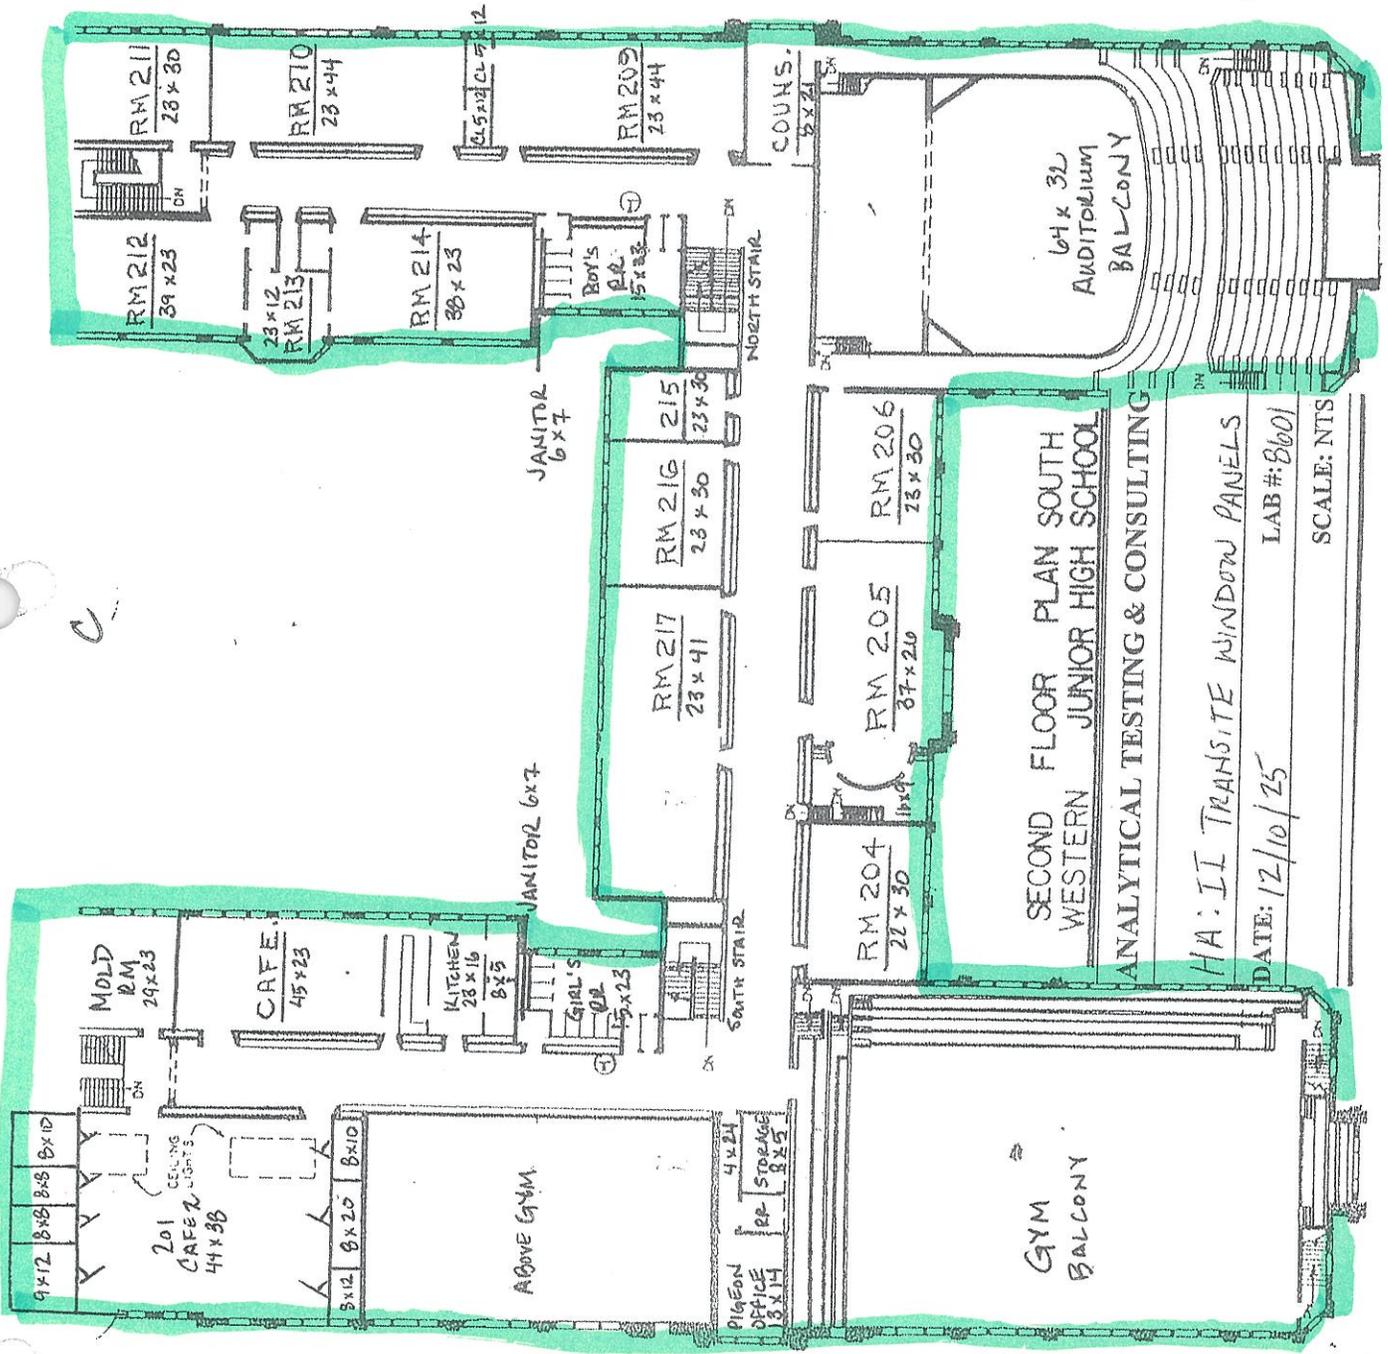
SECOND FLOOR PLAN SOUTH
 WESTERN JUNIOR HIGH SCHOOL
 ANALYTICAL TESTING & CONSULTING

HA: II TRANSITE WINDOW PANELS
 LAB #: 8601
 DATE: 12/10/25

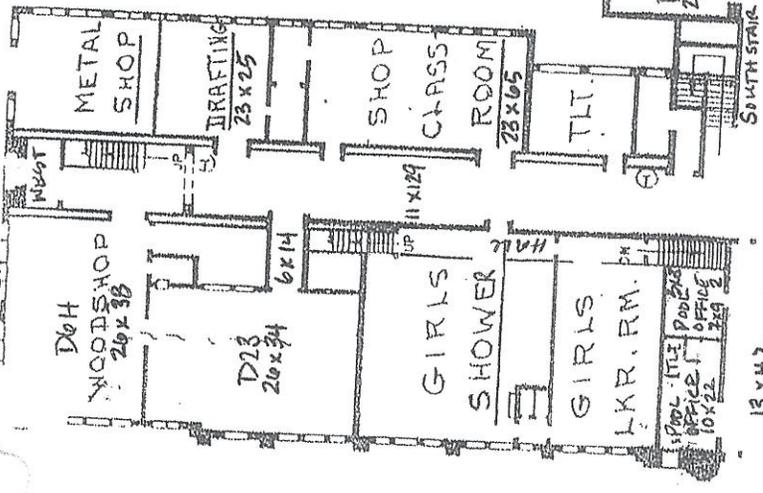
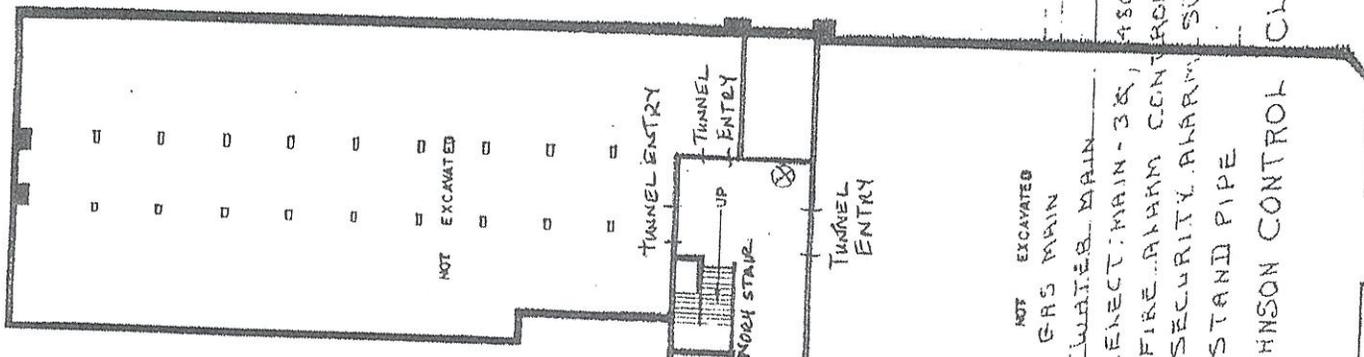
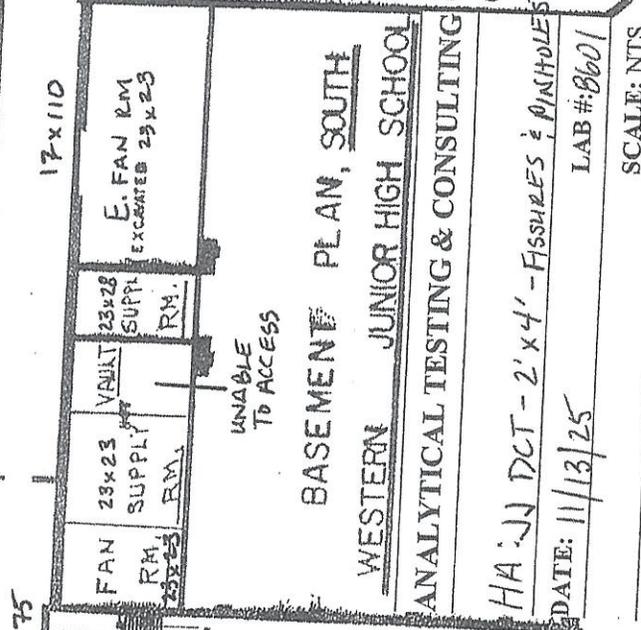
BASEMENT PLAN, SOUTH
WESTERN JUNIOR HIGH SCHOOL
ANALYTICAL TESTING & CONSULTING

HA DESCRIPTION: 2x4 DCT – Fissures and Pinholes

HA LOCATION	Type SM/TSI/MM	Friability F/NF	Physical Condition	Size SF/LF/MF
Room 201 – Café 2	MM	F	7	~1,672 SF
Café 1	MM	F	7	~1,035 SF
Second floor hallway	MM	F	7	~4,038 SF
South stair hallway	MM	F	7	~216 SF
West stairwells	MM	F	7	~396 SF
Room 117	MM	F	7	~690 SF
Room 118	MM	F	7	~690 SF
Room 119	MM	F	7	~690 SF
First floor hallway	MM	F	7	~2,000 SF
First floor girl's restroom	MM	F	5	~345 SF
First floor boy's restroom	MM	F	5	~345 SF
Library – on ground	MM	F	7	~1,150 SF
Second floor Girl's restroom	MM	F	7	~345 SF
Second floor Boy's restroom	MM	F	7	~345 SF
Lower level D6H "Wood Shop"	MM	F	7	~988 SF
TOTAL				~14,945 SF

Sample No.	Description and Location	Results (%)
8601-73	Sample of DCT from 2 nd floor Girl's restroom	None Detected
8601-74	Sample of DCT from "A" hallway center	None Detected
*Note: All samples were collected in a statistically random manner representative of Homogeneous Area in accordance with 40 CFR 763.86.

HA: JJ DCT - 2' x 4' - ASSURES & PINHOLE
 DATE: 11/13/25
 LAB #: B601
 SCALE: NTS

Location	Recommendations
HA-JJ	Non Asbestos

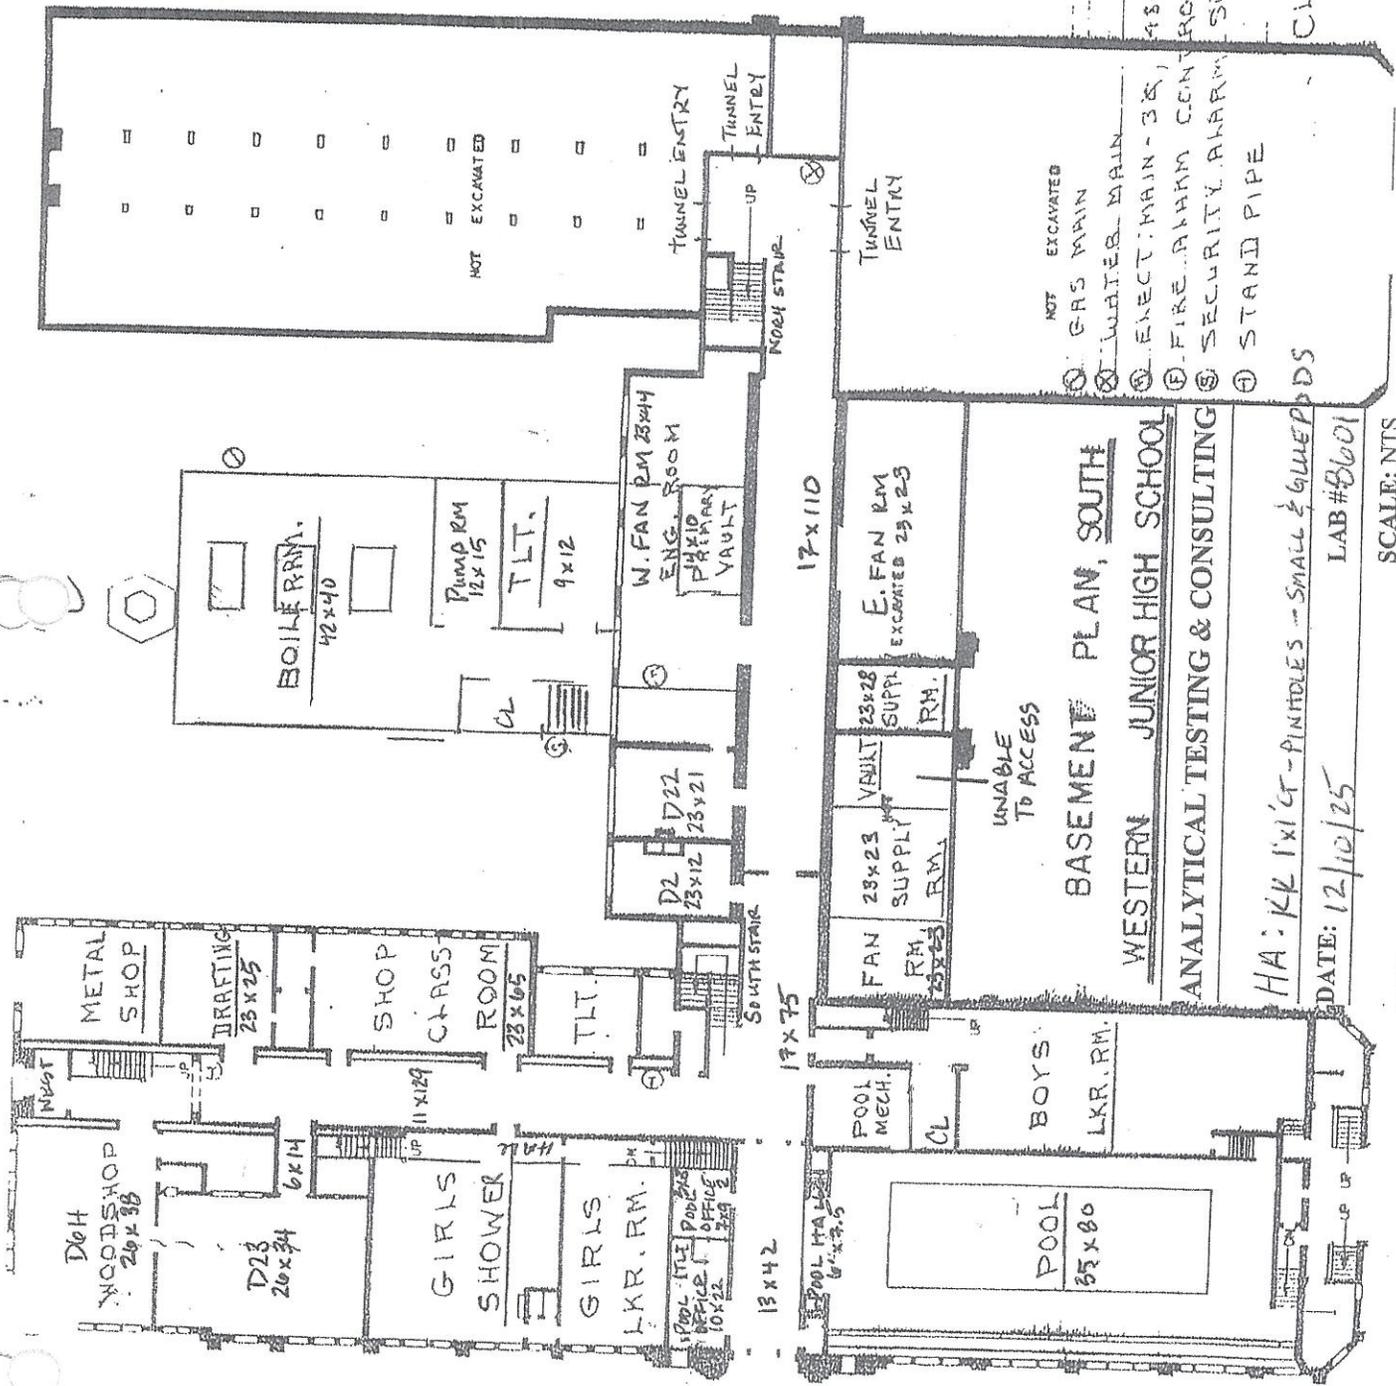
BASEMENT PLAN, SOUTH
WESTERN JUNIOR HIGH SCHOOL
ANALYTICAL TESTING & CONSULTING

HA DESCRIPTION: 1'x1' CT – Pinholes Small and Brown Glue Pods

HA LOCATION	Type SM/TSI/MM	Friability F/NF	Physical Condition	Size SF/LF/MF
Pigeon Office	MM	F	7	~182 SF
Pigeon Office hall	MM	F	7	~96 SF
Pigeon Office restroom	MM	F	7	~40 SF
Room 216	MM	F	7	~690 SF
Room 204	MM	F	7	~660 SF
Room 209	MM	F	7	~1,012 SF
Room 214	MM	F	7	~874 SF
Room 114	MM	F	7	~660 SF
Room 116	MM	F	7	~690 SF
Lower level south hall near classroom	MM	F	7	~1,419 SF
D23	MM	F	7	~884 SF
Shop/ Drafting	MM	F	7	~1,150 SF
Room 117 – Glue pods only; brown	MM	F	7	~690 SF
Room 118 – Glue pods only; brown	MM	F	7	~690 SF
Room 119 – Glue pods only; brown	MM	F	7	~690 SF
TOTAL				~10,427 SF

Sample No.	Description and Location	Results (%)
8601-75	Sample of 1'x1' CT from Pigeon Office on ground	Layer 1 – None Detected Layer 2 – None Detected
8601-76	Sample of 1'x1' CT from Room 114 on ground	Layer 1 – None Detected Layer 2 – None Detected
*Note: All samples were collected in a statistically random manner representative of Homogeneous Area in accordance with 40 CFR 763.86.

HA: KK 1'x1' CT - PINDLES - SMALL & GUEP PDS
 DATE: 12/10/25
 LAB #8601

Location	Recommendations
HA-KK	Non Asbestos

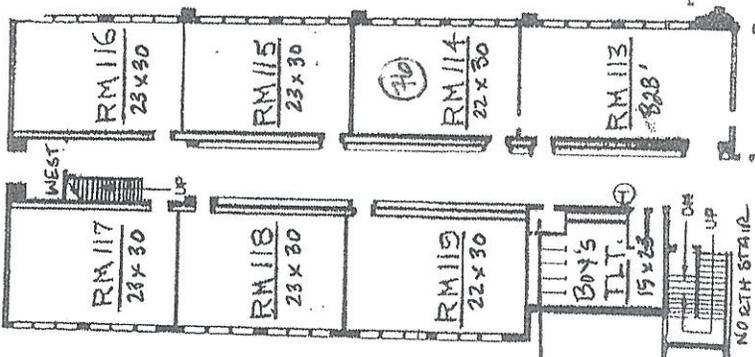
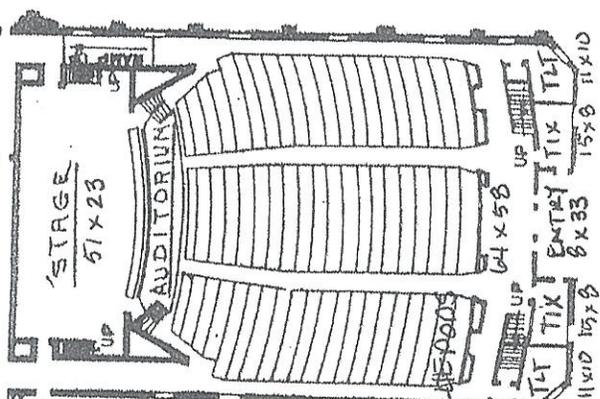
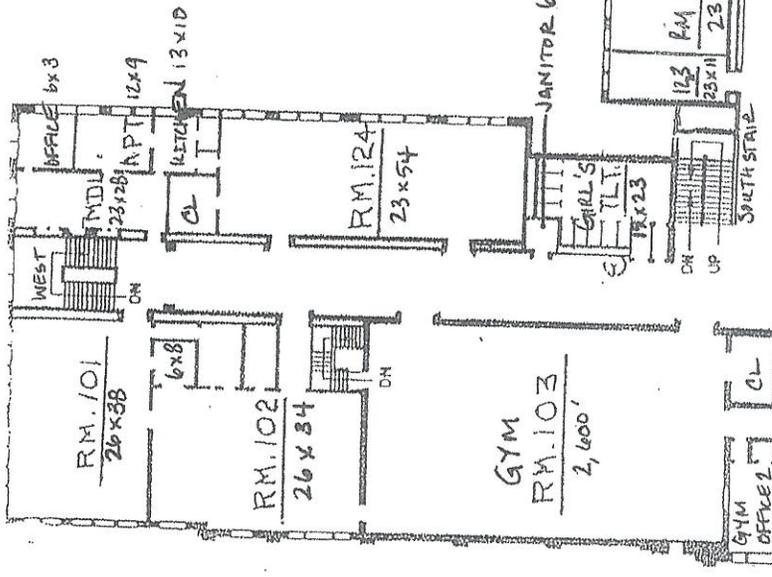
FIRST FLOOR PLAN, SOUTH
 WESTERN JUNIOR HIGH SCHOOL
 ANALYTICAL TESTING & CONSULTING

HA: K/L 1' x 1' CT - PINHOLE - SMALL & G
 DATE: 11/13/25
 LAB #: 8601
 SCALE: NTS

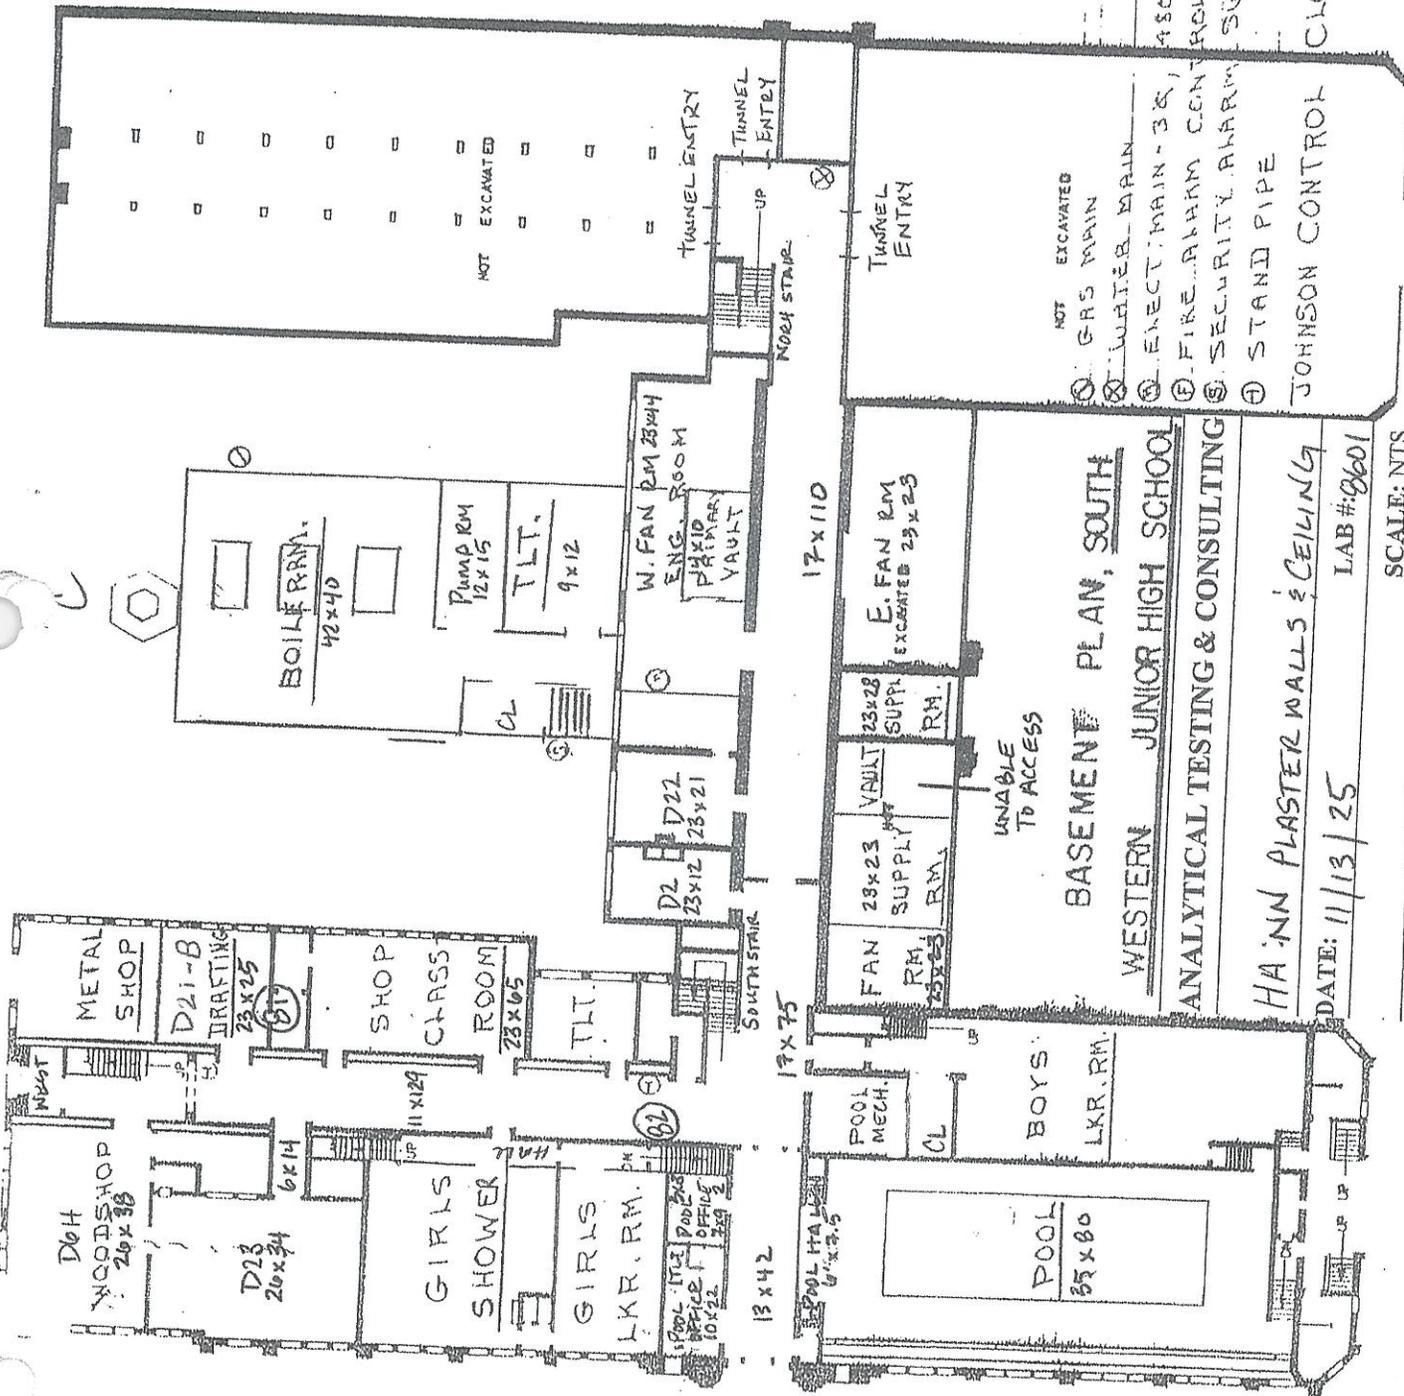
BASEMENT PLAN, SOUTH
WESTERN JUNIOR HIGH SCHOOL
ANALYTICAL TESTING & CONSULTING

HA LOCATION	Type SM/TSI/MM	Friability F/NF	Physical Condition	Size SF/LF/MF
Throughout building	SM	NF	5	~252,500 SF
TOTAL				~252,500 SF

Location	Recommendations
HA-NN	Non Asbestos

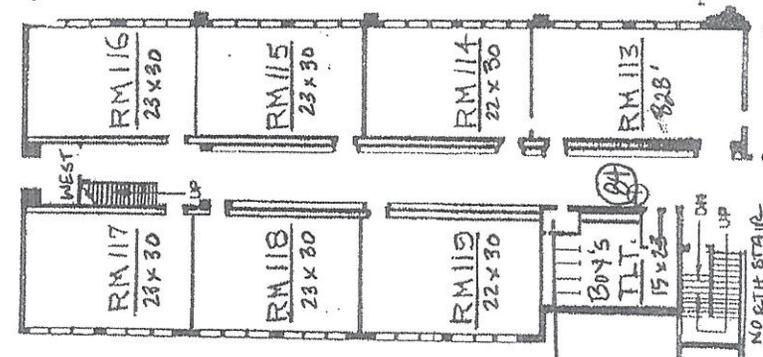
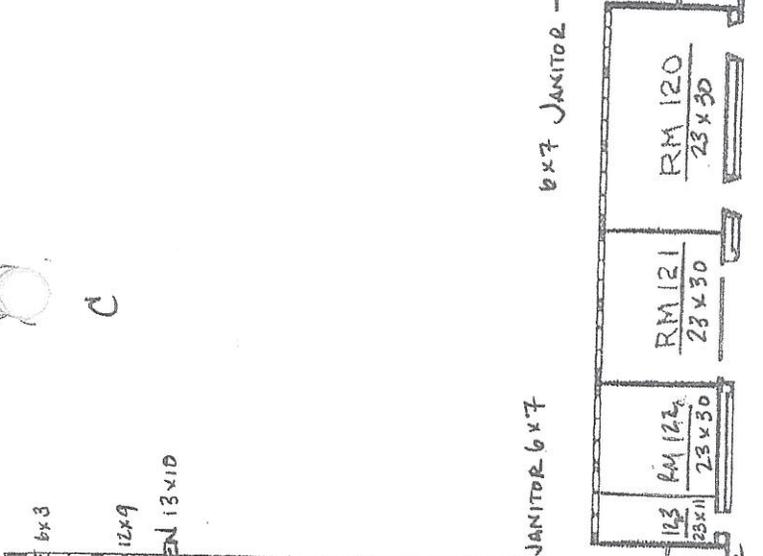
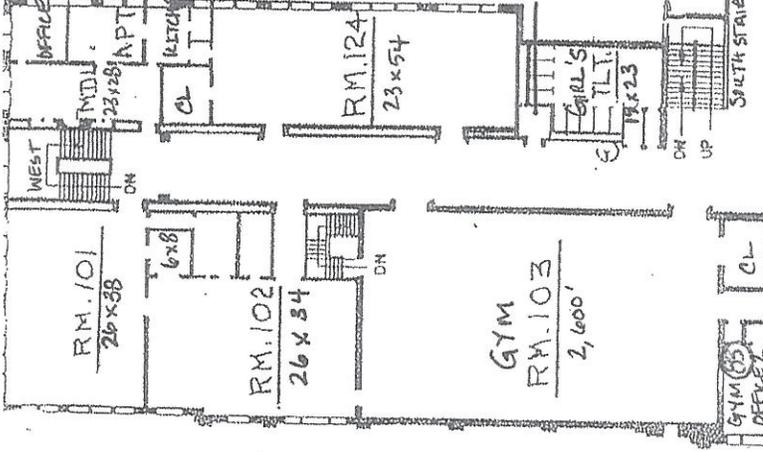
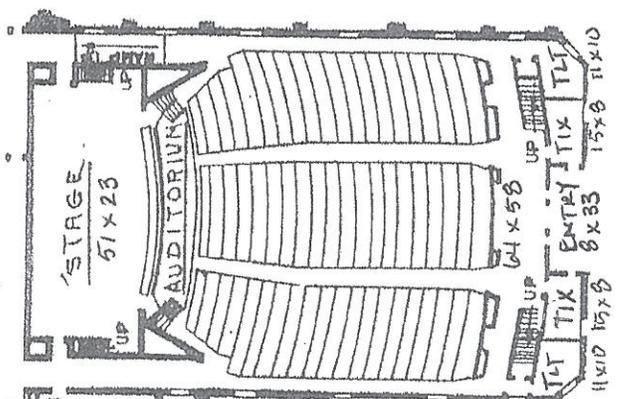
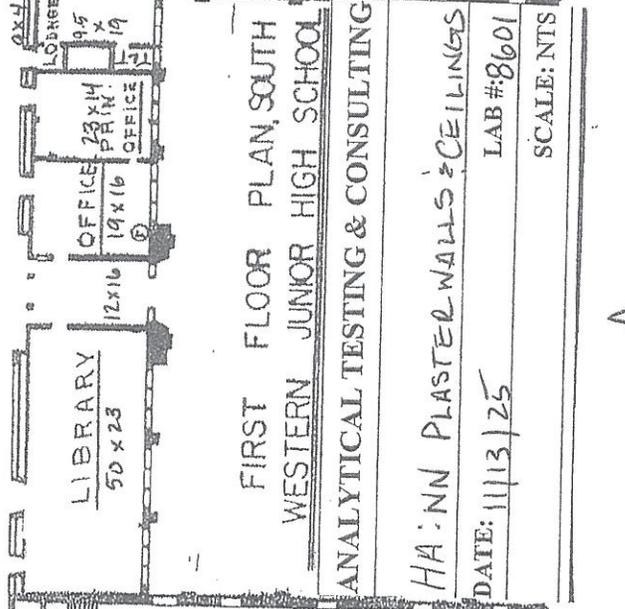
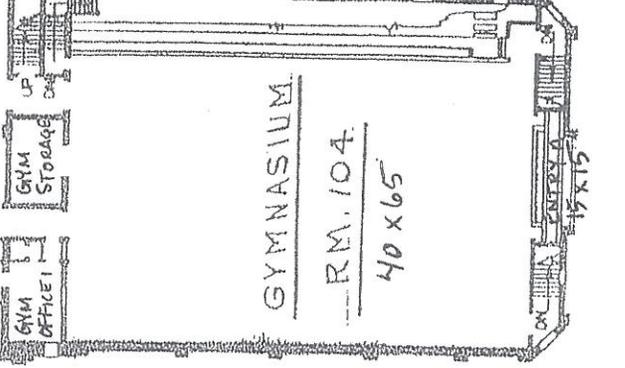
FIRST FLOOR PLAN, SOUTH
 WESTERN JUNIOR HIGH SCHOOL
 ANALYTICAL TESTING & CONSULTING

HA: NN PLASTER WALLS & CEILINGS
 DATE: 11/13/25
 LAB # 8601
 SCALE: NTS

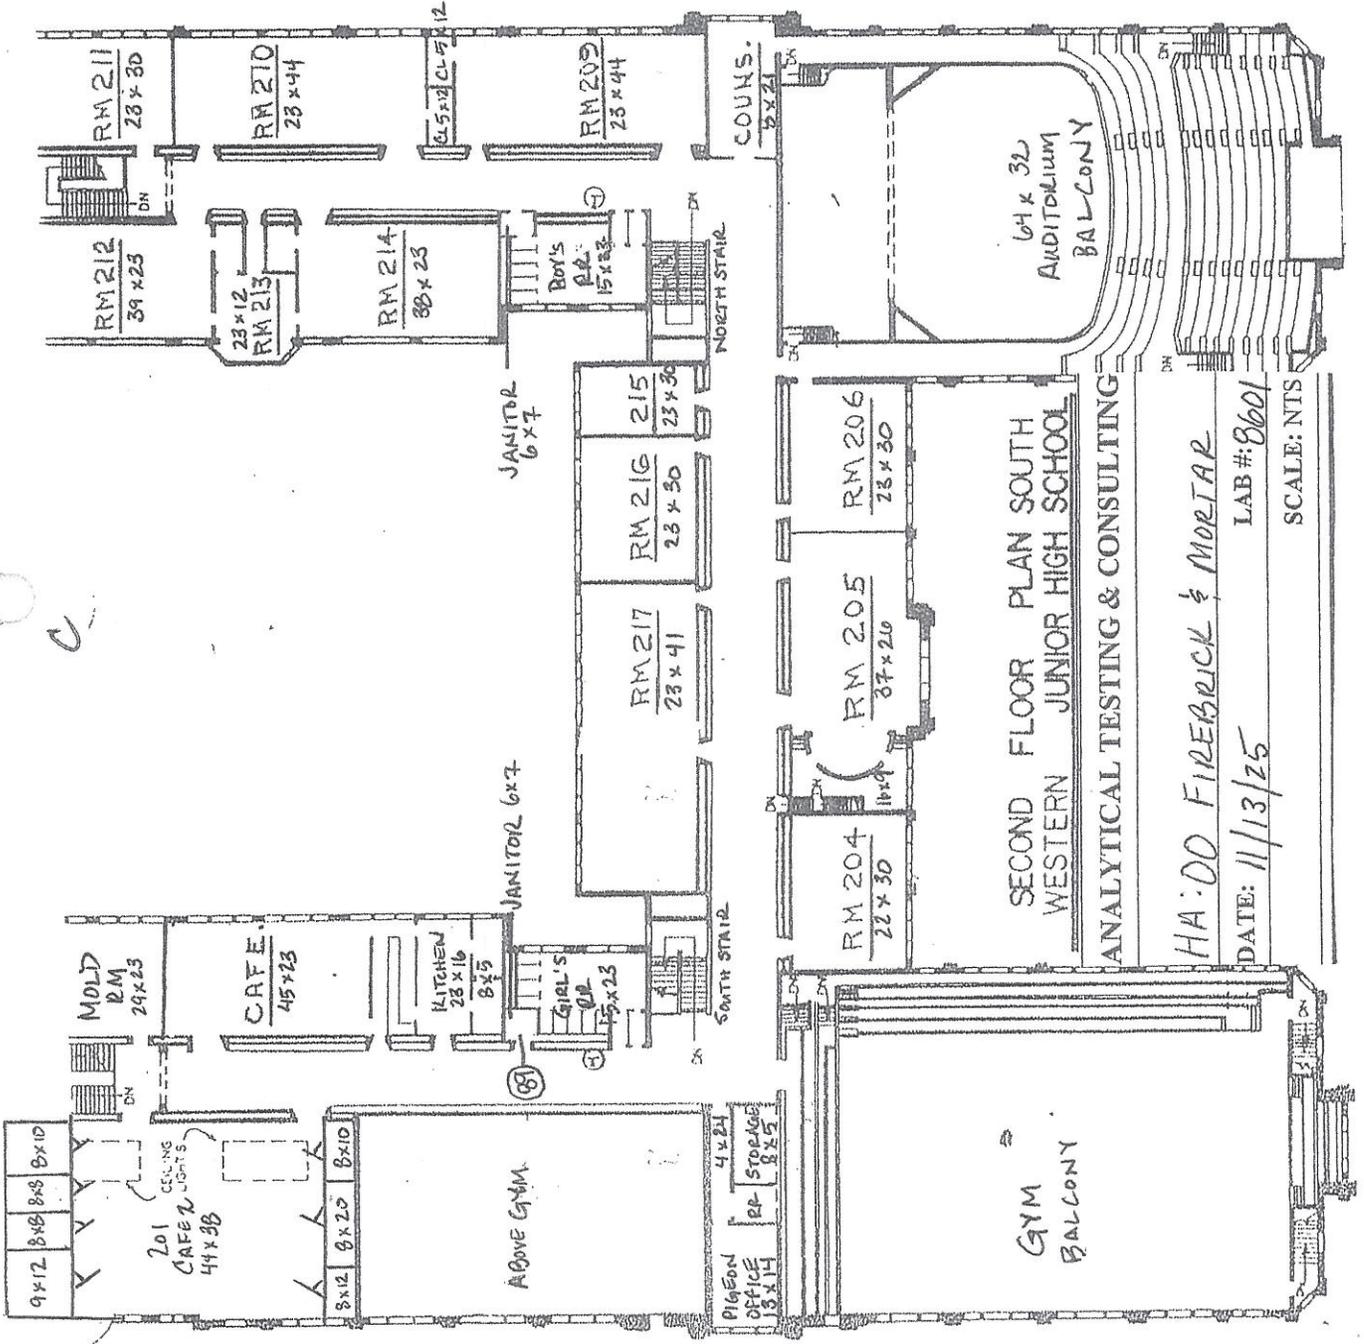
SECOND FLOOR PLAN SOUTH
 WESTERN JUNIOR HIGH SCHOOL
 ANALYTICAL TESTING & CONSULTING

HA LOCATION	Type SM/TSI/MM	Friability F/NF	Physical Condition	Size SF/LF/MF
Throughout building – behind plaster and behind lockers	MM	NF	7	~252,500 SF
TOTAL				~252,500 SF

HA:DO FIREBRICK & MORTAR
 LAB # 8601
 DATE: 11/13/25
 SCALE: NTS

Location	Recommendations
HA-OO	Non Asbestos

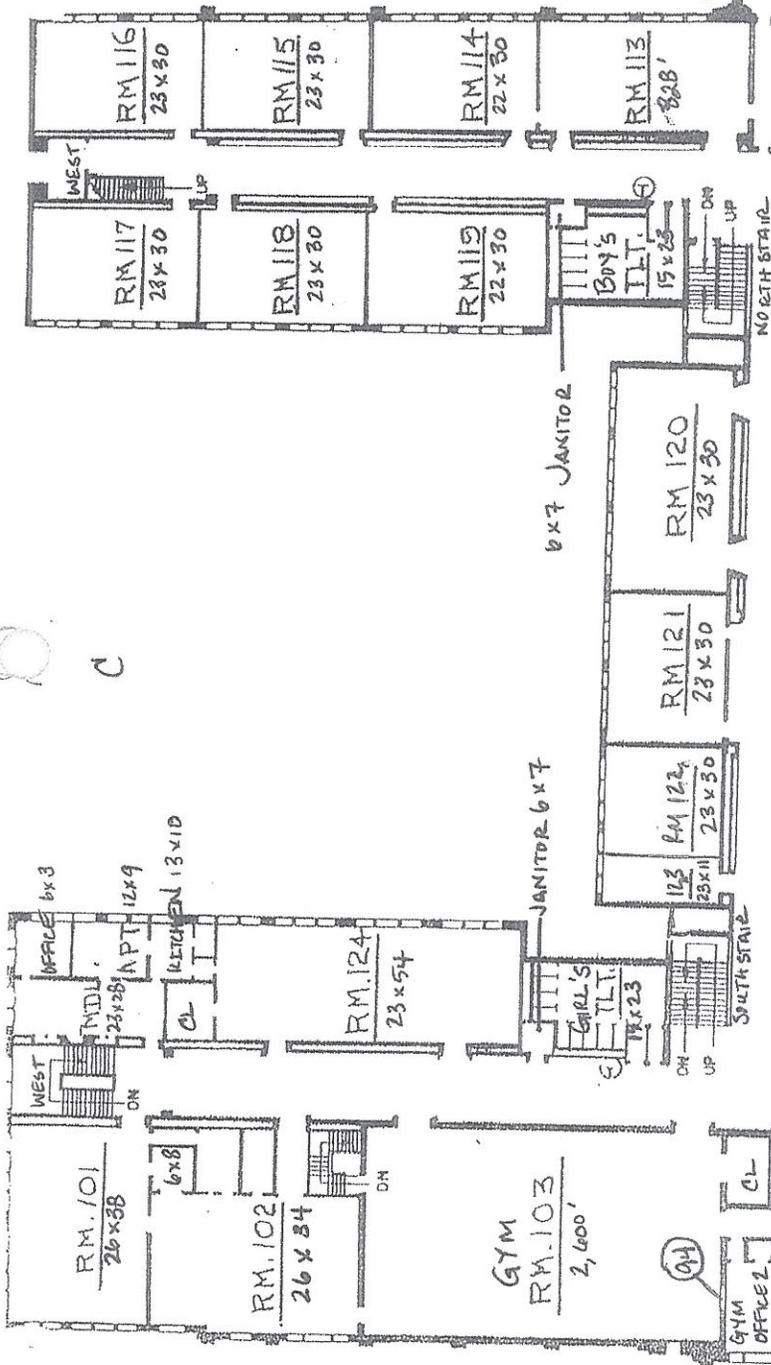
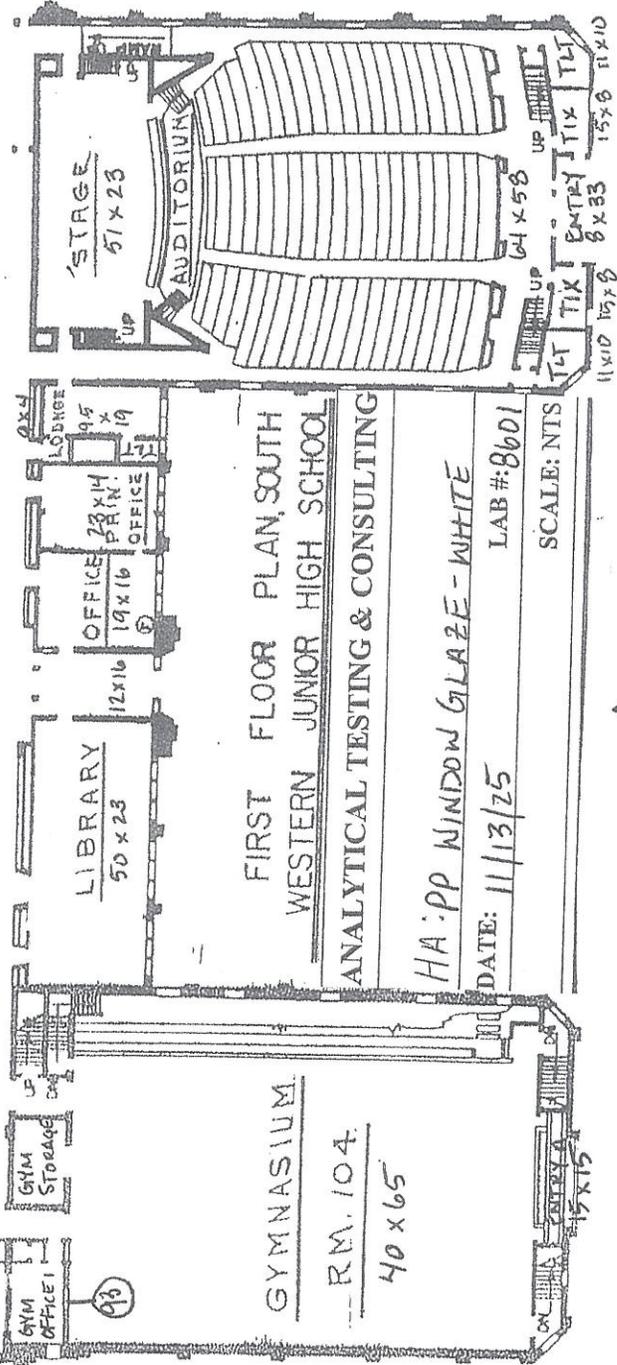
FIRST FLOOR PLAN, SOUTH
 WESTERN JUNIOR HIGH SCHOOL
 ANALYTICAL TESTING & CONSULTING
 HA:PP WINDOW GLAZE - WHITE
 DATE: 11/13/75
 LAB #: 8601
 SCALE: NTS

HA LOCATION	Type SM/TSI/MM	Friability F/NF	Physical Condition	Size SF/LF/MF
Gym Office 1 Side A (6 panels)	MM	NF	7	~1 Window
Gym Office 2 Side C (6 panels)	MM	NF	7	~1 Window
Stair well to roof access	MM	NF	7	~1 Window
West exits (2 windows)	MM	NF	7	~2 Windows
TOTAL				~5 Windows ----- ~70 LF/ ~35 SF

Location	Recommendations
HA-PP	Non Asbestos

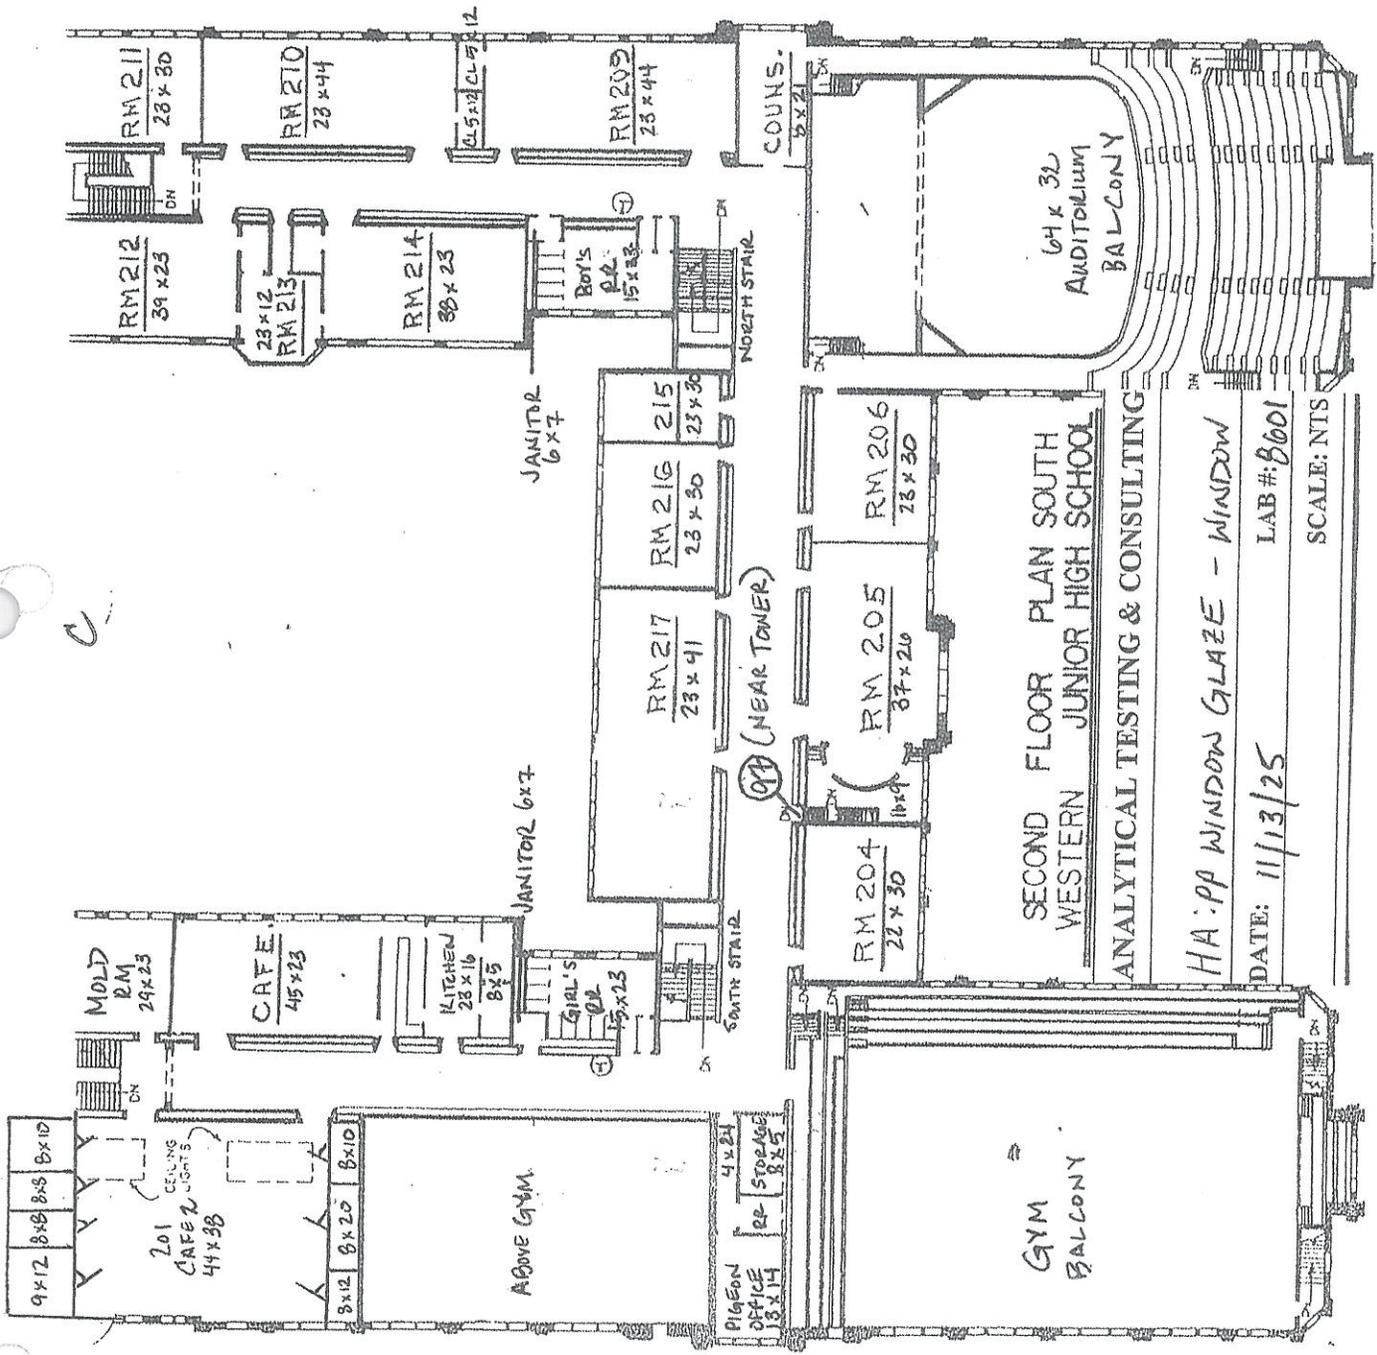
SECOND FLOOR PLAN SOUTH
 WESTERN JUNIOR HIGH SCHOOL
 ANALYTICAL TESTING & CONSULTING

HA:PP WINDOW GLAZE - WINDOW
 LAB #: 8001
 DATE: 11/13/25
 SCALE: NTS

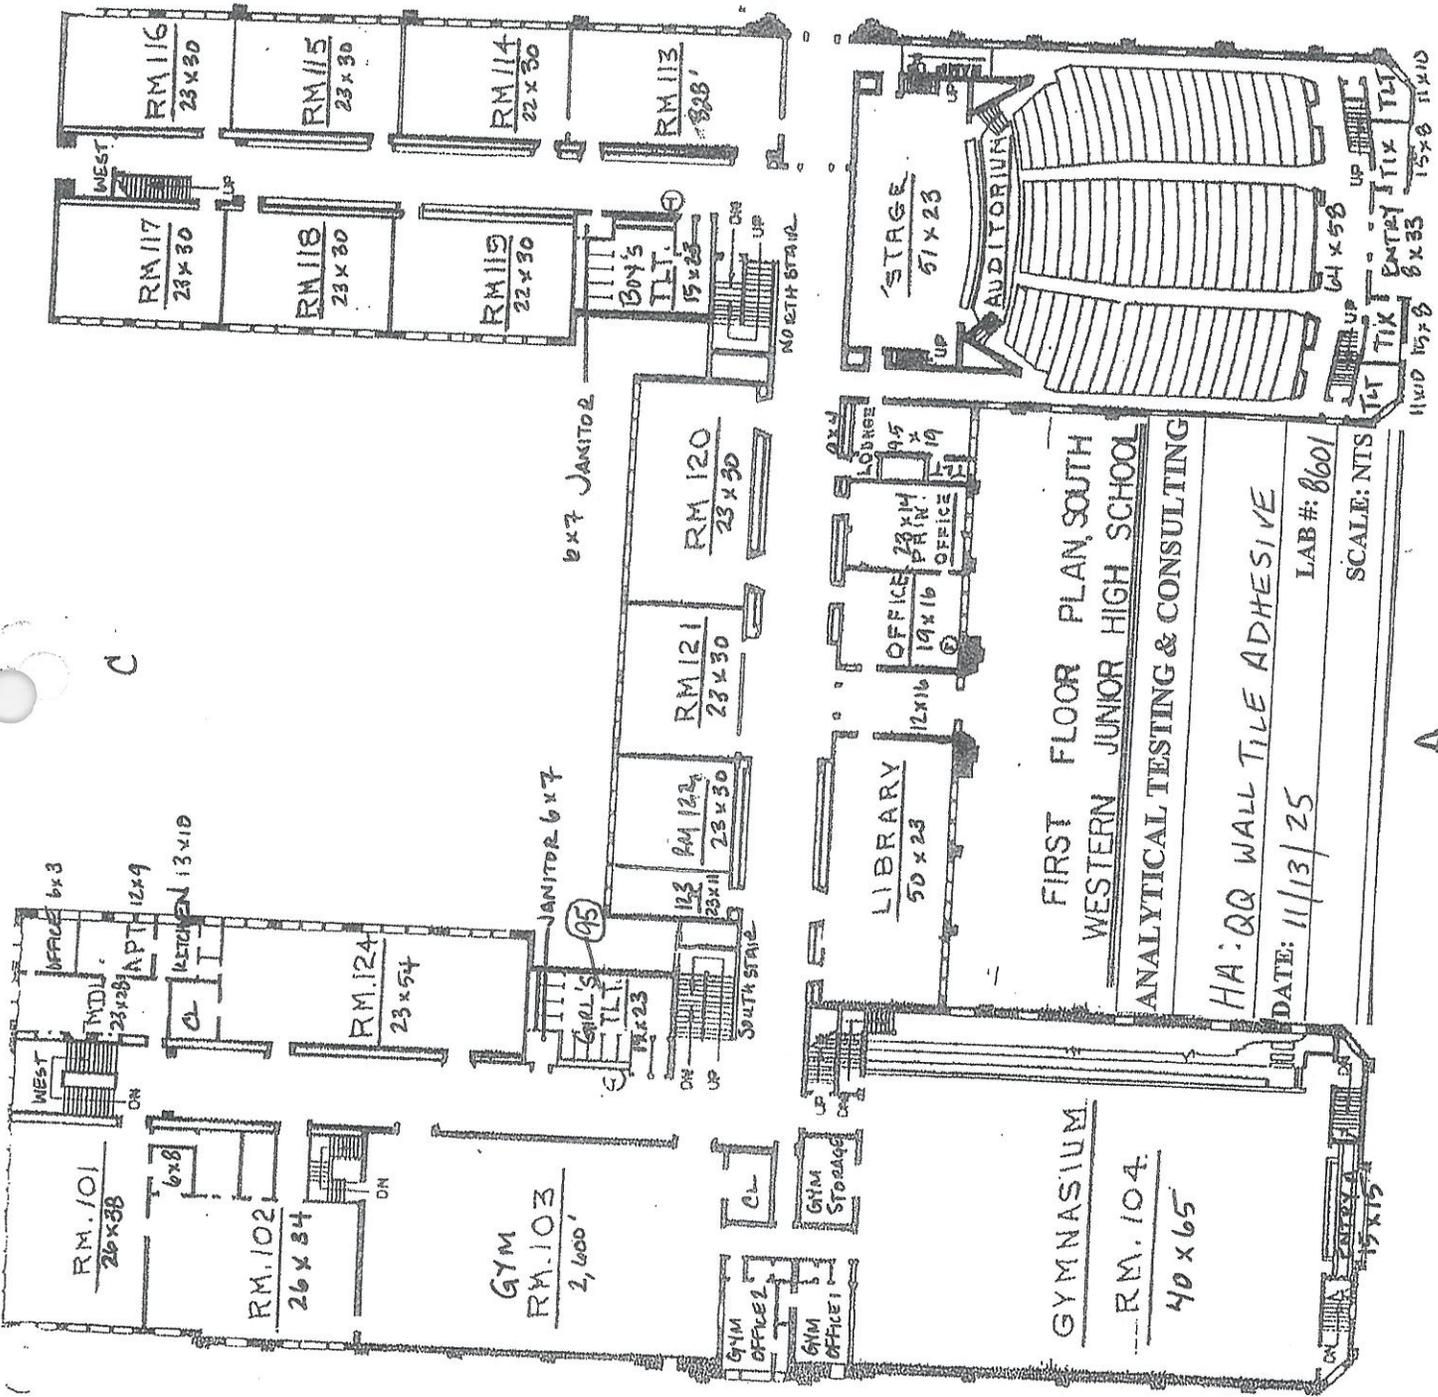
HA LOCATION	Type SM/TSI/MM	Friability F/NF	Physical Condition	Size SF/LF/MF
1 st Floor Girl's restroom walls	MM	NF	1	~400 SF
1 st Floor Goy's restroom walls	MM	NF	1	~400 SF
2 nd Floor Girl's restroom walls	MM	NF	1	~400 SF
2 nd Floor Boy's restroom walls	MM	NF	1	~400 SF
			TOTAL	~1,600 SF

HA: QQ WALL TILE ADHESIVE

Location	Recommendations
HA-QQ	Non Asbestos
