## ASBESTOS SURVEY DATA FORM

**LOCATION:** Southwestern Junior High School

**ADDRESS:** 390 S. Washington, Battle Creek, Michigan 49017

**DATE:** Sept/Oct/Nov/Dec 2025

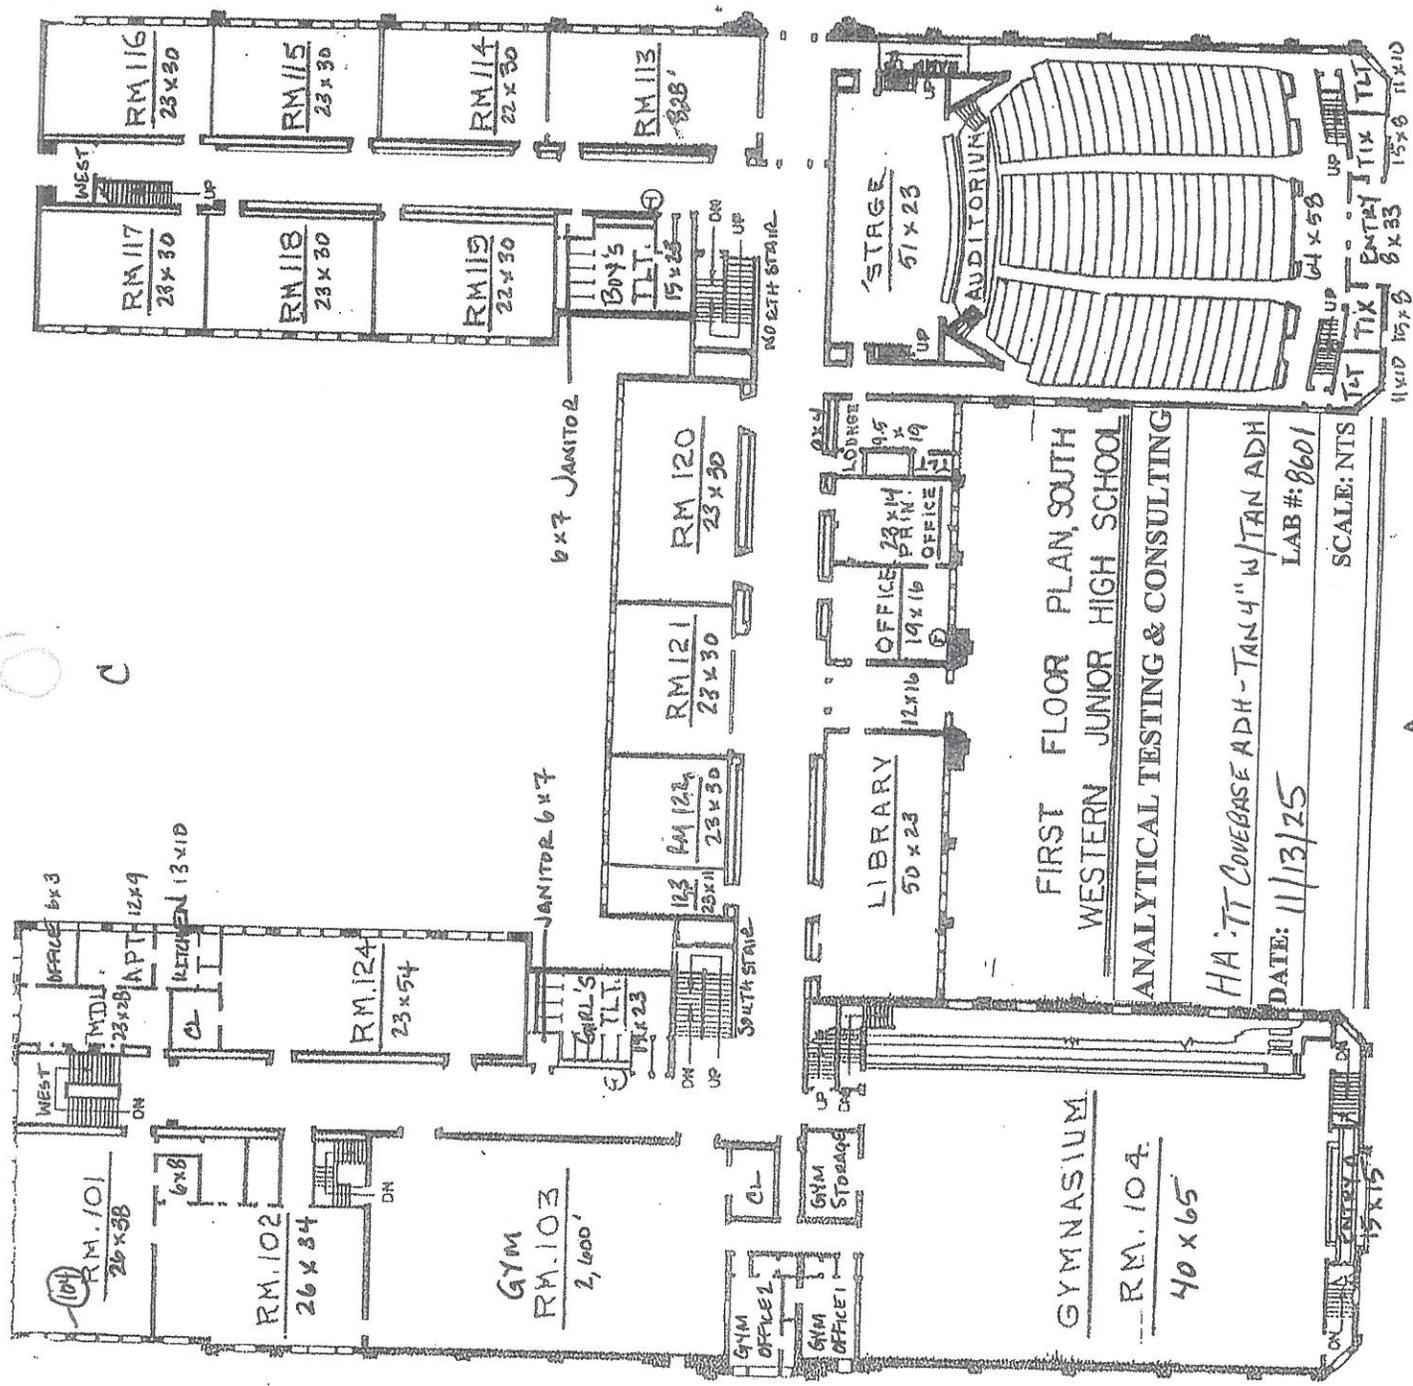
FIRST FLOOR PLAN, SOUTH  
WESTERN JUNIOR HIGH SCHOOL  
ANALYTICAL TESTING & CONSULTING

HA:SS COVERBASE ADH. - RED 4" W/TAN  
LAB #: 8601  
DATE: 11/13/25  
SCALE: NTS

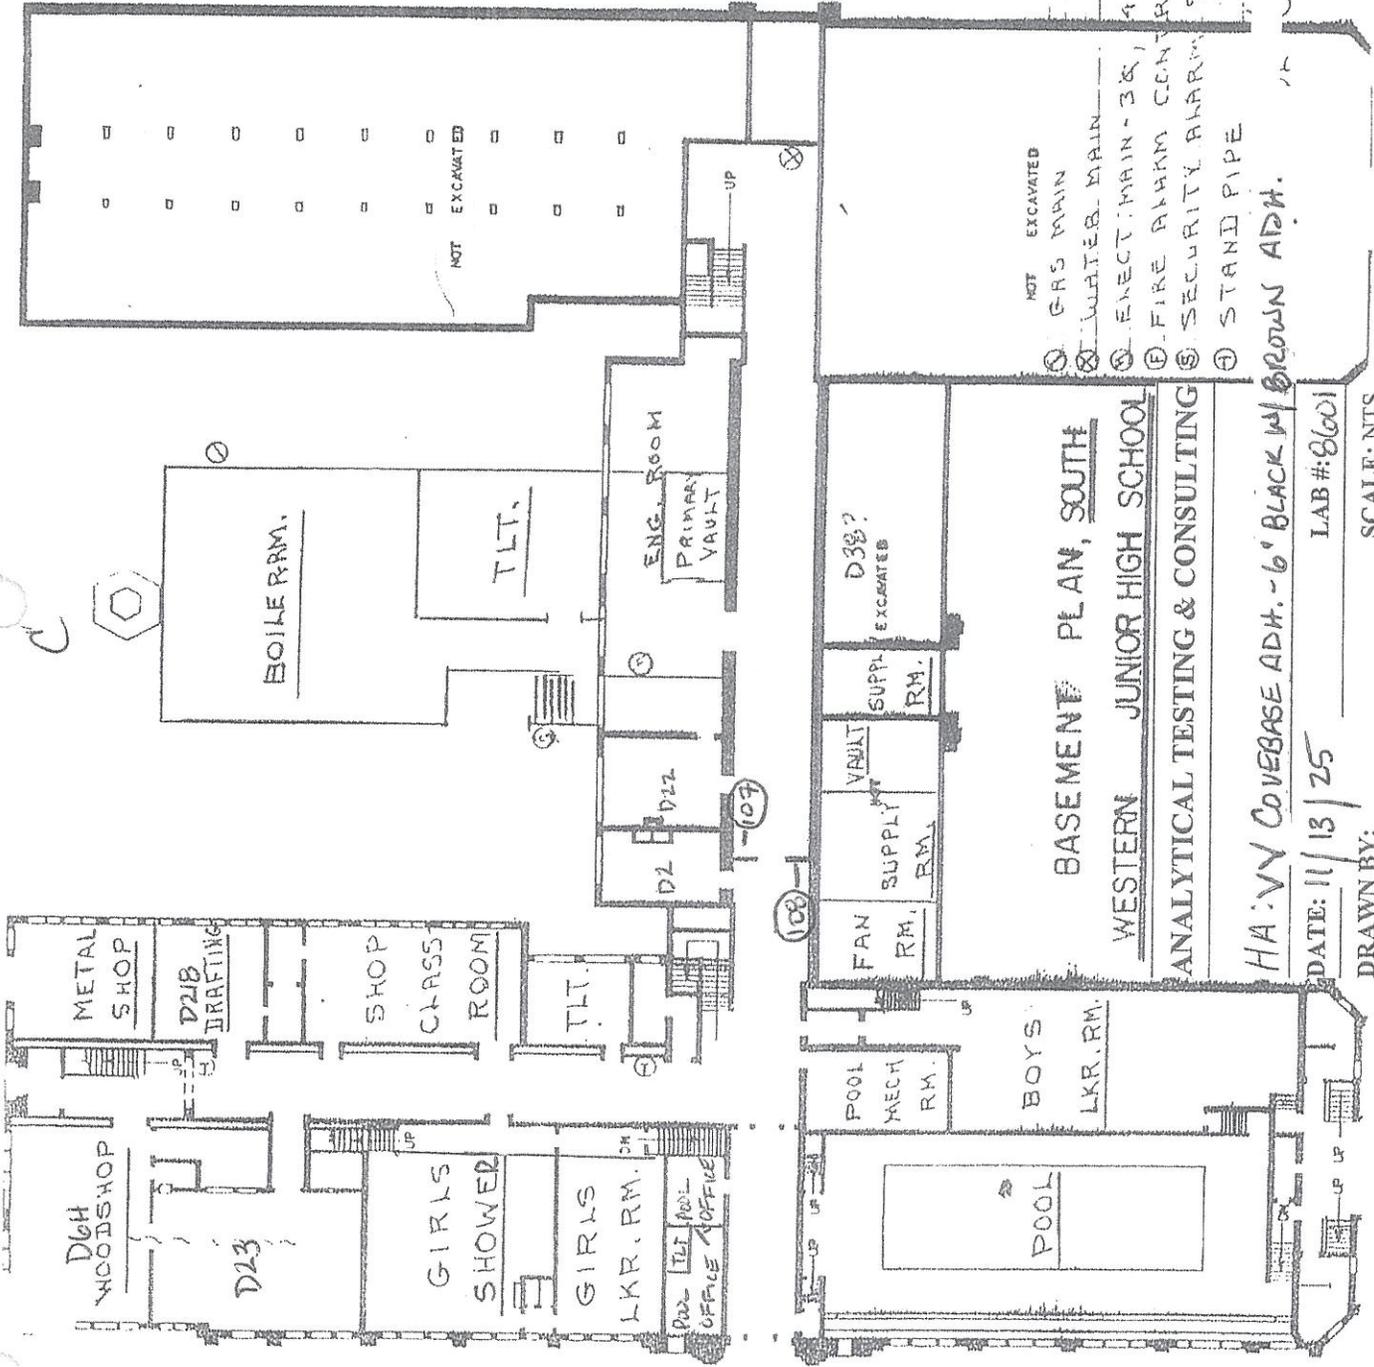
BASEMENT PLAN, SOUTH  
 WESTERN JUNIOR HIGH SCHOOL  
 ANALYTICAL TESTING & CONSULTING

HA: VV COVERBASE ADH. - 6" BLACK W/ BROWN ADH.
