SPR[®]RO CASE STUDY

THREDBO DN1800 mm (72 inch) CULVERT
RENEWAL AUSTRALIA

SPR[®]RO technology, incorporating
ROTALOC[®] spirally wound system
by RIB LOC[®]

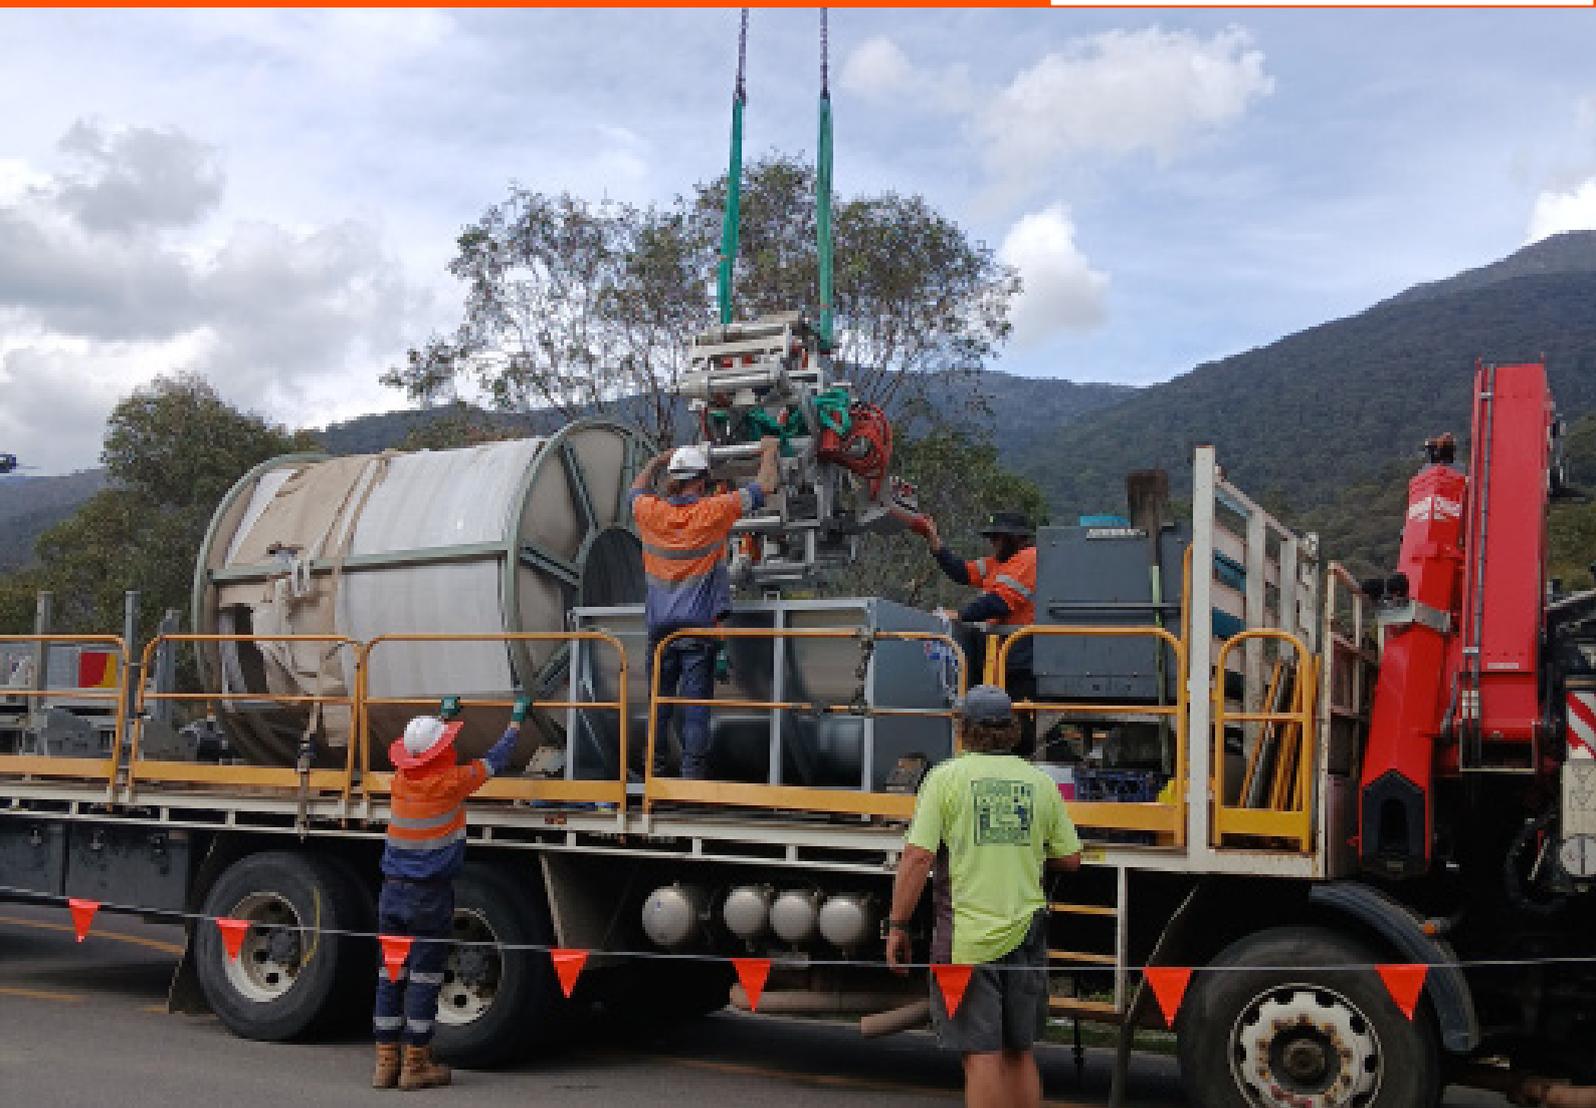
The project focused on the rehabilitation of two 10 m long DN 1800 mm (72 inch) concrete culvert cells located in the alpine resort town of Thredbo. The culvert had suffered severe deterioration, presenting a significant risk to vehicular traffic on the road above. To restore the asset to its former condition, the team addressed the client's needs using steel reinforced SPR®RO technology, incorporating the Rotaloc® spirally wound system by RIB LOC®, to rehabilitate the culvert and ensure its long term structural stability.

Using the SPR®RO / Rotaloc® system, the culvert was able to be efficiently lined with a robust, corrosion resistant and smooth-bore fixed diameter liner. The annular space between the liner and host pipe was then grouted using a cementitious grout.

The SPR®RO / Rotaloc® 91-32ROS steel reinforced liner was selected for this culvert rehabilitation project due to its ability to meet the client's rigorous structural requirements and, thanks to a small construction footprint, be successfully installed in challenging site conditions with minimal disruption to the environment.

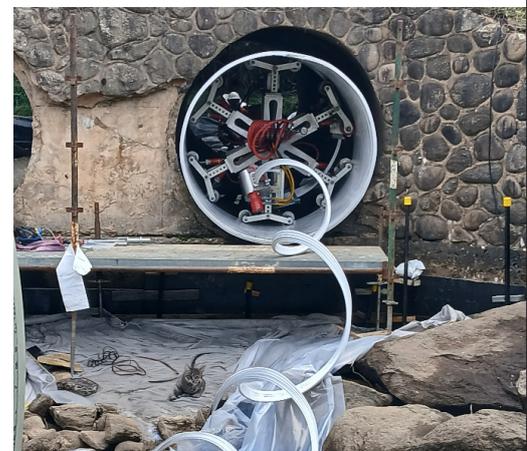
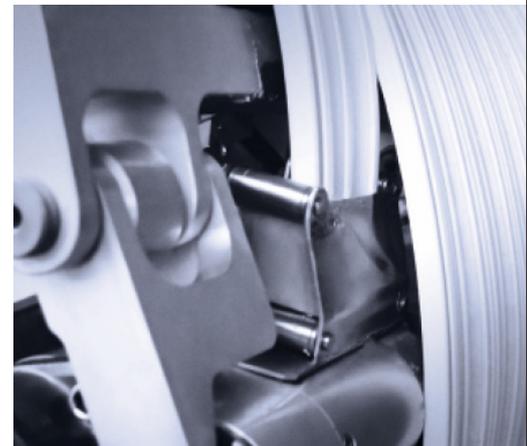
Despite the challenging site conditions and the asset's significant deterioration, the rehabilitation of the large diameter culvert was successfully completed, restoring its structural integrity. The renewed asset has secured the natural flow of water along the creek and will reliably serve road users and the local community well into the future.
