ASBESTOS SURVEY DATA FORM

LOCATION: Southwestern Junior High School

ADDRESS: 390 S. Washington, Battle Creek, Michigan 49017

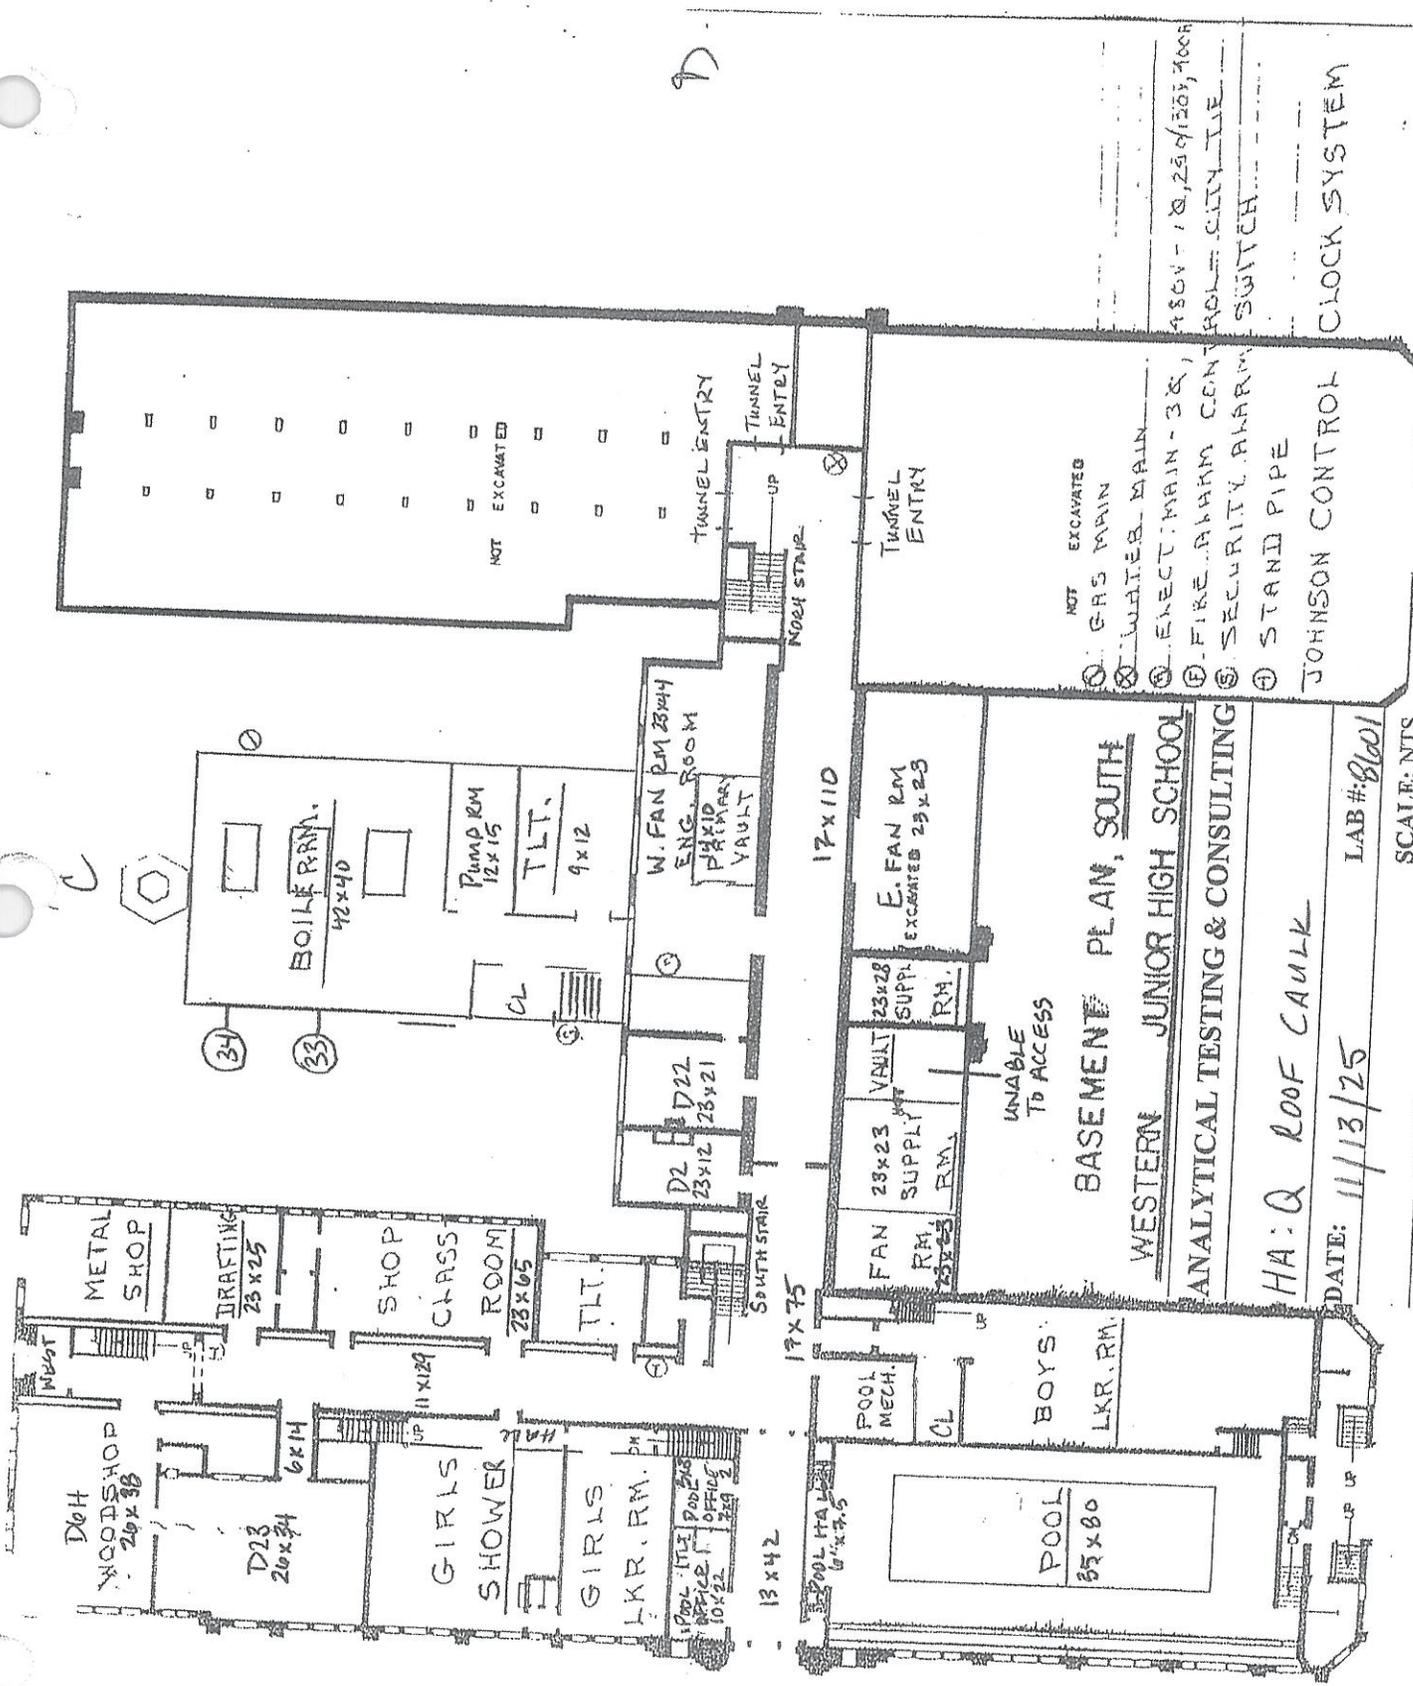
BASEMENT PLAN, SOUTH
 WESTERN JUNIOR HIGH SCHOOL
 ANALYTICAL TESTING & CONSULTING

HA: Q ROOF CAULK

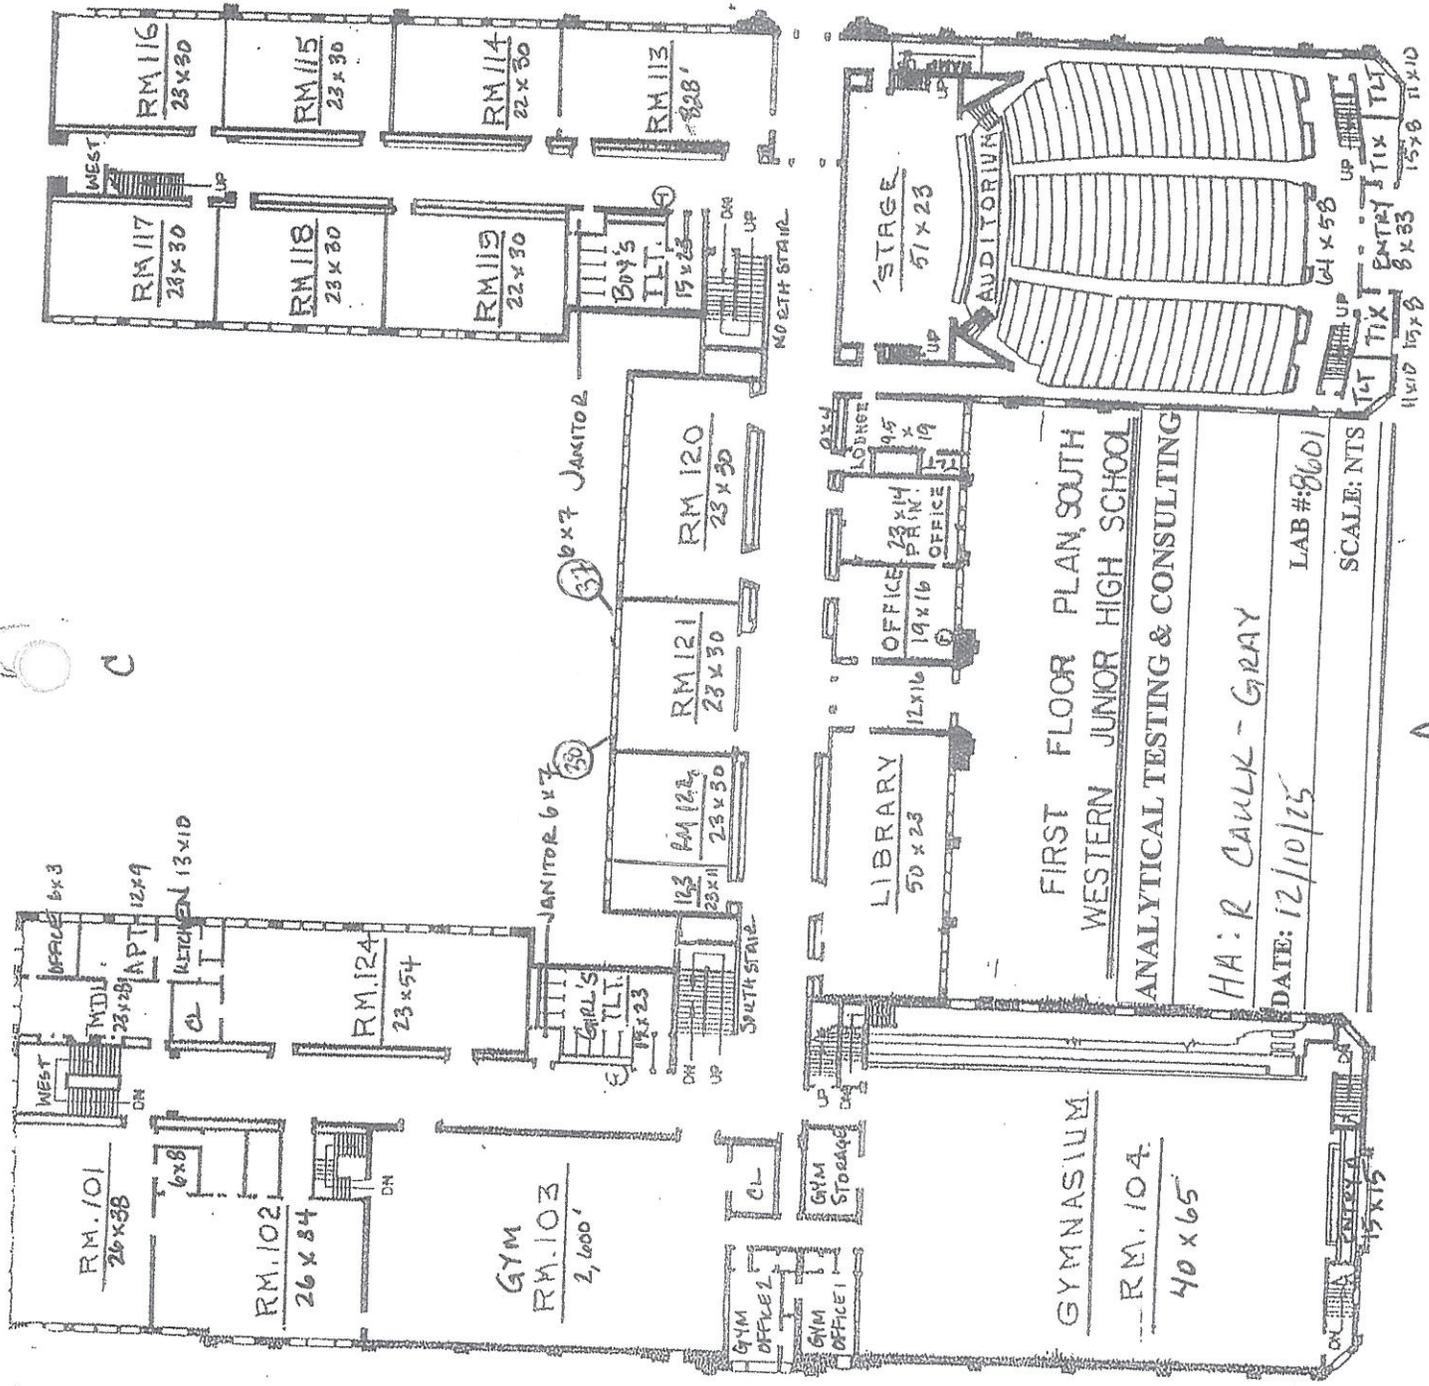
FIRST FLOOR PLAN, SOUTH
WESTERN JUNIOR HIGH SCHOOL
ANALYTICAL TESTING & CONSULTING

HA DESCRIPTION: Caulk – Gray

HA LOCATION	Type SM/TSI/MM	Friability F/NF	Physical Condition	Size SF/LF/MF
Old caulk line from under metal casings (windows) ~261 window openings	MM	NF	5	~7,370 / ~308 SF
TOTAL				~7,370 / ~308 SF

Sample No.	Description and Location	Results (%)
8601-37	Sample of old caulk line under metal window casing from exterior of room 121 left	None Detected
8601-38	Sample of old caulk line under metal window casing from exterior of room 121 right	None Detected
*Note: All samples were collected in a statistically random manner representative of Homogeneous Area in accordance with 40 CFR 763.86.

HA: R. CAULK - GRAY

Location	Recommendations
HA-R	Non Asbestos

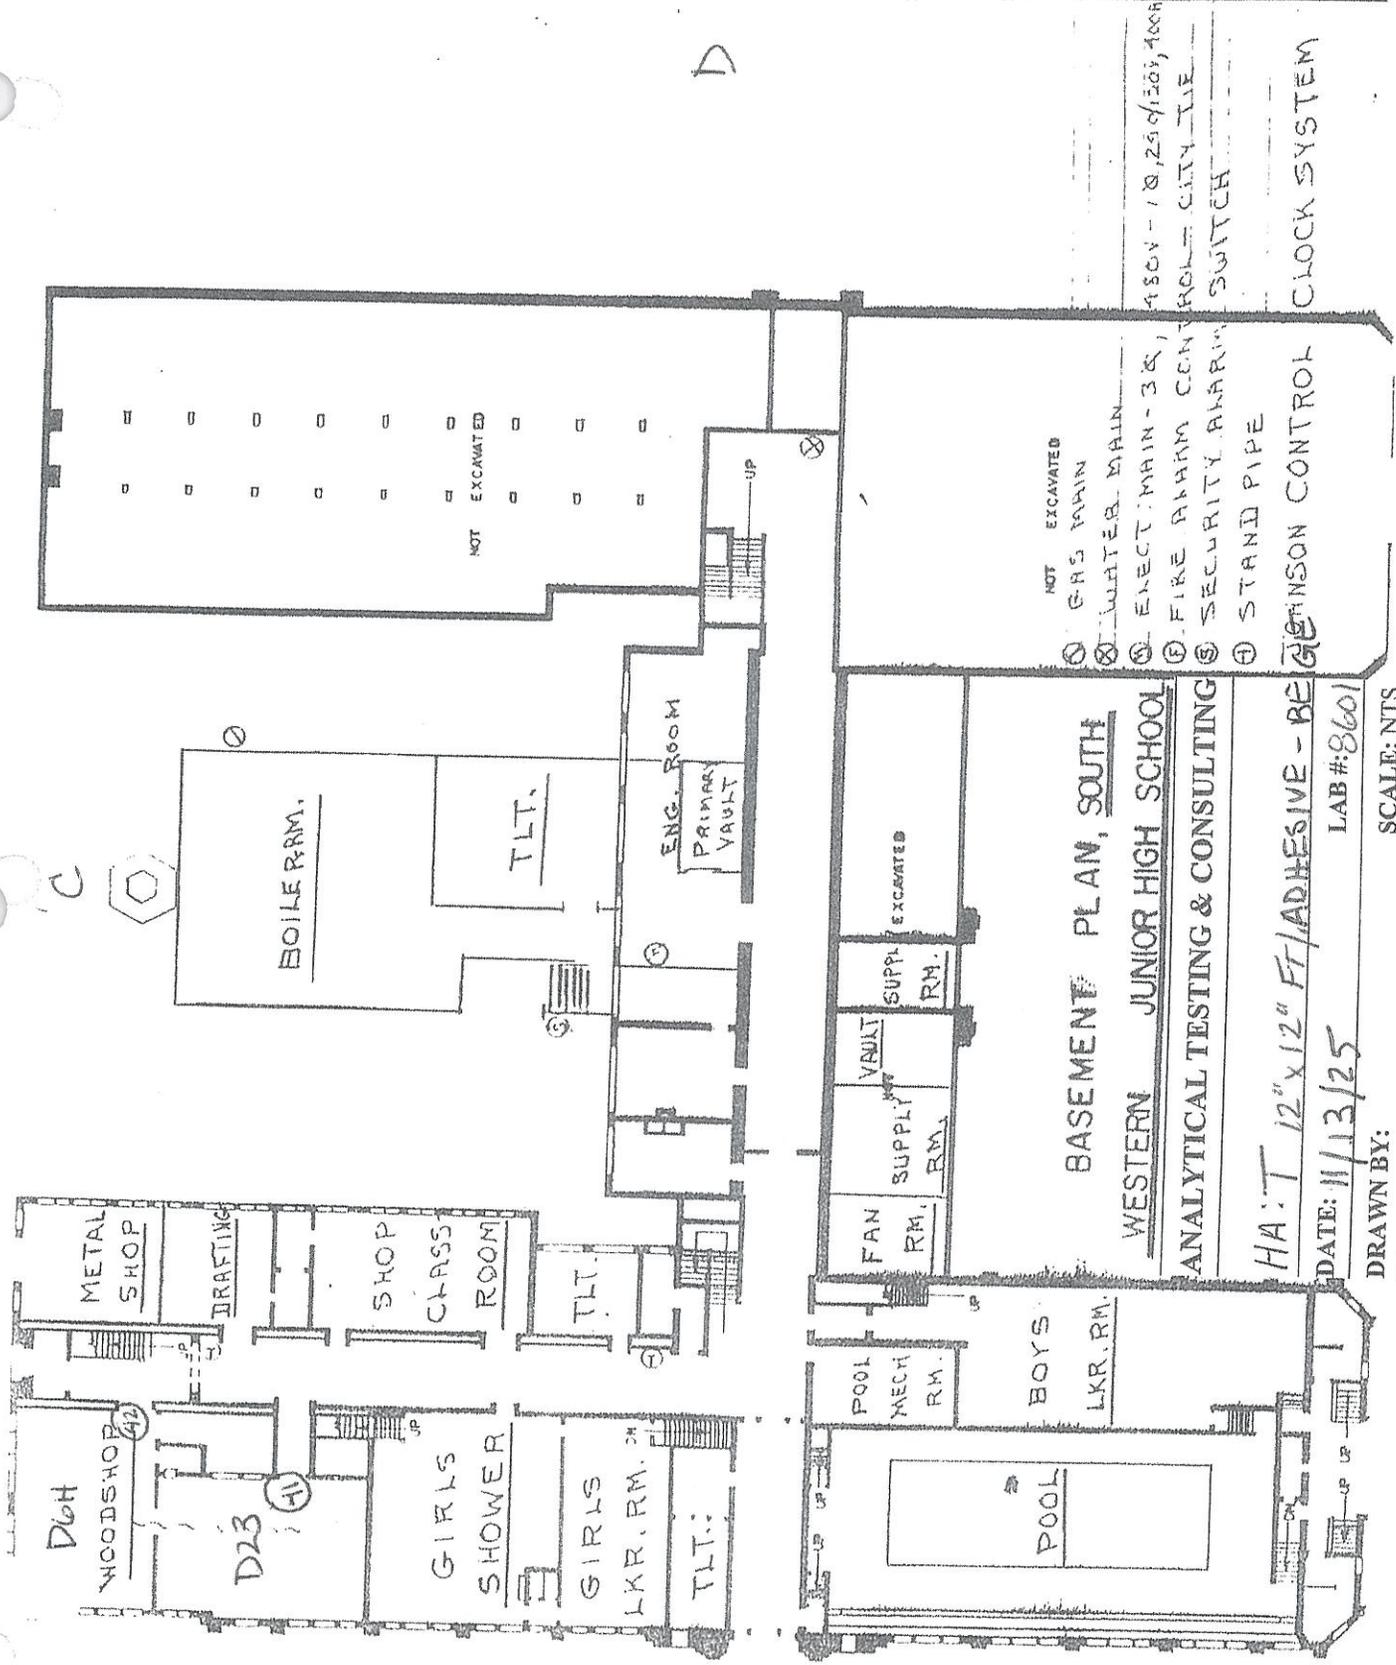
BASEMENT PLAN, SOUTH
 WESTERN JUNIOR HIGH SCHOOL
 ANALYTICAL TESTING & CONSULTING

HA DESCRIPTION: 12"x12" Floor Tile/ Adhesive – Beige

HA LOCATION	Type SM/TSI/MM	Friability F/NF	Physical Condition	Size SF/LF/MF
D23	MM	NF	7	~968 SF
D6H – Woodshop	MM	NF	7	~988 SF
TOTAL				~1,956 SF

Sample No.	Description and Location	Results (%)
8601-41	Sample of floor tile and adhesive from D23 Side D near entry	Layer 1 – None Detected Layer 2 – None Detected
8601-42	Sample of floor tile and adhesive from D6H (Woodshop) Side D near entry	Layer 1 – None Detected Layer 2 – None Detected
*Note: All samples were collected in a statistically random manner representative of Homogeneous Area in accordance with 40 CFR 763.86.

HA: T 12" x 12" FT / ADHESIVE - BE
 DATE: 11/13/25
 LAB #: 8601
 DRAWN BY:
 SCALE: NTS

Location	Recommendations
HA-T	Non Asbestos

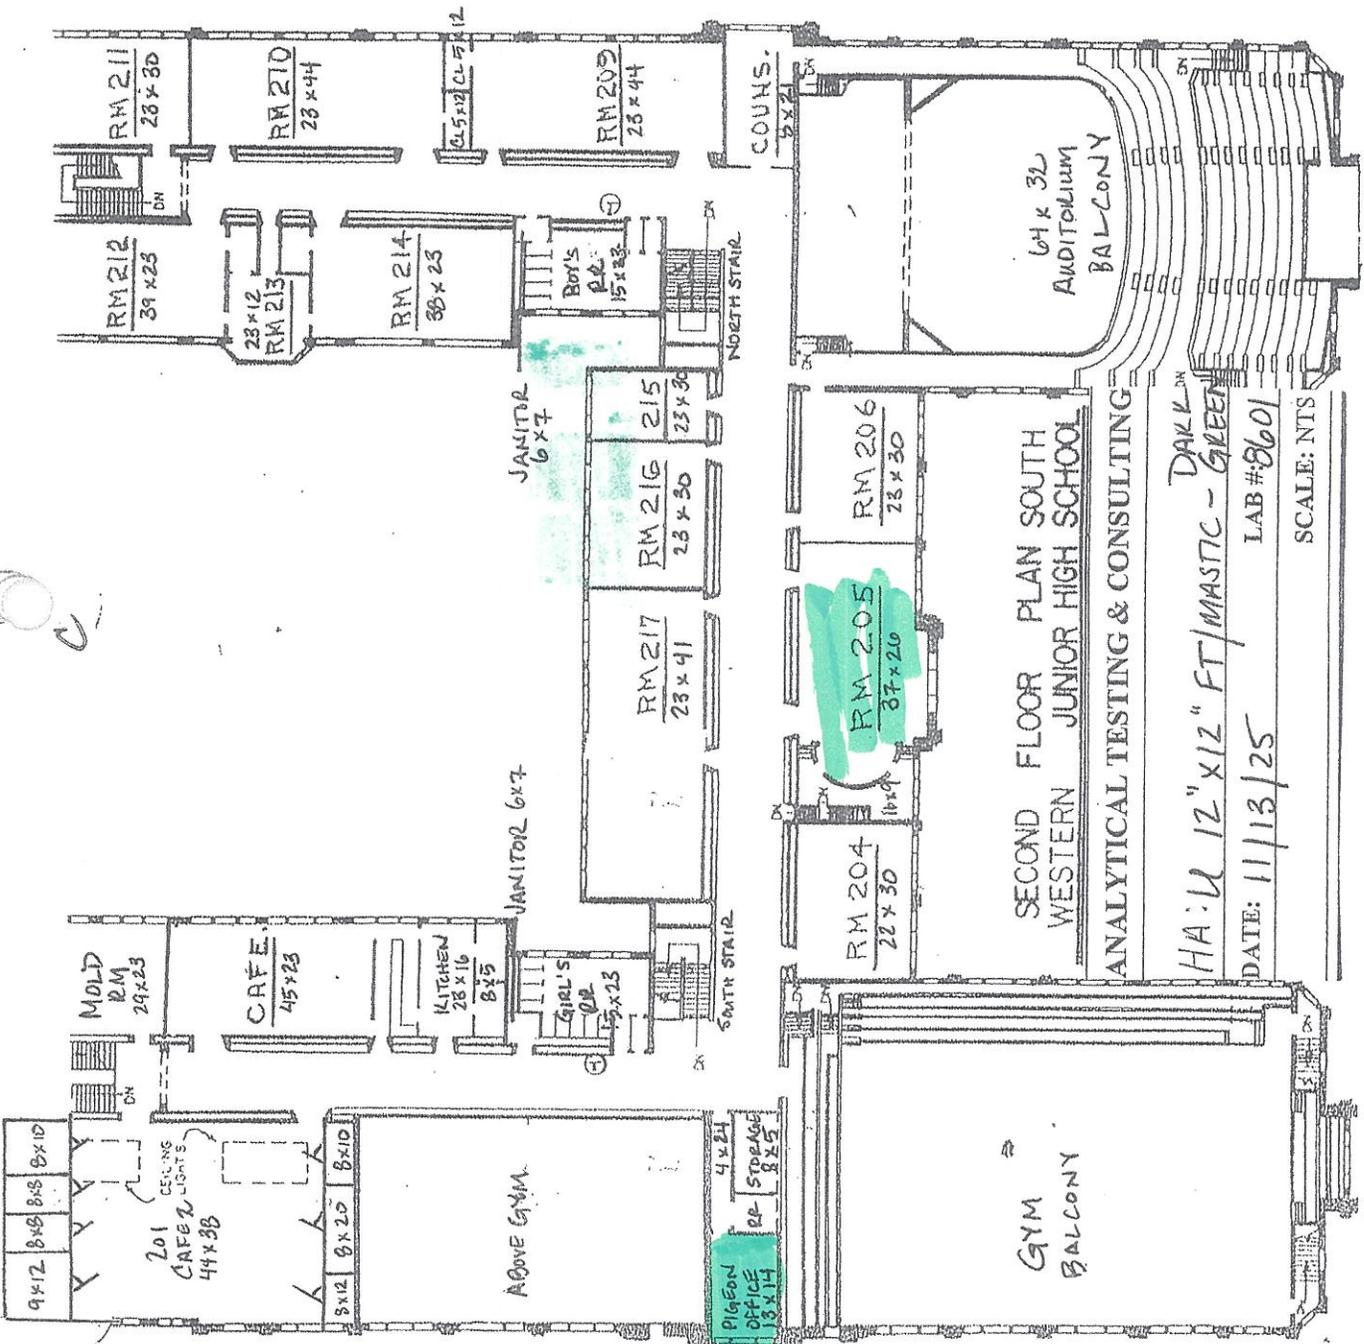
SECOND FLOOR PLAN SOUTH
WESTERN JUNIOR HIGH SCHOOL
ANALYTICAL TESTING & CONSULTING

HA DESCRIPTION: 12"x12" Floor Tile/ Mastic – Dark Green

HA LOCATION	Type SM/TSI/MM	Friability F/NF	Physical Condition	Size SF/LF/MF
Main "old" office – under carpet	MM	NF	7	~304 SF
Main "old" office closets	MM	NF	7	~42 SF
Principal's office – under carpet	MM	NF	7	~322 SF
Principal's office closet	MM	NF	7	~16 SF
Teacher's lounge – under 12x12	MM	NF	7	~180.5 SF
Teacher's lounge hall under 12x12	MM	NF	7	~36 SF
Pigeon office – bottom layer	MM	NF	7	~182 SF
Room 205 – bottom later	MM	NF	7	~962 SF
TOTAL				~2,045 SF

Sample No.	Description and Location	Results (%)
8601-43	Sample of floor tile/ mastic from old office closet Side C	Layer 1 – 5% Chrysotile Layer 2 – None Detected
8601-44	Sample of floor tile/ mastic from old office – under carpet	Layer 1 – 5% Chrysotile Layer 2 – None Detected
<p><i>*Note: All samples were collected in a statistically random manner representative of Homogeneous Area in accordance with 40 CFR 763.86.</i></p>

HA: U 12" X 12" FT / MASTIC - GREEN
DATE: 11/13/25
LAB #: 8601
SCALE: NTS

Location	Recommendations
HA-U	Remove Asbestos Prior to Demolition/ Renovation

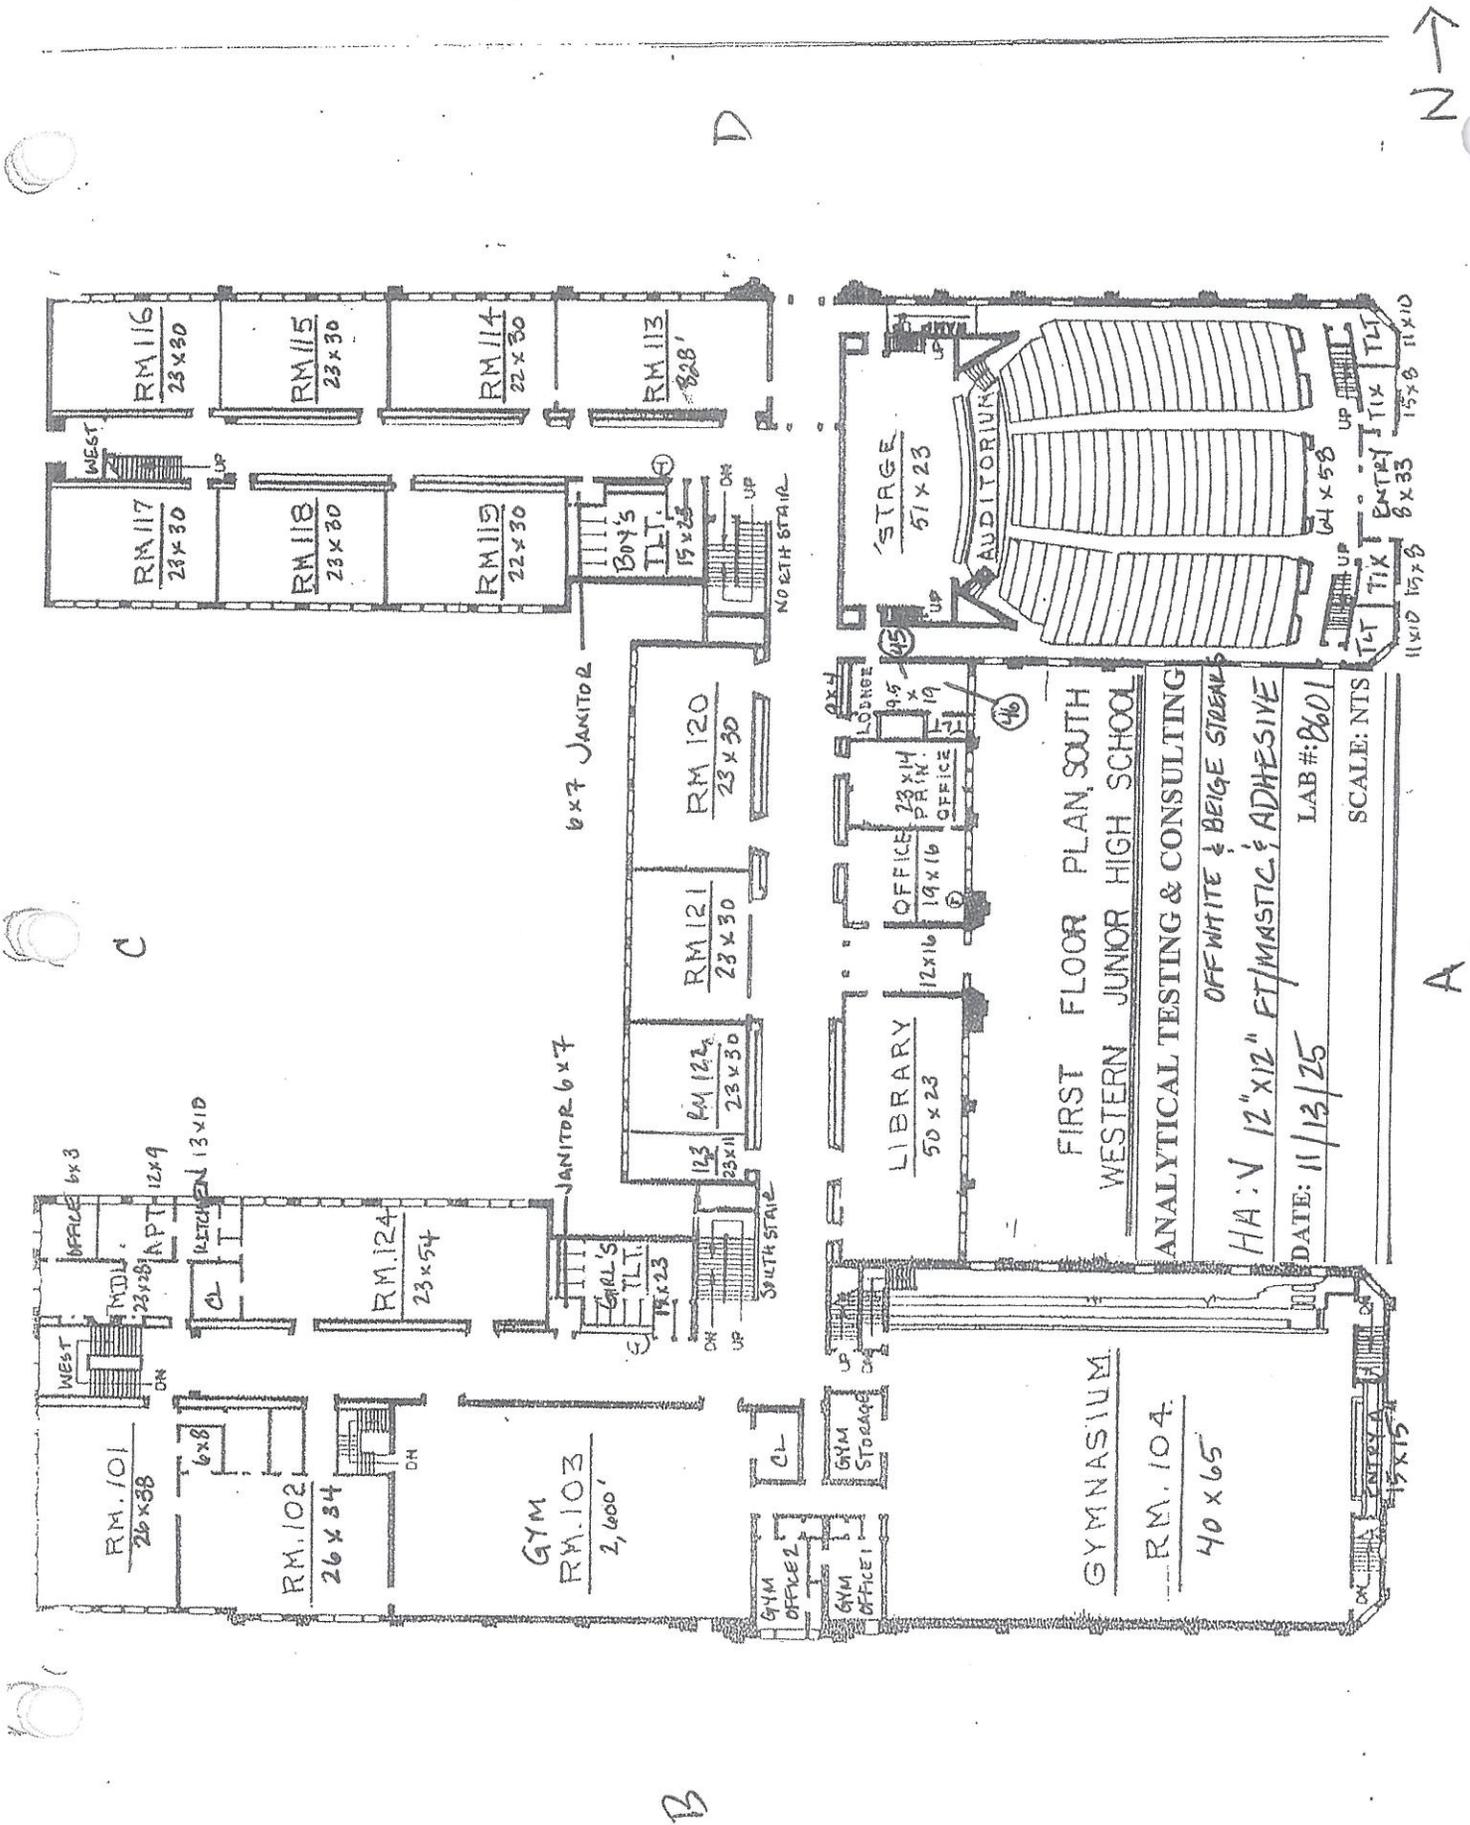
HA DESCRIPTION: 12"x12" Floor Tile/ Mastic and Adhesive – Off White and Beige Streaks

HA LOCATION	Type SM/TSI/MM	Friability F/NF	Physical Condition	Size SF/LF/MF
Teacher's Lounge – top layer	MM	NF	4	~180.5 SF
TOTAL				~180.5 SF

Sample No.	Description and Location	Results (%)
8601-45	Sample of floor tile/ mastic from Teacher's Lounge Side B	Layer 1 – None Detected Layer 2 – None Detected
8601-46	Sample of floor tile/ mastic from Teacher's Lounge at entry	Layer 1 – None Detected Layer 2 – None Detected
<p><i>*Note: All samples were collected in a statistically random manner representative of Homogeneous Area in accordance with 40 CFR 763.86.</i></p>

FIRST FLOOR PLAN, SOUTH
WESTERN JUNIOR HIGH SCHOOL
ANALYTICAL TESTING & CONSULTING
OFF WHITE & BEIGE STREALS
HA: V 12" X 12" FT/MASTIC & ADHESIVE
DATE: 11/13/25
LAB #: 8601
SCALE: NTS

Location	Recommendations
HA-V	Non Asbestos

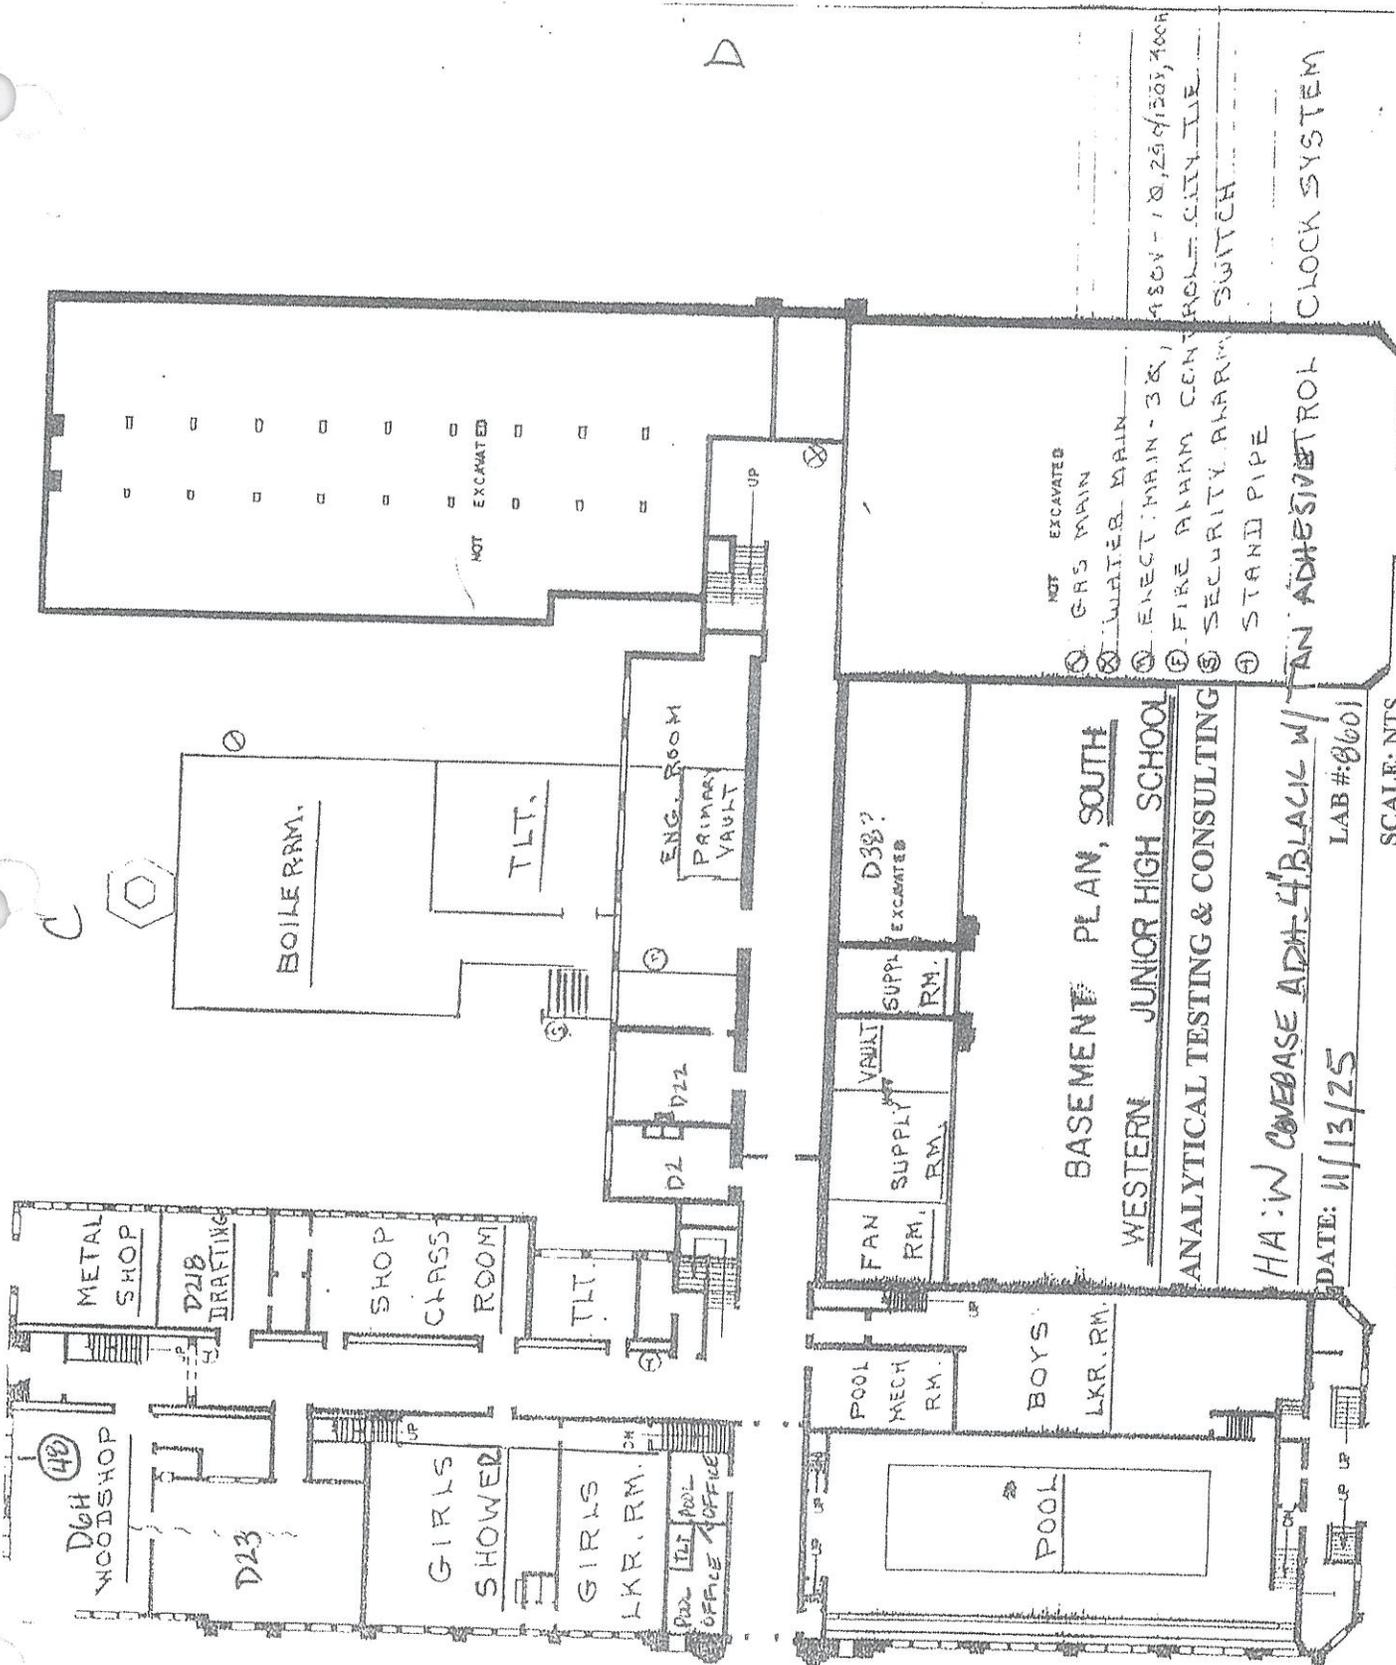
BASEMENT PLAN, SOUTH
WESTERN JUNIOR HIGH SCHOOL
ANALYTICAL TESTING & CONSULTING

HA DESCRIPTION: Cove Base Adhesive – Black 4” with Tan Adhesive

HA LOCATION	Type SM/TSI/MM	Friability F/NF	Physical Condition	Size SF/LF/MF
Teacher's Lounge	MM	NF	7	~48 LF
Teacher's Lounge hall	MM	NF	7	~26 LF
D6H	MM	NF	7	~128 LF
Gym Office 1 and hall	MM	NF	7	~94 LF
Gym office 2 and hall	MM	NF	7	~94 LF
Room 102	MM	NF	7	~120 LF
Room 117	MM	NF	7	~106 LF
Room 118	MM	NF	7	~106 LF
Room 119	MM	NF	7	~106 LF
Room 113	MM	NF	7	~104 LF
North hall at doors – entry	MM	NF	7	~20LF
South hall at doors – entry	MM	NF	7	~20 LF
1 st and 2 nd floor landings – (Not 1 st floor north stairwell)	MM	NF	7	~40 LF
Room 201 – Café 2 and all attached rooms	MM	NF	7	~300 LF
Mold Room	MM	NF	7	~104 LF
Café 1	MM	NF	7	~136 LF
Room 217	MM	NF	7	~128 LF
Room 205	MM	NF	7	~126 LF
Room 209	MM	NF	7	~134 LF
Room 210	MM	NF	7	~134 LF
Room 212	MM	NF	7	~124 LF
TOTAL				~2,198 LF / ~550 SF

Sample No.	Description and Location	Results (%)
8601-47	Sample of cove base adhesive from Teacher's Lounge Side B near restroom entry	Layer 1 – None Detected Layer 2 – None Detected
8601-48	Sample of cove base adhesive from Room D6H	Layer 1 – None Detected Layer 2 – None Detected
*Note: All samples were collected in a statistically random manner representative of Homogeneous Area in accordance with 40 CFR 763.86.

HA: W COMBASE ADH-4 BLACIL W/
 DATE: 11/13/25
 LAB #: 8601

Location	Recommendations
HA-W	Non Asbestos

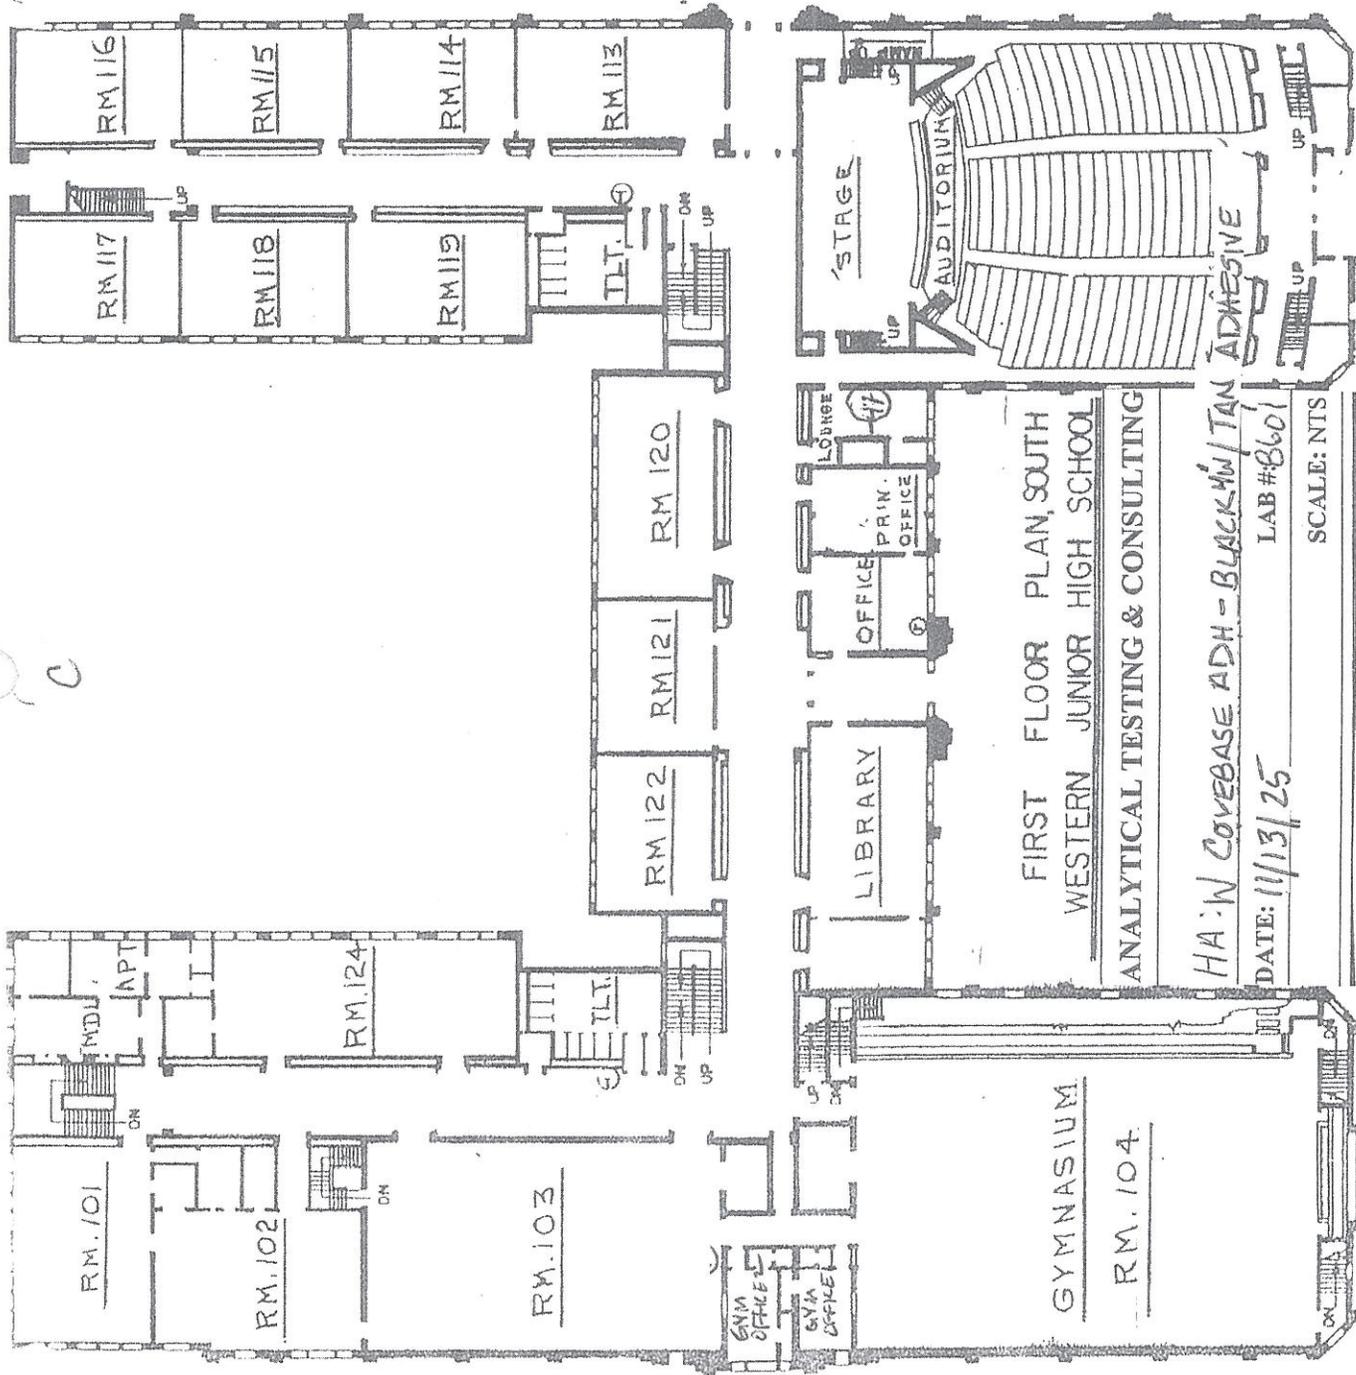
FIRST FLOOR PLAN, SOUTH
WESTERN JUNIOR HIGH SCHOOL

HA: W COVEBASE ADH - BLACK/W/TAN

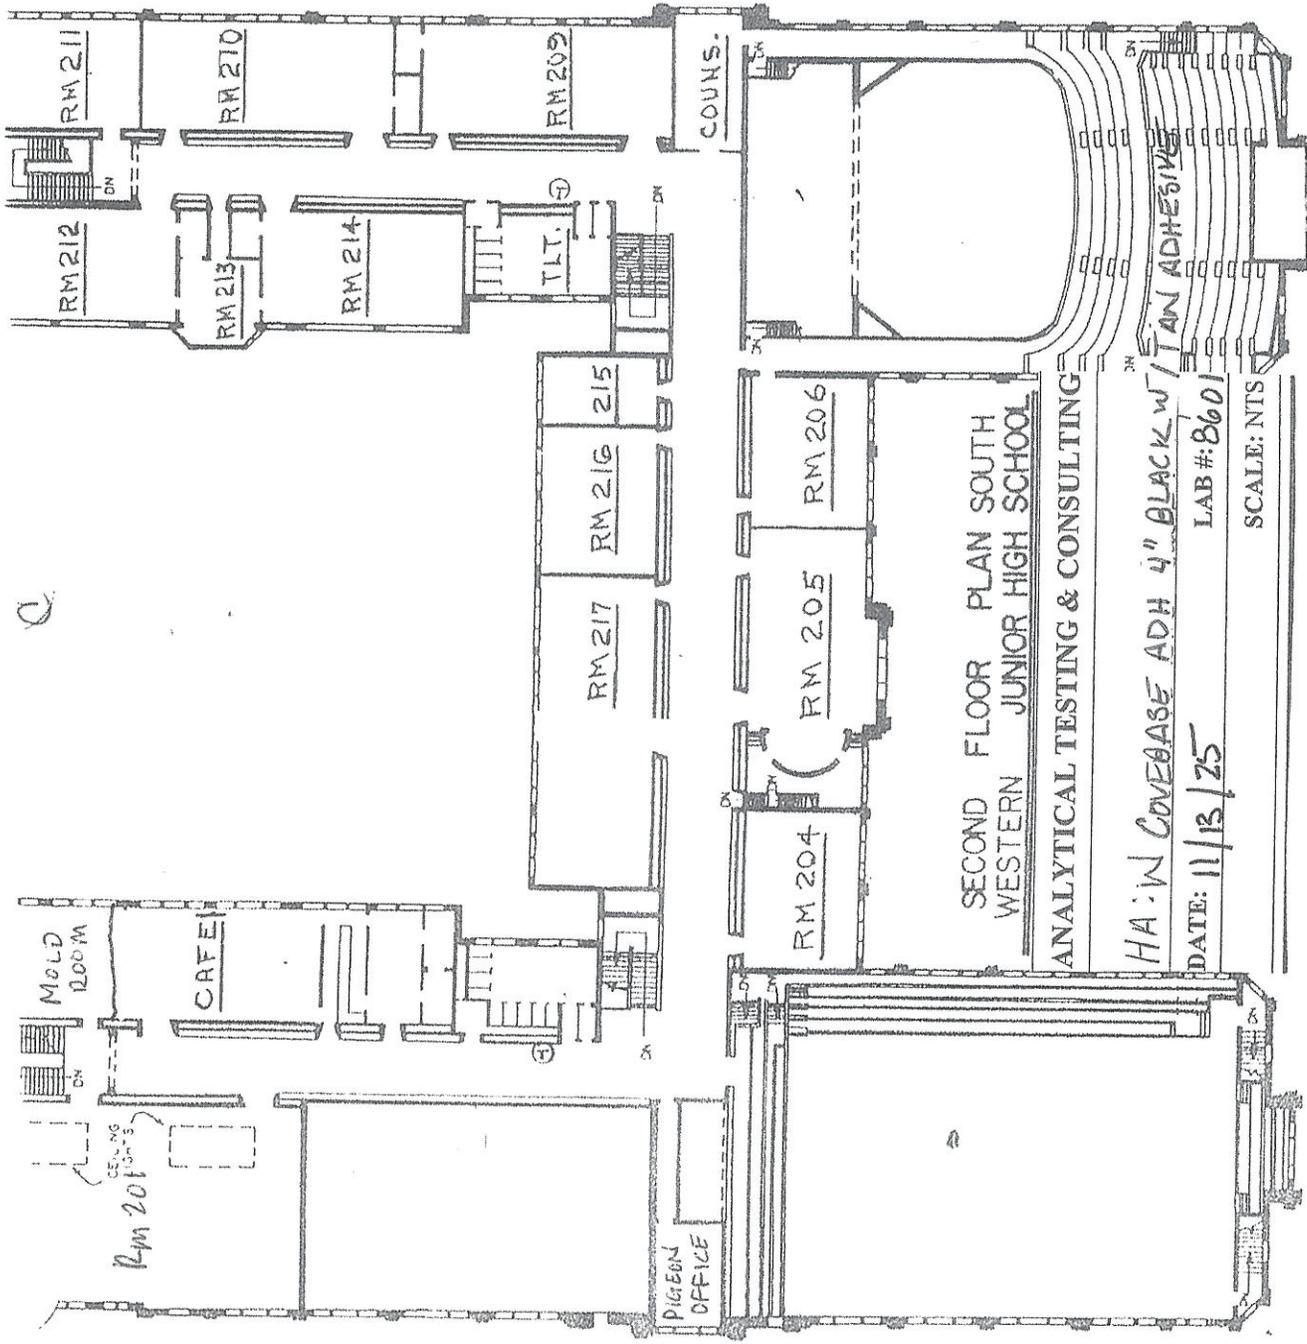
SECOND FLOOR PLAN SOUTH
 WESTERN JUNIOR HIGH SCHOOL
 ANALYTICAL TESTING & CONSULTING

HA: W COVEBASE ADH 4" BLACK W / TAN ADHESIVE

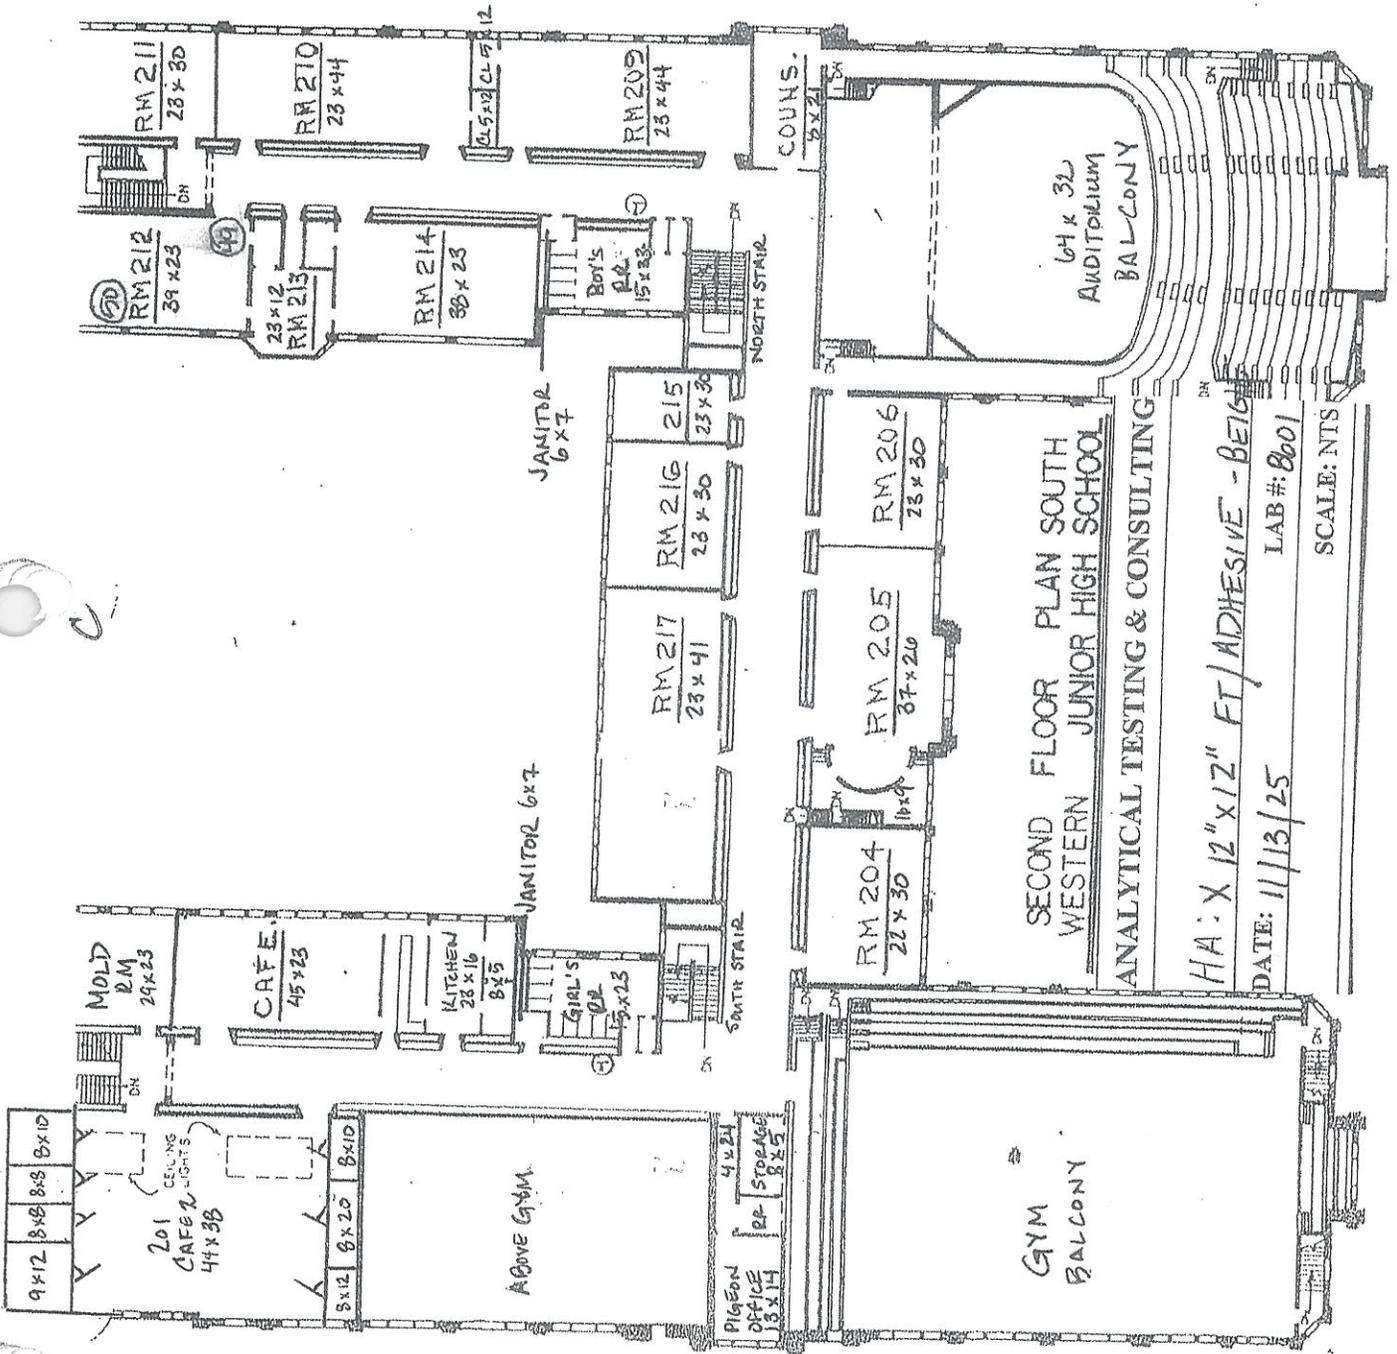
HA DESCRIPTION: 12"x12" Floor Tile/ Adhesive – Beige

HA LOCATION	Type SM/TSI/MM	Friability F/NF	Physical Condition	Size SF/LF/MF
Room 117	MM	NF	1	~690 SF
TOTAL				~690 SF

Sample No.	Description and Location	Results (%)
8601-49	Sample of floor tile/ mastic from Room 117 at entry	Layer 1 – None Detected Layer 2 – None Detected
8601-50	Sample of floor tile/ mastic from Room 117 Side B	Layer 1 – None Detected Layer 2 – None Detected
*Note: All samples were collected in a statistically random manner representative of Homogeneous Area in accordance with 40 CFR 763.86.

Location	Recommendations
HA-X	Non Asbestos

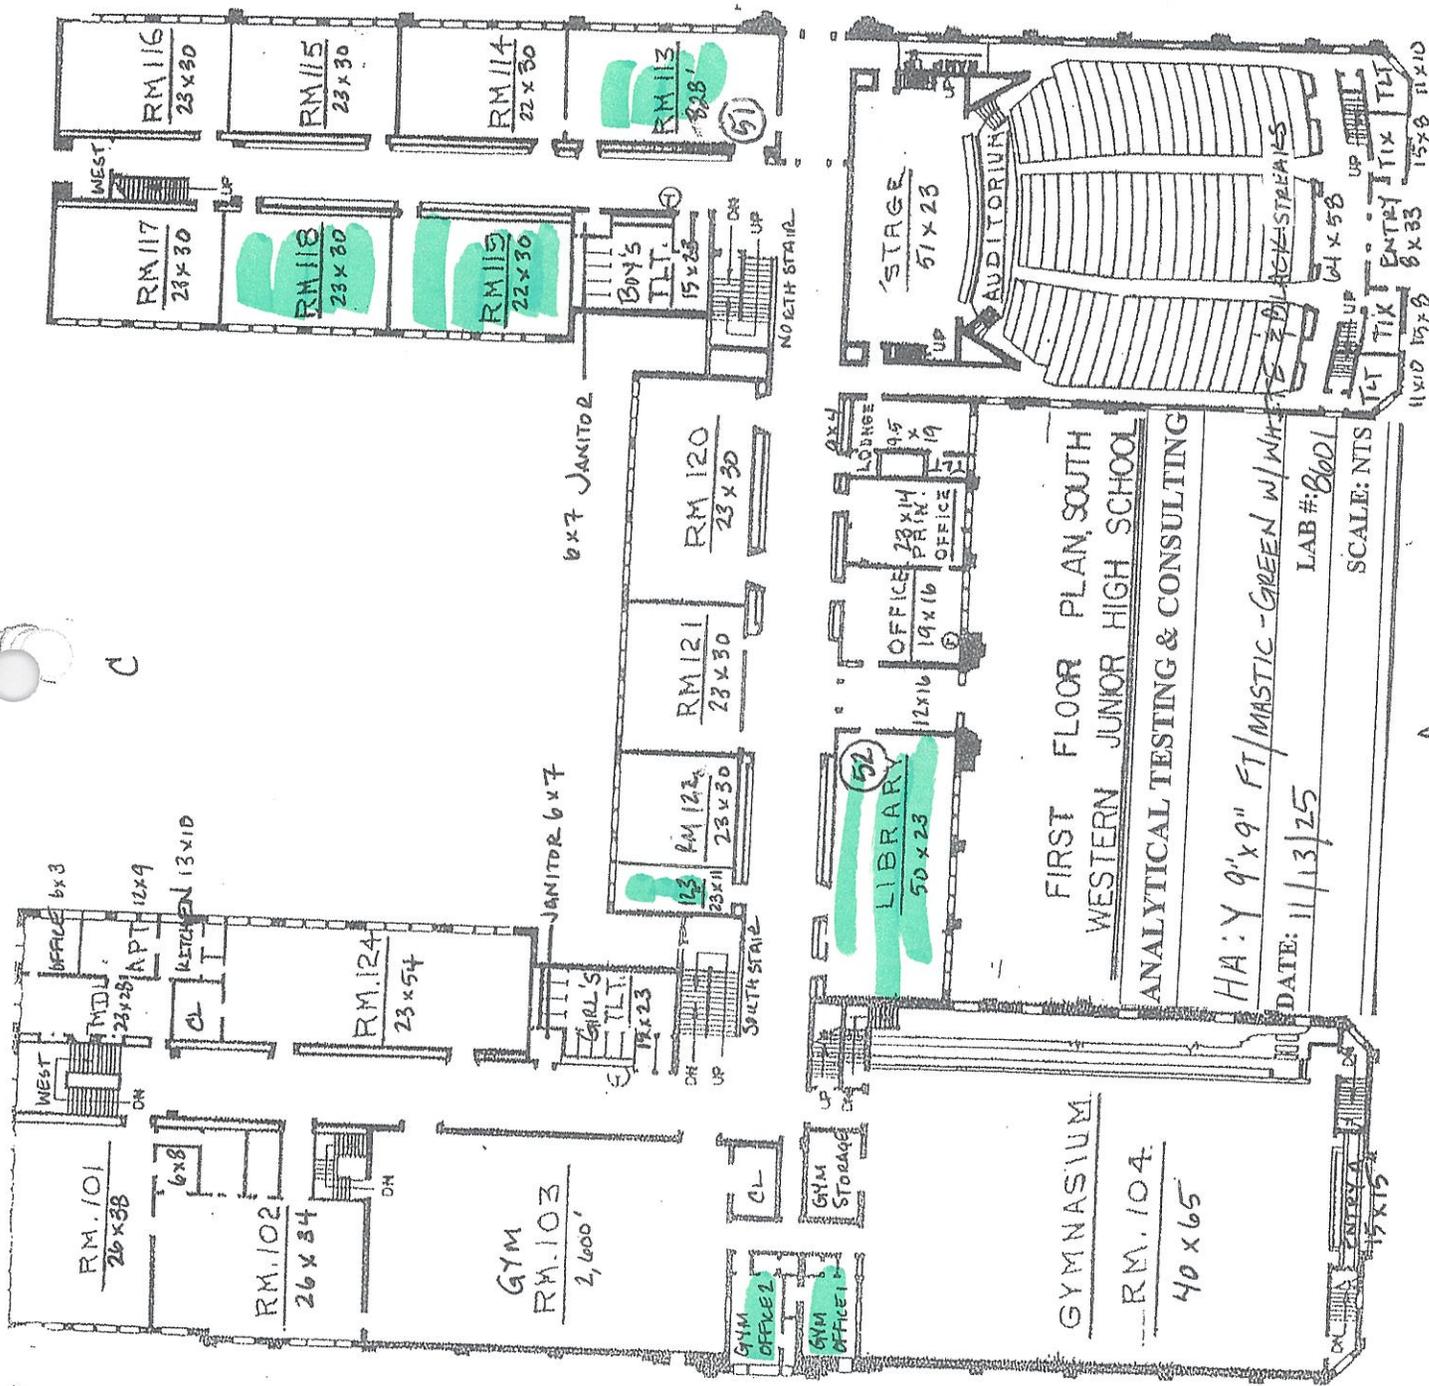
FIRST FLOOR PLAN, SOUTH
 WESTERN JUNIOR HIGH SCHOOL
 ANALYTICAL TESTING & CONSULTING

HA DESCRIPTION: 9"x9" Floor Tile/ Mastic – Green with White and Black Streaks

HA LOCATION	Type SM/TSI/MM	Friability F/NF	Physical Condition	Size SF/LF/MF
Room 113	MM	NF	2	~828 SF
Room 118	MM	NF	2	~690 SF
Room 119	MM	NF	5	~690 SF
Library – under carpet	MM	NF	7	~1,150 SF
Room 123 – under carpet	MM	NF	4	~242 SF
Gym Office 1, hall and closet	MM	NF	4	~300 SF
Gym Office 2, hall and closet	MM	NF	4	~167 SF
TOTAL				~4,067 SF

Sample No.	Description and Location	Results (%)
8601-51	Sample of floor tile/ mastic from Room 113 at entry	Layer 1 – 5% Chrysotile Layer 2 – None Detected
8601-52	Sample of floor tile/ mastic from Library Side D with carpet adhesive	Layer 1 – 5% Chrysotile Layer 2 – None Detected
*Note: All samples were collected in a statistically random manner representative of Homogeneous Area in accordance with 40 CFR 763.86.

HA: Y 9" x 9" FT/MASTIC - GREEN W/WHITE
 DATE: 11/13/25
 LAB #: 8601
 SCALE: NTS

Location	Recommendations
HA-Y	Remove Asbestos Prior to Demolition/ Renovation
