ASBESTOS SURVEY DATA FORM

LOCATION: Southwestern Junior High School

ADDRESS: 390 S. Washington, Battle Creek, Michigan 49017

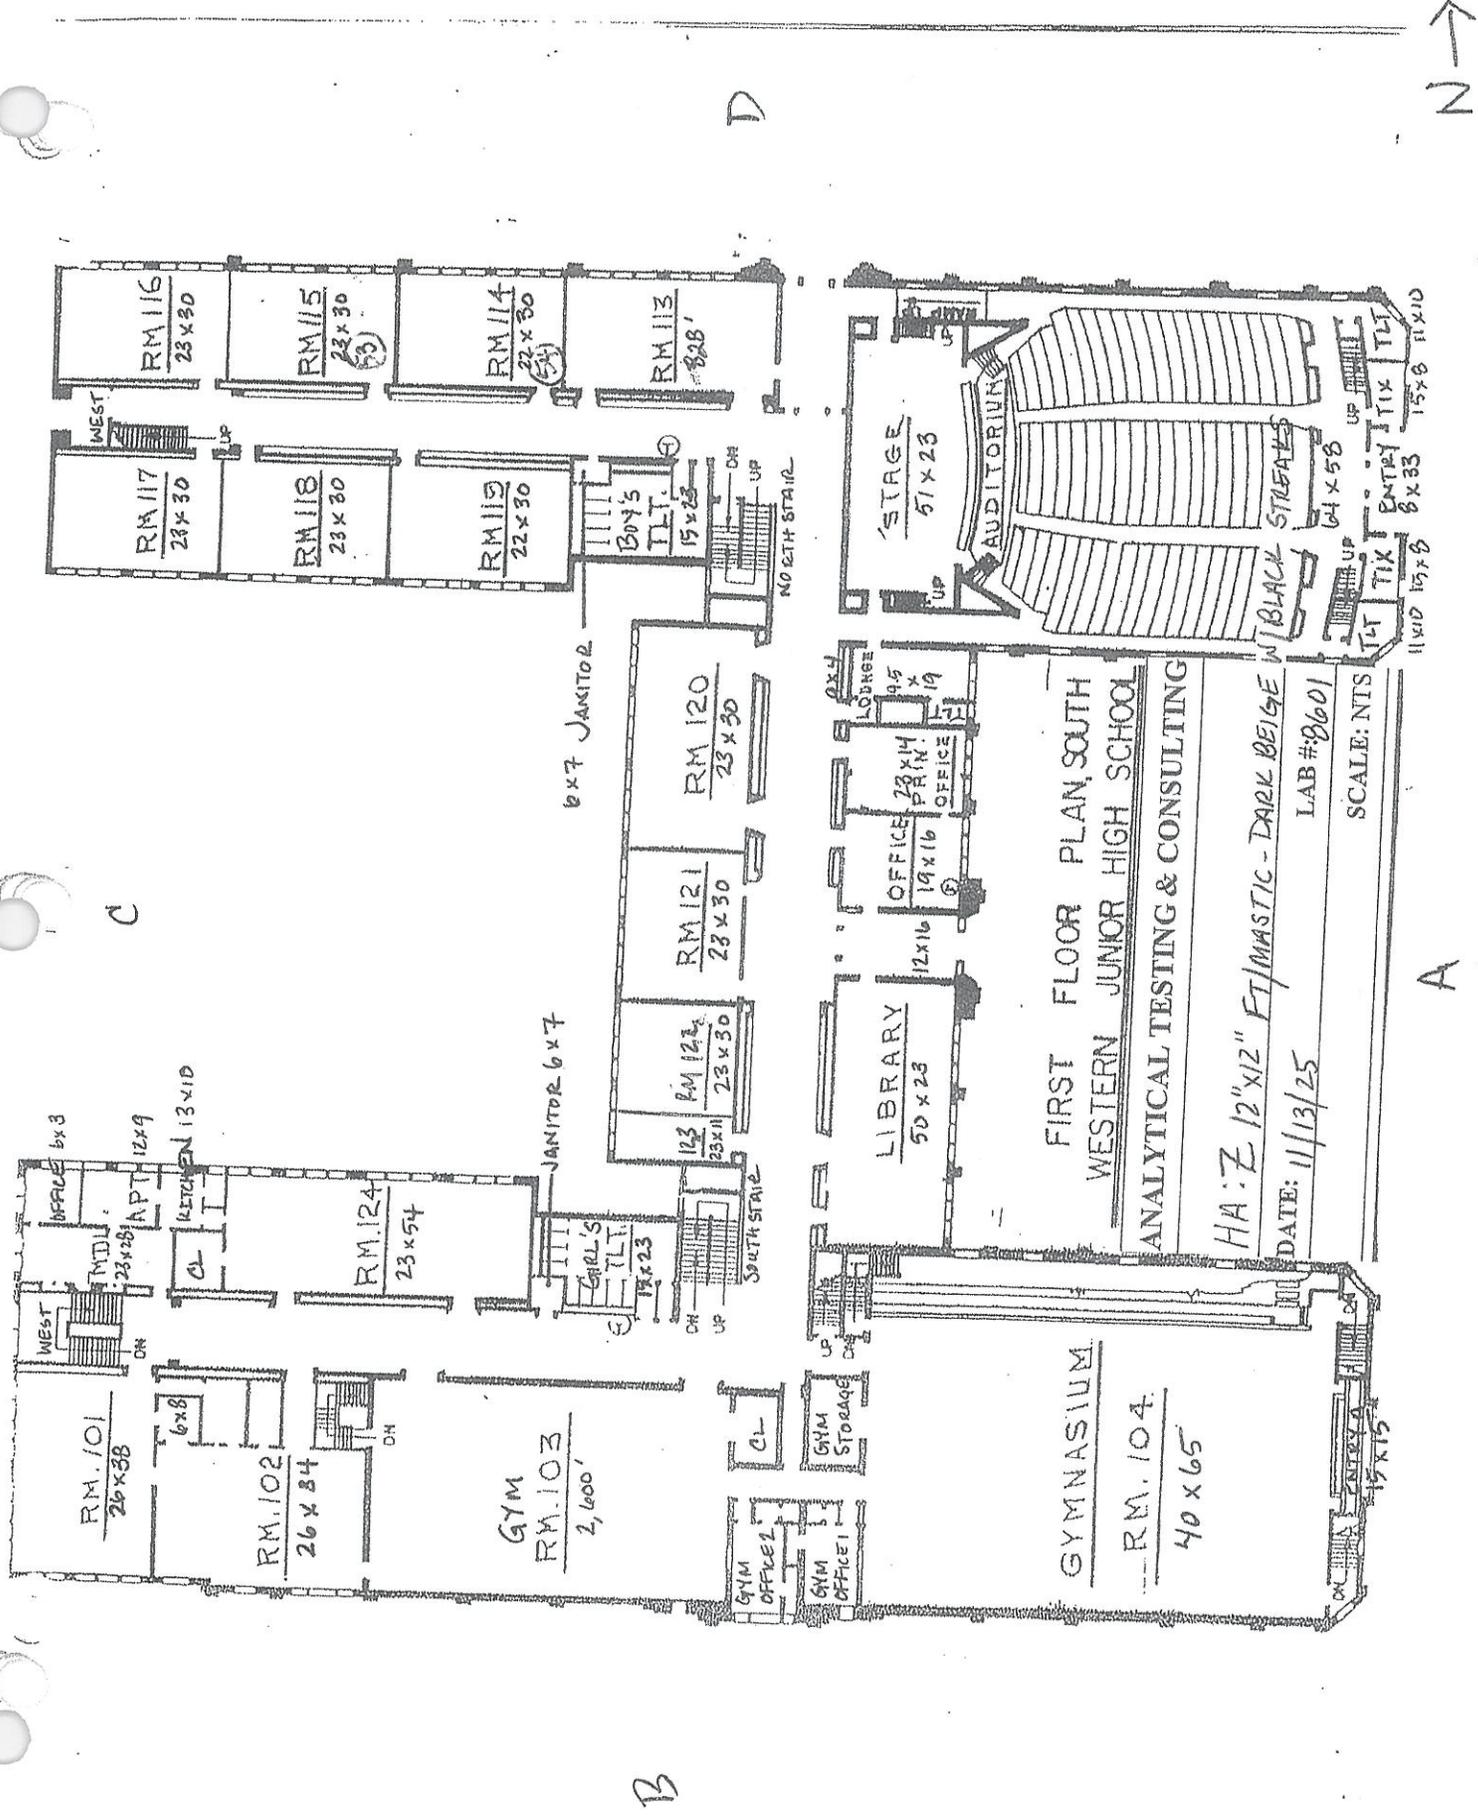
FIRST FLOOR PLAN, SOUTH
WESTERN JUNIOR HIGH SCHOOL
ANALYTICAL TESTING & CONSULTING

HA DESCRIPTION: 12"x12" Floor Tile/ Mastic – Dark Beige with Black Streaks

HA LOCATION	Type SM/TSI/MM	Friability F/NF	Physical Condition	Size SF/LF/MF
Room 115 – with subfloor	MM	NF	4	~660 SF
Room 114 – with floor tile subfloor	MM	NF	4	~660 SF
			TOTAL	~1,320 SF

Sample No.	Description and Location	Results (%)
8601-53	Sample of floor tile/ mastic with subfloor from Room 115 at entry	Layer 1 – None Detected Layer 2 – None Detected Layer 3 – None Detected
8601-54	Sample of floor tile/ mastic from Room 114 at entry	Layer 1 – None Detected Layer 2 – None Detected Layer 3 – None Detected
*Note: All samples were collected in a statistically random manner representative of Homogeneous Area in accordance with 40 CFR 763.86.

HA: Z 12" X 12" FT/MASTIC - DARK BEIGE
DATE: 11/13/25
LAB # 8601

Location	Recommendations
HA-Z	Non Asbestos

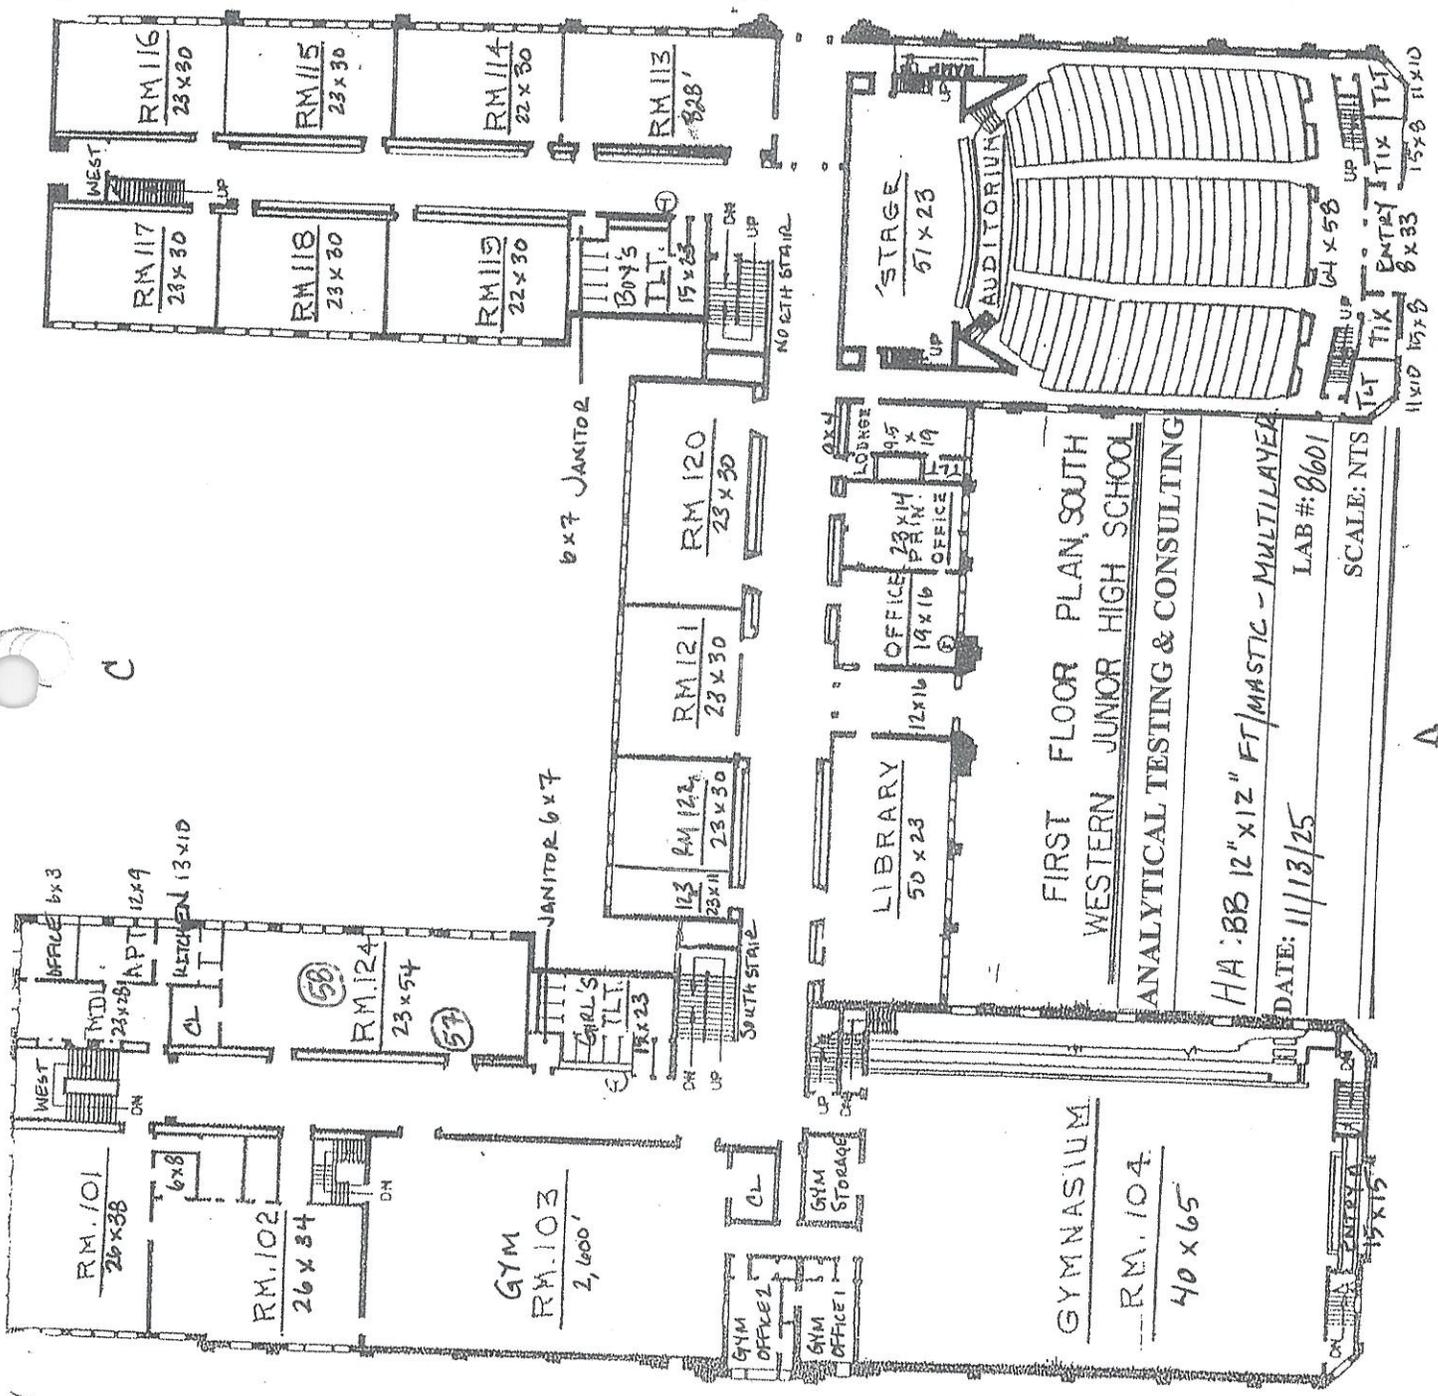
HA DESCRIPTION: 12"x12" Floor Tile/ Mastic – Beige with White

HA LOCATION	Type SM/TSI/MM	Friability F/NF	Physical Condition	Size SF/LF/MF
Room 124 – Beige top layer	MM	NF	2	~1,242 SF
Room 124 closet	MM	NF	2	~110 SF
Room 101 and closets – top layer only	MM	NF	7	~1,054 SF
Room 124 Kitchen – top layer	MM	NF	7	~130 SF
			TOTAL	~2,536 SF

Sample No.	Description and Location	Results (%)
8601-57	Sample of multilayer floor tile/ mastic from Room 124 at entry door	Layer 1 – None Detected Layer 2 – None Detected
8601-58	Sample of multilayer floor tile/ mastic from Room 124	Layer 1 – None Detected Layer 2 – None Detected
*Note: All samples were collected in a statistically random manner representative of Homogeneous Area in accordance with 40 CFR 763.86.

FIRST FLOOR PLAN, SOUTH
 WESTERN JUNIOR HIGH SCHOOL
 ANALYTICAL TESTING & CONSULTING
 HA:BB 12"X12" FT/MASTIC - MULTILAYER
 DATE: 11/18/25
 LAB #: 8601
 SCALE: NTS

Location	Recommendations
HA-BB	Non Asbestos

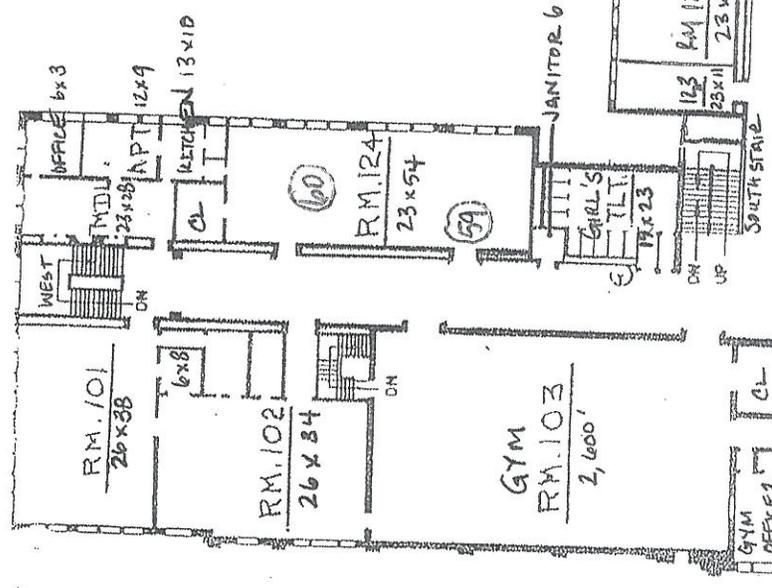
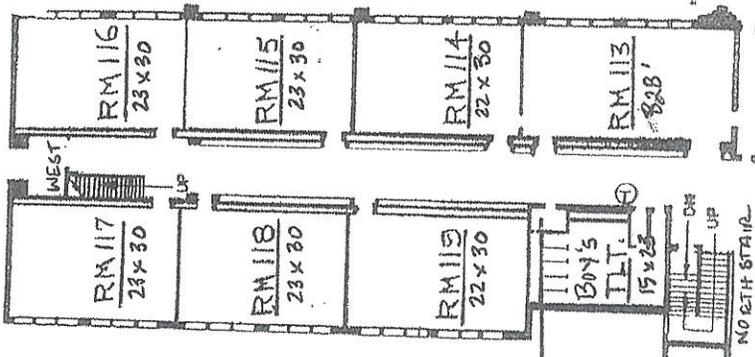
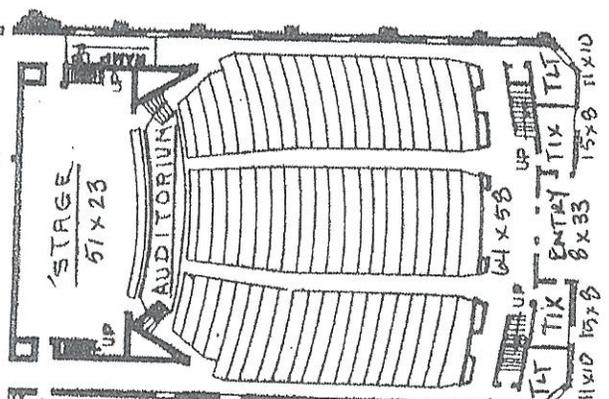
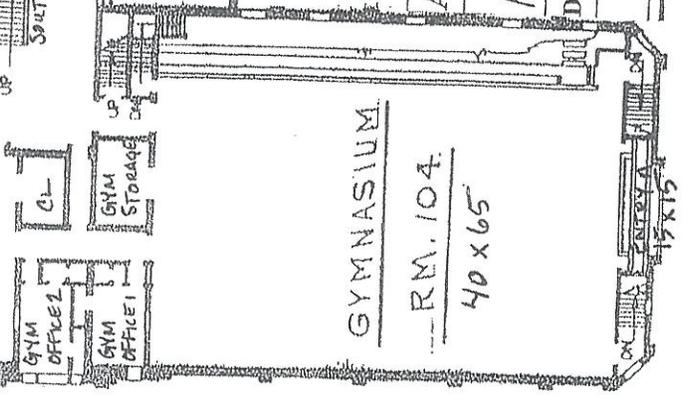
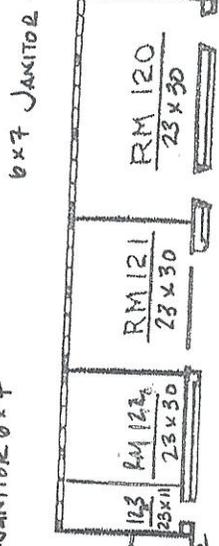
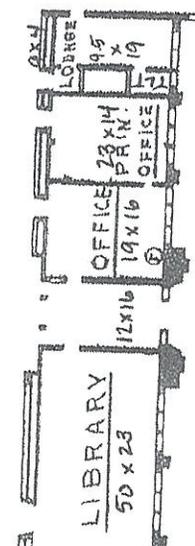
HA DESCRIPTION: Floor Tile/ Mastic – Tan

HA LOCATION	Type SM/TSI/MM	Friability F/NF	Physical Condition	Size SF/LF/MF
Room 124 – second layer	MM	NF	2	~1,242 SF
Room 124 closet – second layer	MM	NF	2	~110 SF
			TOTAL	~1,352 SF

Sample No.	Description and Location	Results (%)
8601-59	Sample of floor tile/ mastic from Room 124 at entry	Layer 1 – None Detected Layer 2 – None Detected
8601-60	Sample of floor tile/ mastic from Room 124 center near counter	Layer 1 – None Detected Layer 2 – None Detected
<p><i>*Note: All samples were collected in a statistically random manner representative of Homogeneous Area in accordance with 40 CFR 763.86.</i></p>

FIRST FLOOR PLAN, SOUTH
 WESTERN JUNIOR HIGH SCHOOL
 ANALYTICAL TESTING & CONSULTING
 HA:CC FT/MASTIC-TAN
 DATE: 11/13/25
 LAB #: 0601
 SCALE: NTS

Location	Recommendations
HA-CC	Non Asbestos

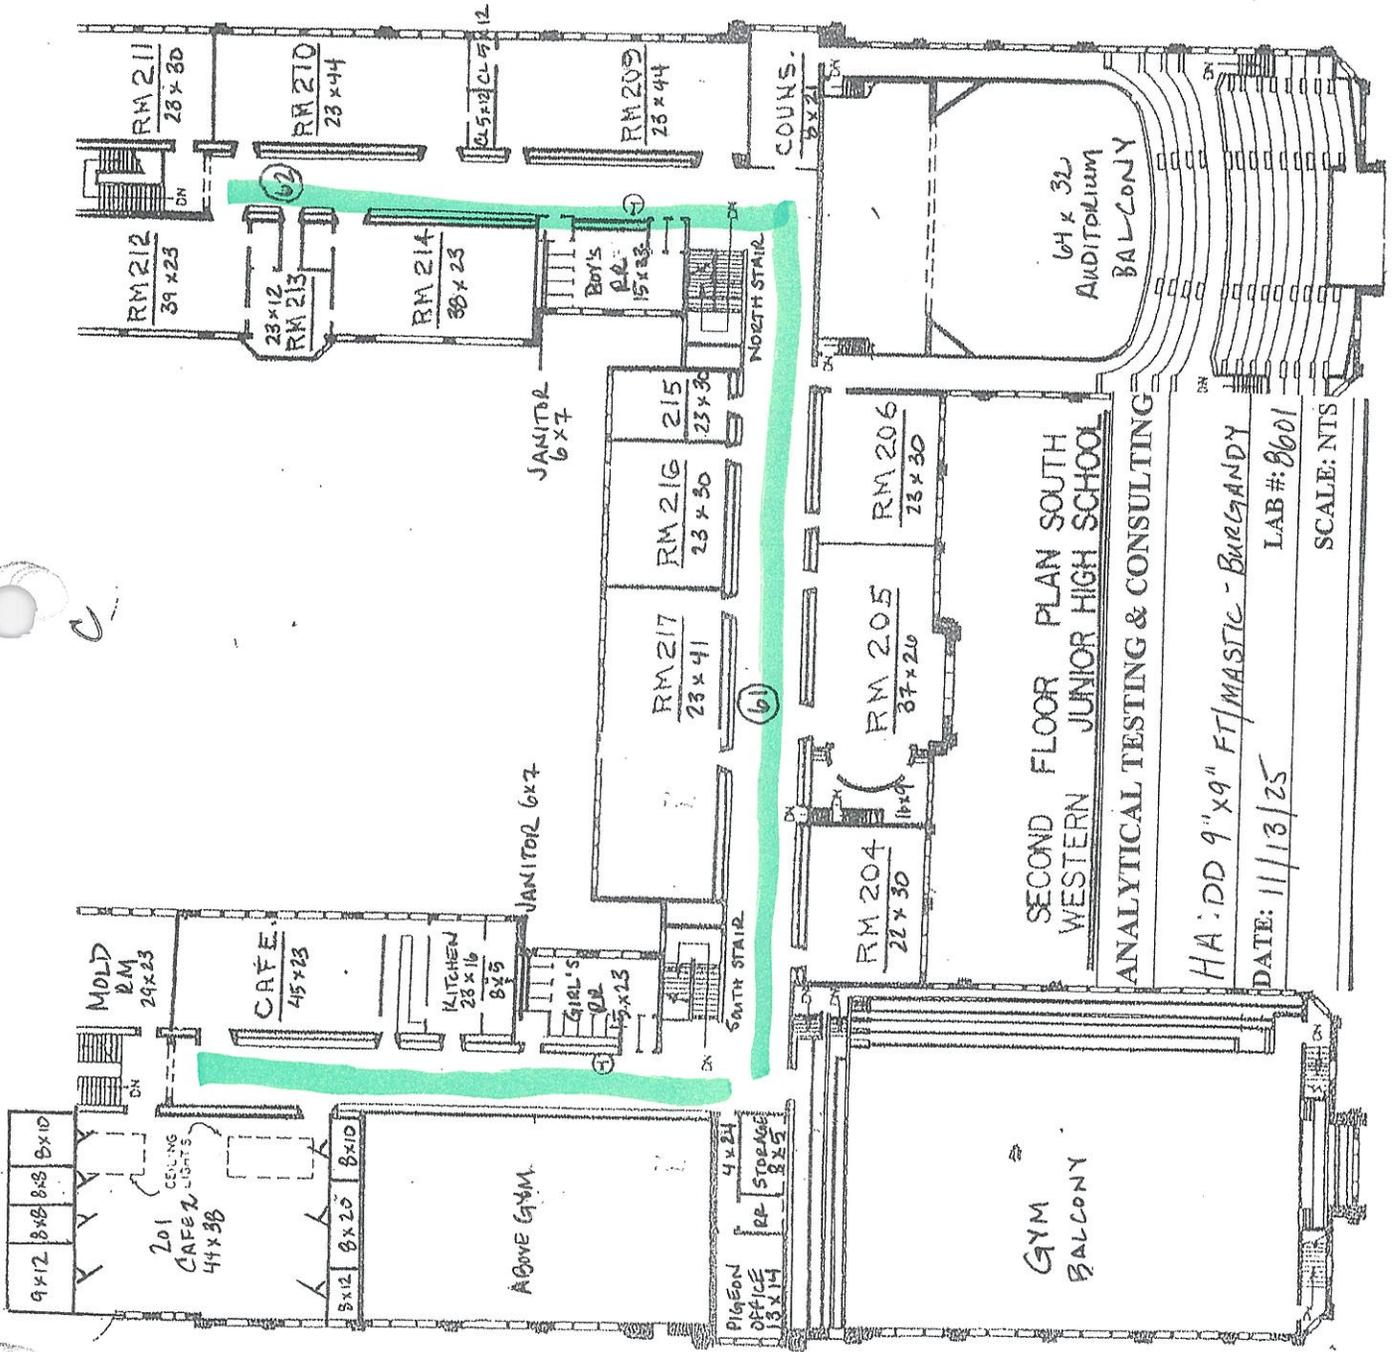
SECOND FLOOR PLAN SOUTH
WESTERN JUNIOR HIGH SCHOOL
ANALYTICAL TESTING & CONSULTING

HA DESCRIPTION: 9"x9" Floor Tile/ Mastic – Burgandy

HA LOCATION	Type SM/TSI/MM	Friability F/NF	Physical Condition	Size SF/LF/MF
Second floor hall	MM	NF	7	~4,038 SF
TOTAL				~4,038 SF

Sample No.	Description and Location	Results (%)
8601-61	Sample of floor tile/ mastic from hall outside Room 217	Layer 1 – 5% Chrysotile Layer 2 – None Detected
8601-62	Sample of floor tile/ mastic from hall outside Room 210	Layer 1 – 5% Chrysotile Layer 2 – None Detected

HA: DD 9" x 9" FT/MASTIC - BURGANDY
LAB #: 8601
DATE: 11/13/25
SCALE: NTS

Location	Recommendations
HA-DD	Remove Asbestos Prior to Demolition/ Renovation

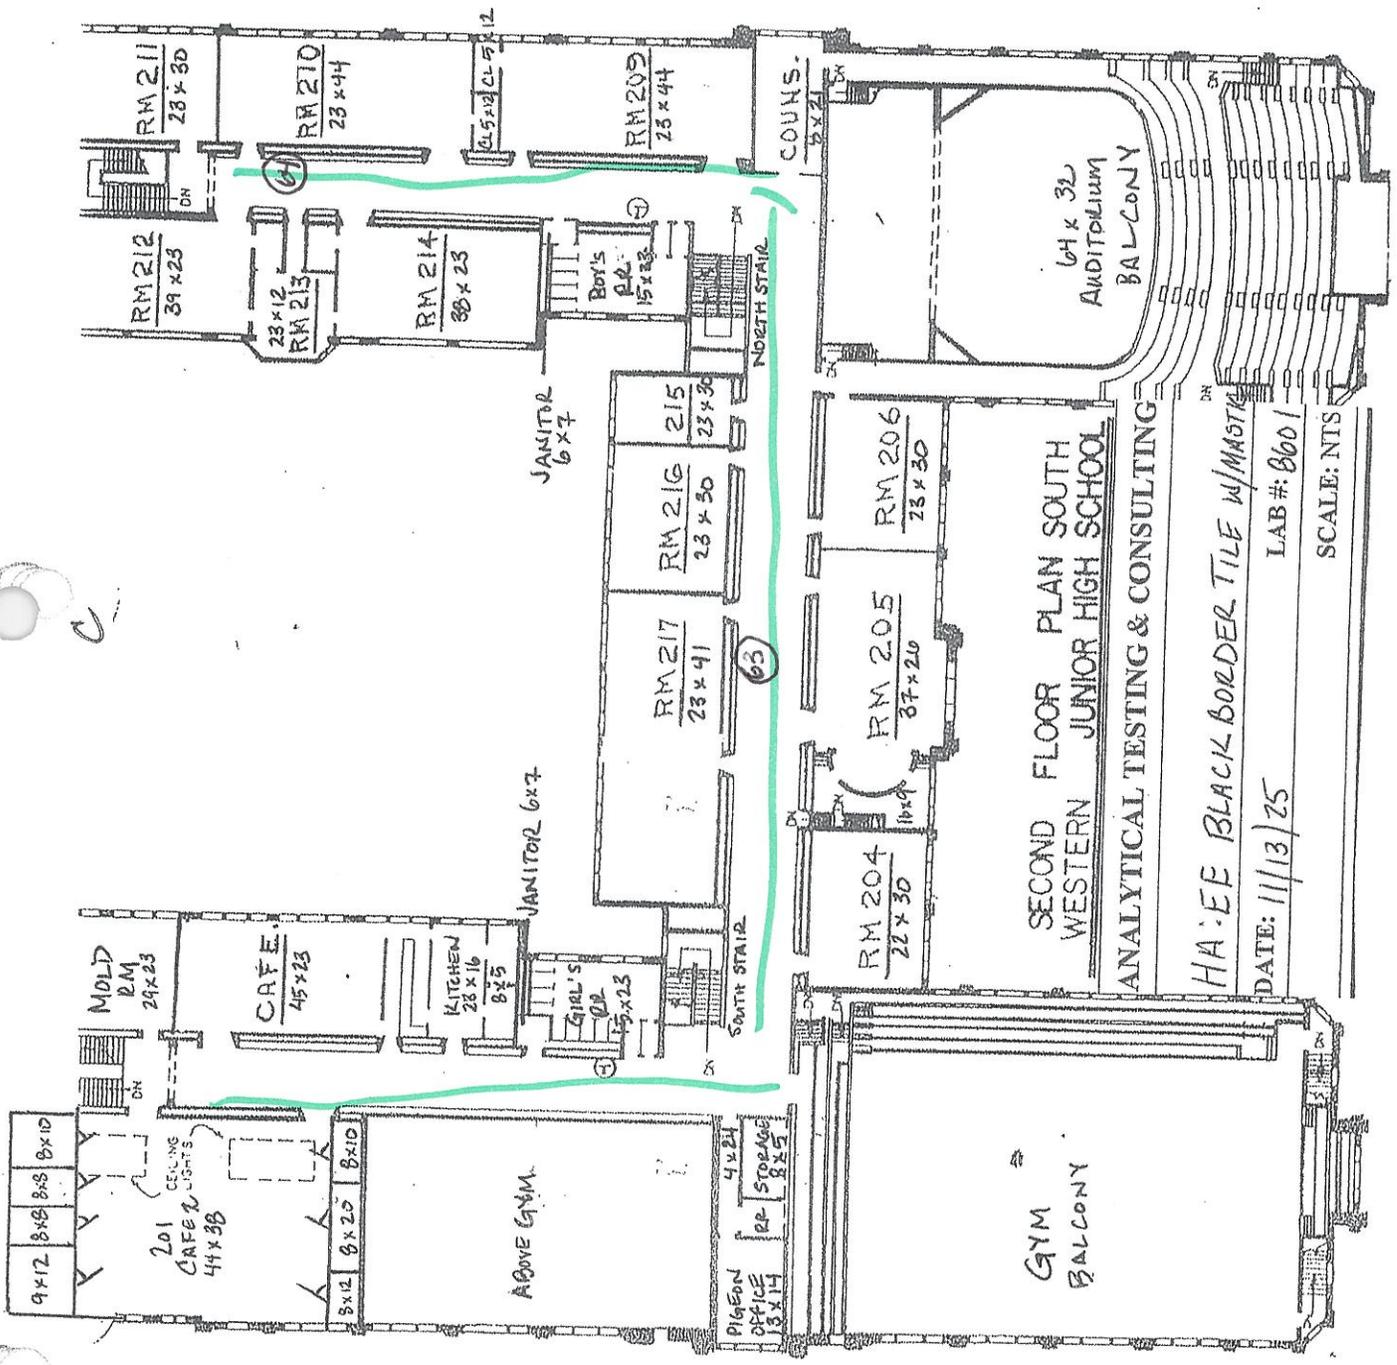
SECOND FLOOR PLAN SOUTH
WESTERN JUNIOR HIGH SCHOOL
ANALYTICAL TESTING & CONSULTING

HA:EE BLACK BORDER TILE W/MASTIC
LAB #: 8601
DATE: 11/13/25
SCALE: NTS

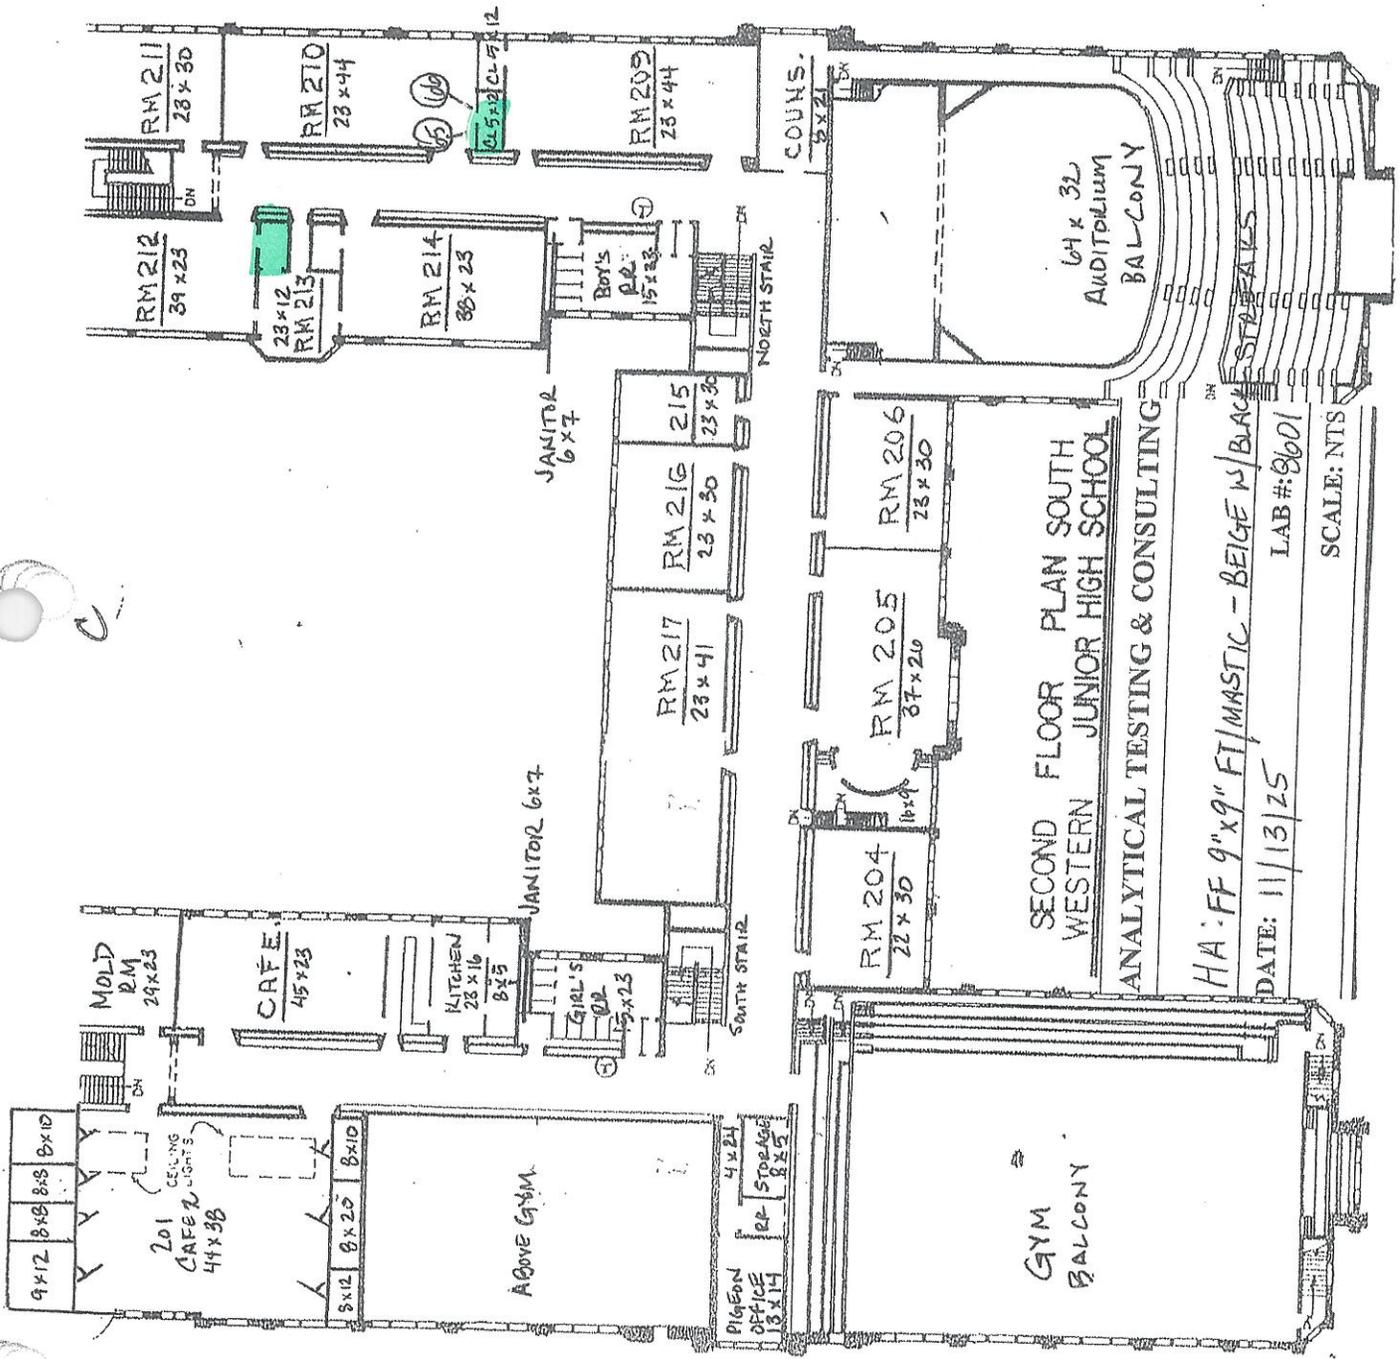
SECOND FLOOR PLAN SOUTH
WESTERN JUNIOR HIGH SCHOOL
ANALYTICAL TESTING & CONSULTING

HA: FF 9"x9" FI/MASTIC - BEIGE W/BLACK STRIPS
LAB #: 8601
DATE: 11/13/25
SCALE: NTS

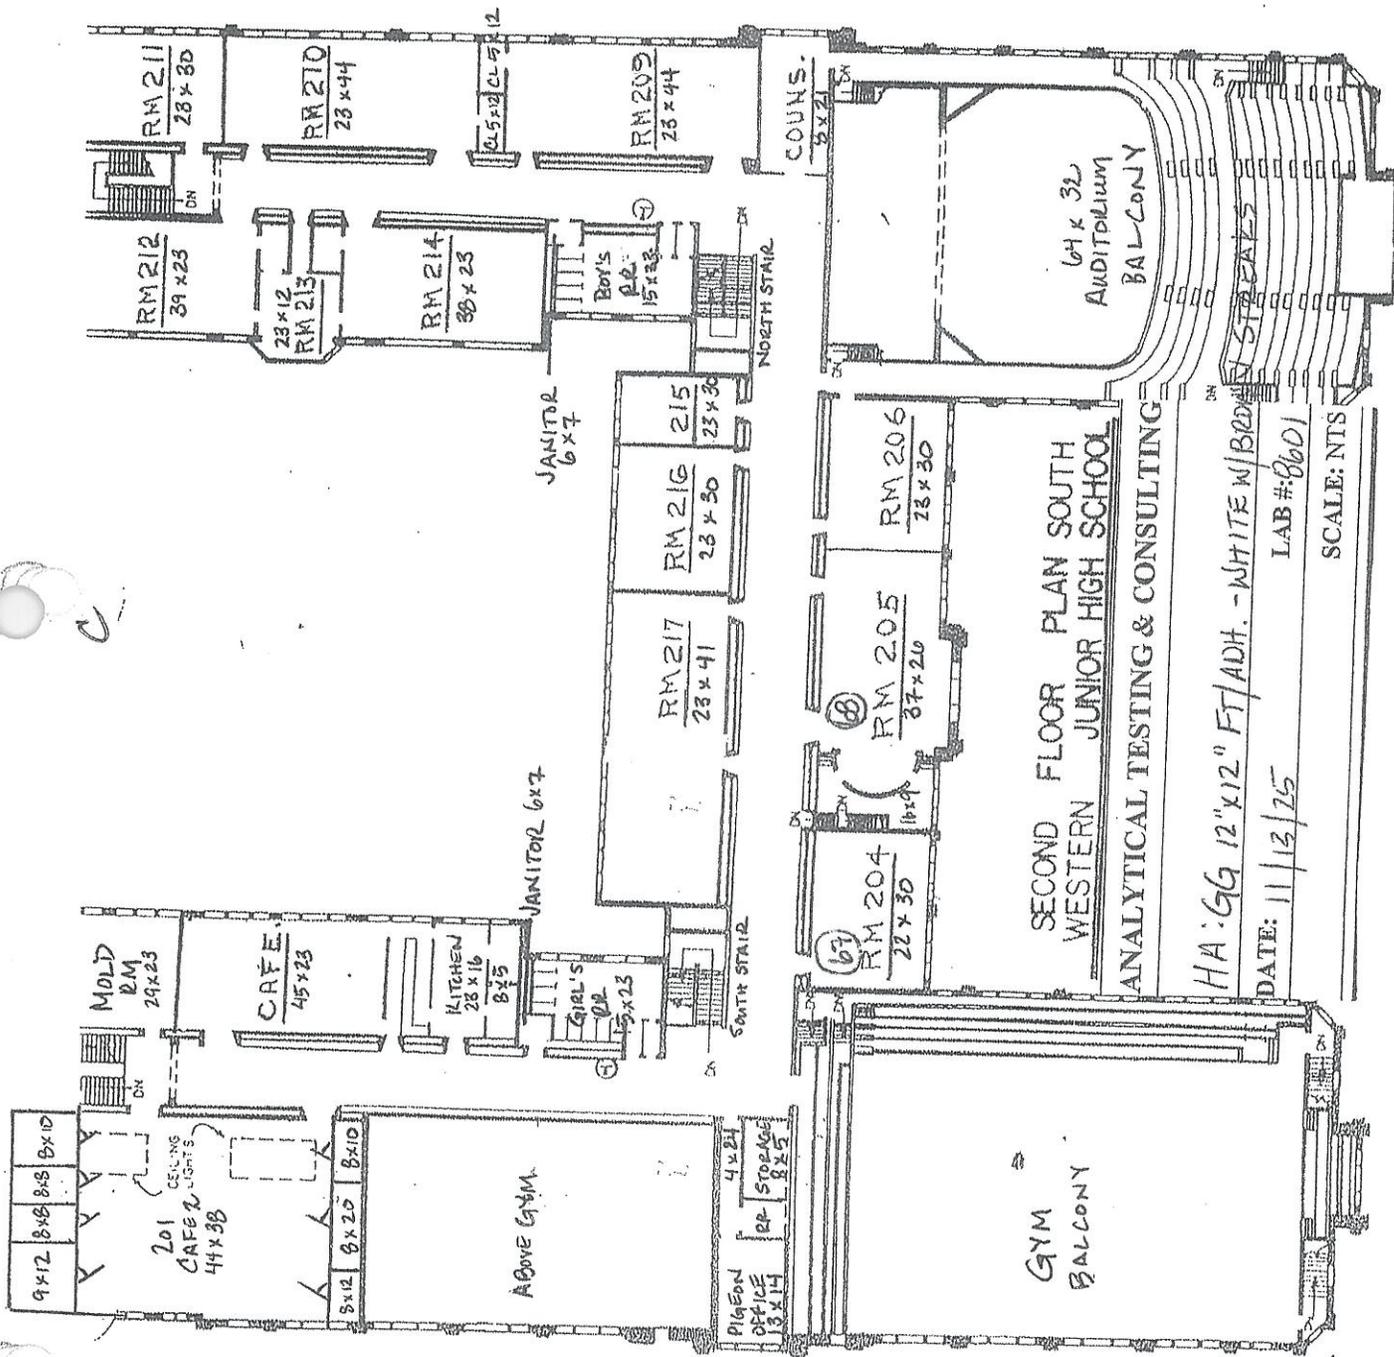
HA DESCRIPTION: 12"x12" Floor Tile/ Adhesive – White with Brown Streaks

HA LOCATION	Type SM/TSI/MM	Friability F/NF	Physical Condition	Size SF/LF/MF
Room 204	MM	NF	7	~660 SF
Pigeon Office – top layer	MM	NF	7	~182 SF
Café 2 and all storage rooms	MM	NF	7	~2,334 SF
Room 205 – top layer	MM	NF	4	~962 SF
Room 214	MM	NF	4	~874 SF
Room 210	MM	NF	4	~1,012 SF
TOTAL				~6,024 SF

Sample No.	Description and Location	Results (%)
8601-67	Sample of floor tile/ mastic from Room 204 center	Layer 1 – None Detected Layer 2 – None Detected
8601-68	Sample of floor tile/ mastic from Room 205 center	Layer 1 – None Detected Layer 2 – None Detected

Location	Recommendations
HA-GG	Non Asbestos

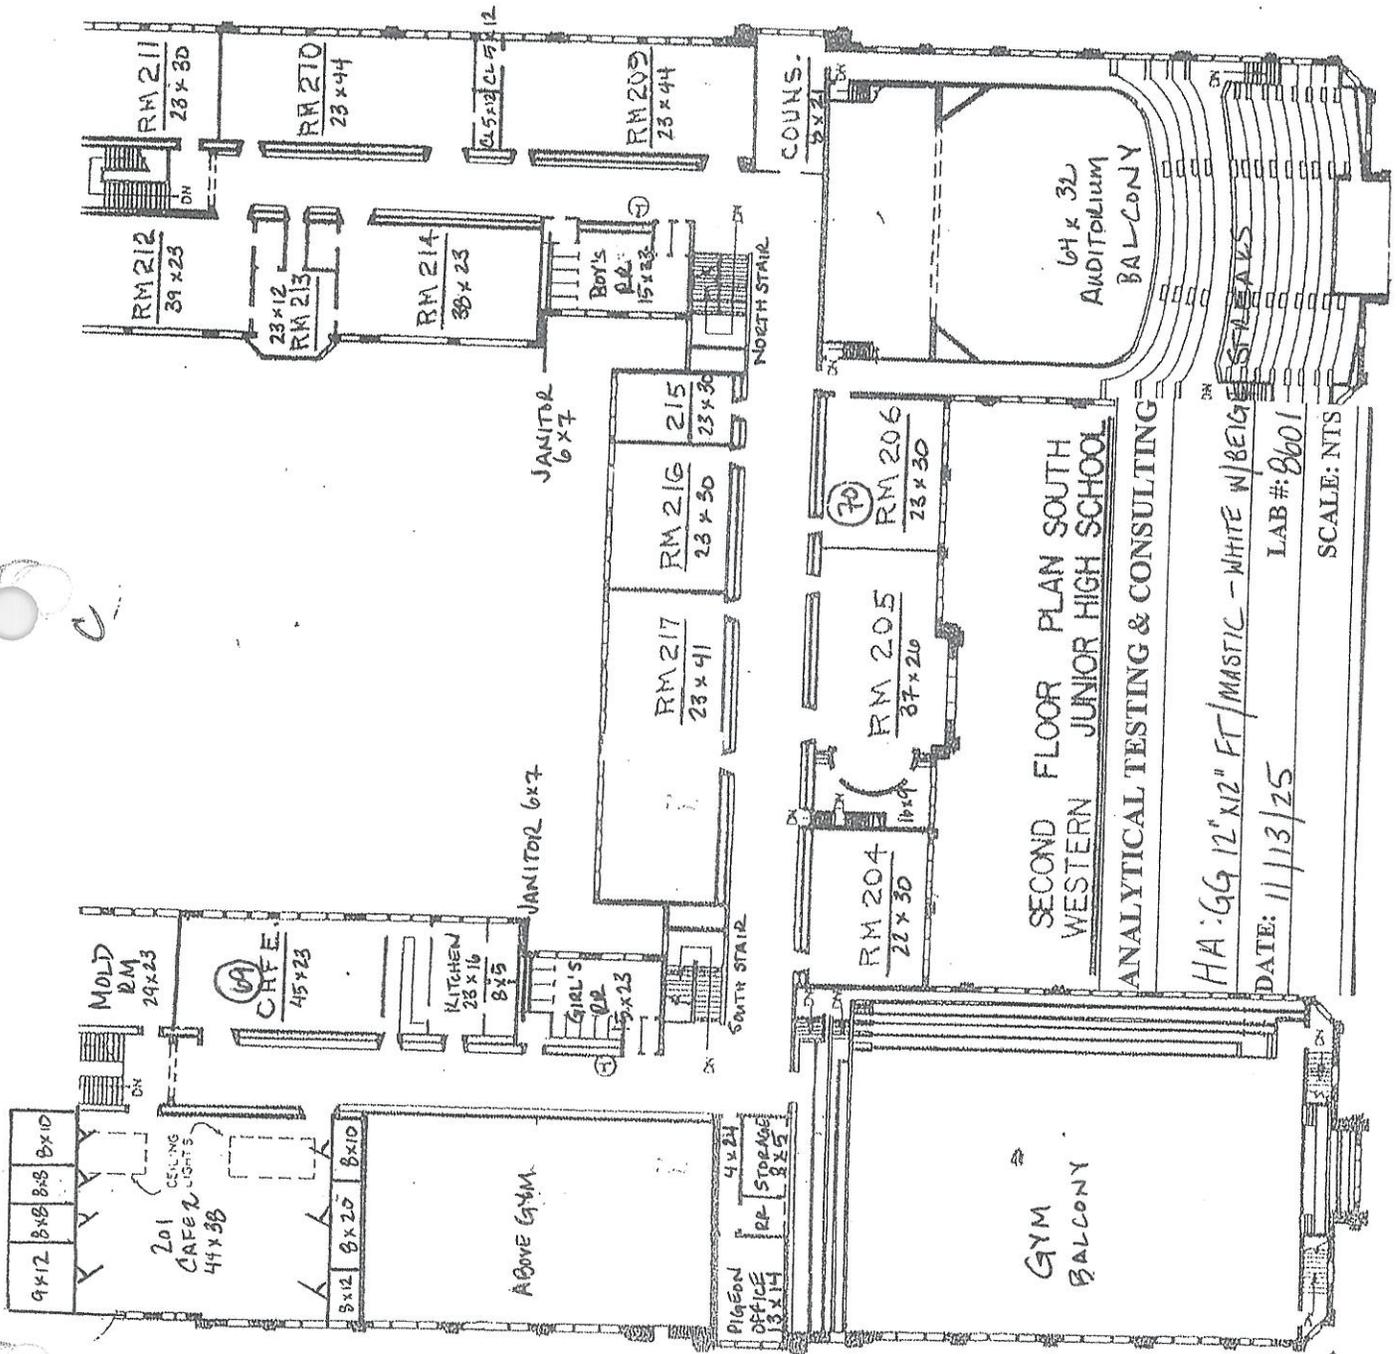
SECOND FLOOR PLAN SOUTH
WESTERN JUNIOR HIGH SCHOOL
ANALYTICAL TESTING & CONSULTING

HA DESCRIPTION: 12"x12" Floor Tile/ Mastic – White with Beige Streaks

HA LOCATION	Type SM/TSI/MM	Friability F/NF	Physical Condition	Size SF/LF/MF
Café 1	MM	NF	4	~1,035 SF
Room 206	MM	NF	4	~690 SF
Room 209	MM	NF	4	~1,012 SF
Room 212	MM	NF	4	~897 SF
TOTAL				~3,634 SF

Sample No.	Description and Location	Results (%)
8601-69	Sample of floor tile/ mastic from Café 1 center	Layer 1 – None Detected Layer 2 – None Detected
8601-70	Sample of floor tile/ mastic from Room 206 at entry	Layer 1 – None Detected Layer 2 – None Detected
*Note: All samples were collected in a statistically random manner representative of Homogeneous Area in accordance with 40 CFR 763.86.

HA: 66 12" x 12" FT / MASTIC - WHITE W/ BEIGE STAIRS
LAB #: 8601
DATE: 11/13/25
SCALE: NTS

Location	Recommendations
HA-HH	Non Asbestos
