Battle Creek Public Schools Ann J. Kellogg School

306 Champion
Battle Creek, MI 49037

Tremco CPG

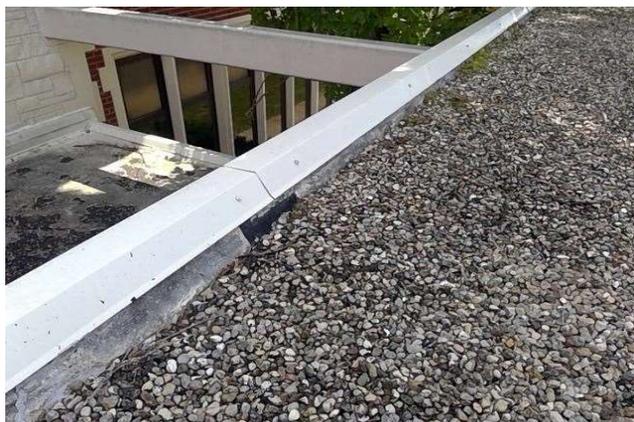
Weathered coating.

Work Beyond Scope of Maintenance Agreement (Customer Responsibility)			
Task	Year	Project \$	Task Description
Repairs Required, Minor	2020		Replace damaged perimeter metal.
Repairs Required, Minor	2020		Recommend applying aluminum coating to perimeter membrane flashings.
Tree Work	2020		Recommend trimming back the tree limbs that overhang the roof surface.

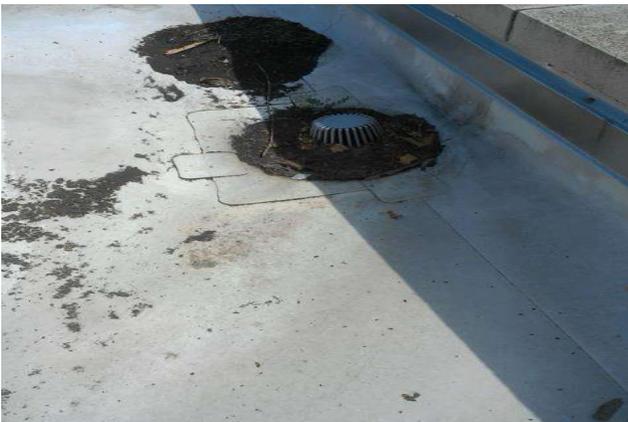
Debris.

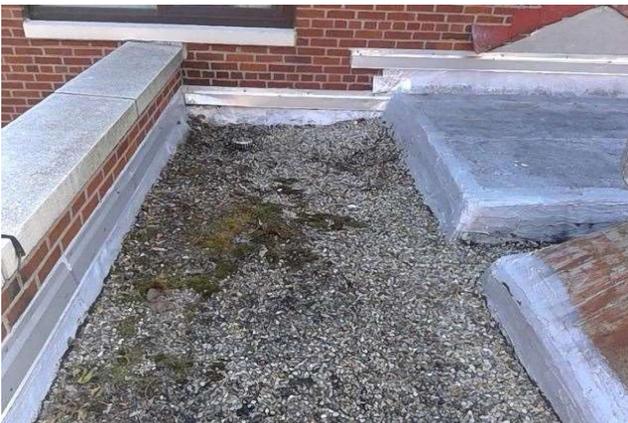
Overview/Moss growth.

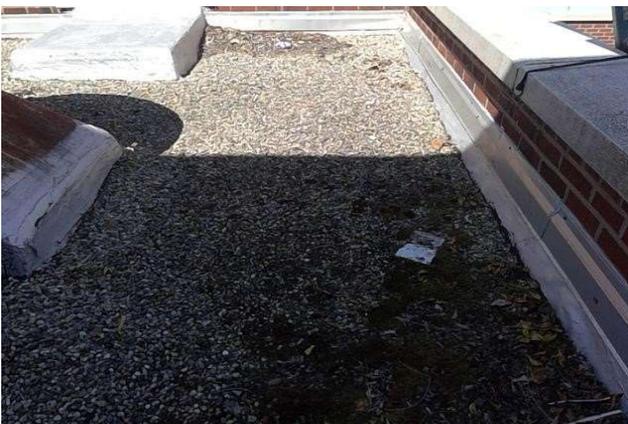
Debris.

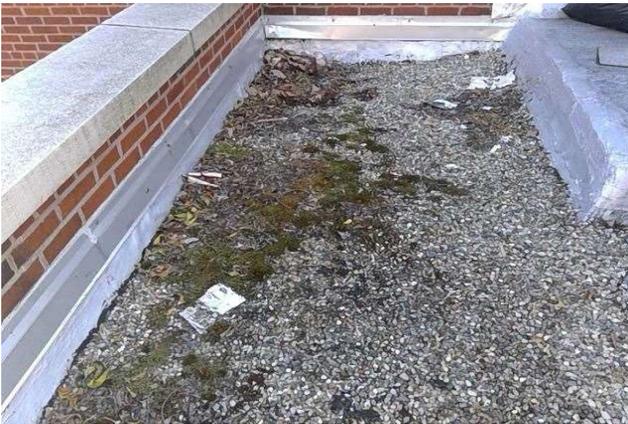
Debris.

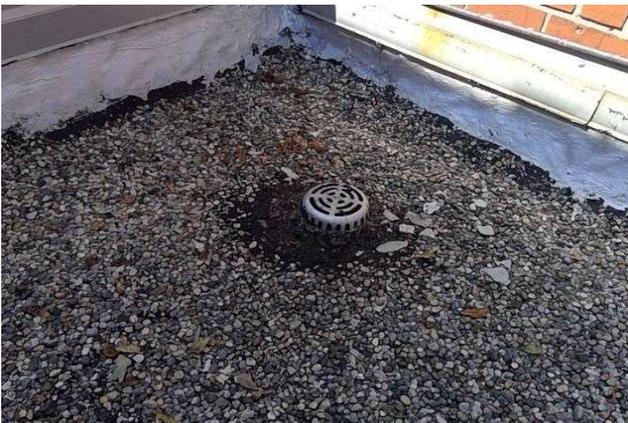
Debris.

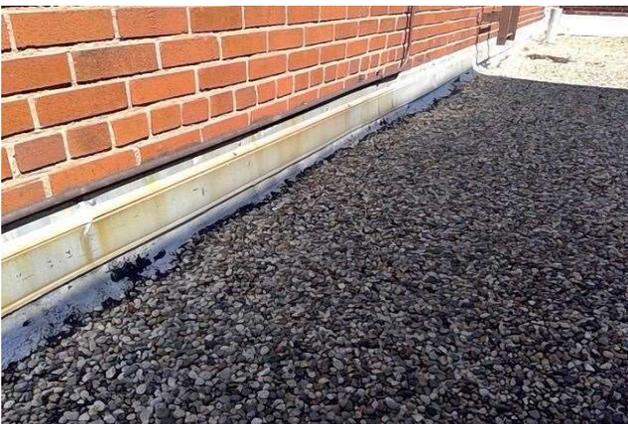
Weathered flashing membrane.

Work Beyond Scope of Maintenance Agreement (Customer Responsibility)			
Task	Year	Project \$	Task Description
Repairs Required, Minor	2020		Recommend applying aluminum coating to base flashing membrane.

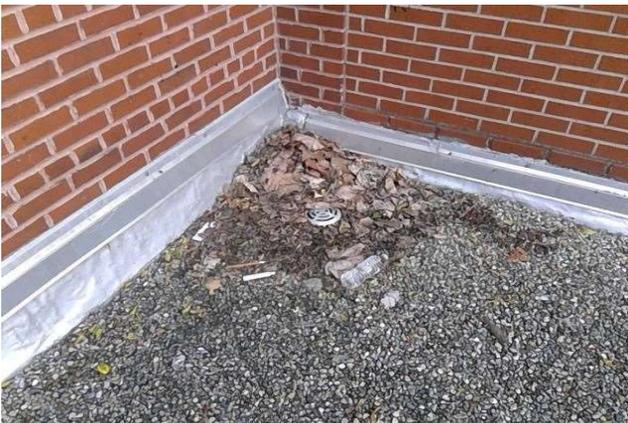
Debris accumulation around roof drain.

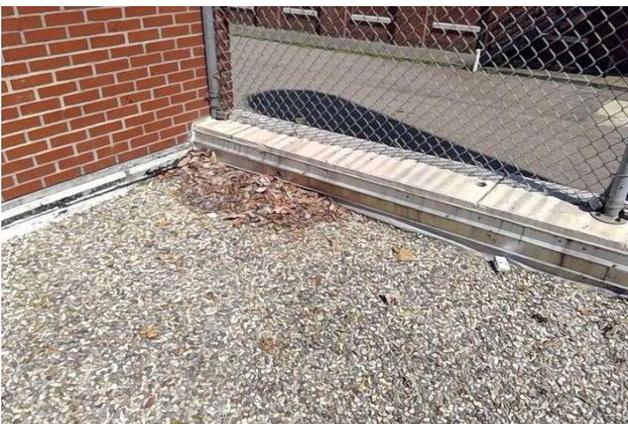
Debris accumulation on roof area.

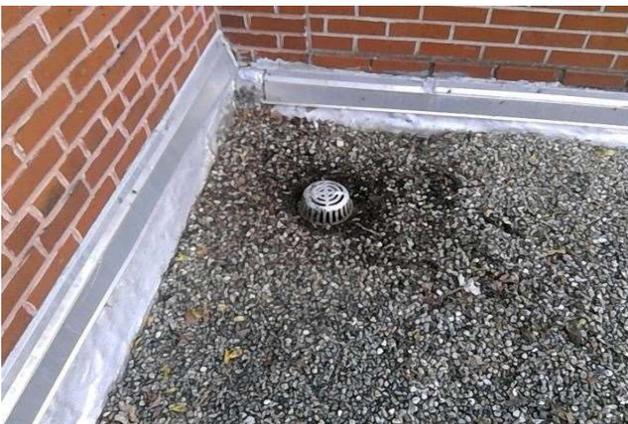
Removed debris from roof and drain.

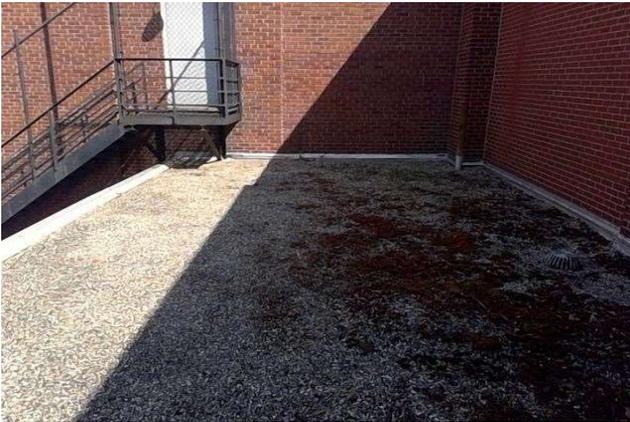
Defect(s)	Magnitude
	Moss	Less than ¾ of roof
	Vegetation	Less than ¼ of roof

Moss growth.

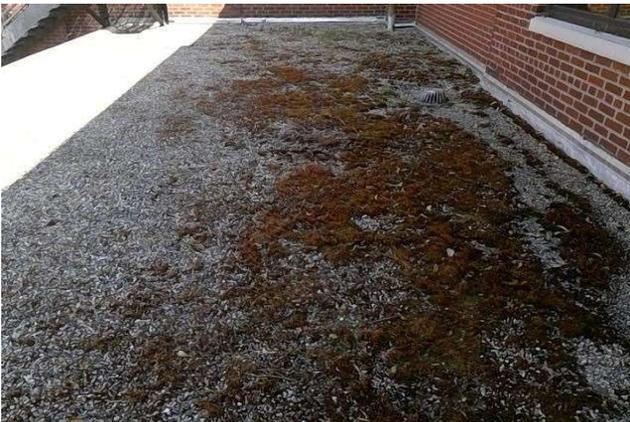
Moss growth.

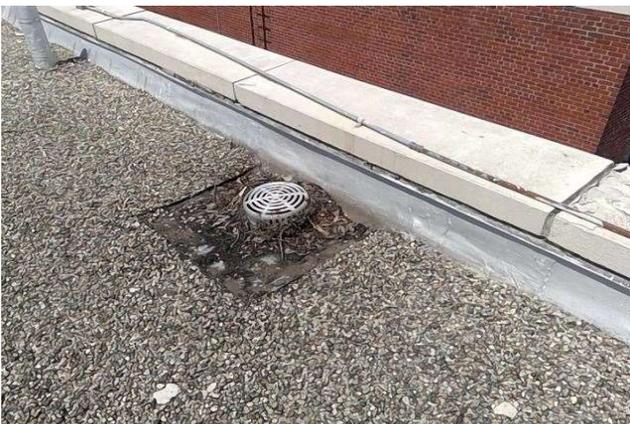
Debris around roof drain.

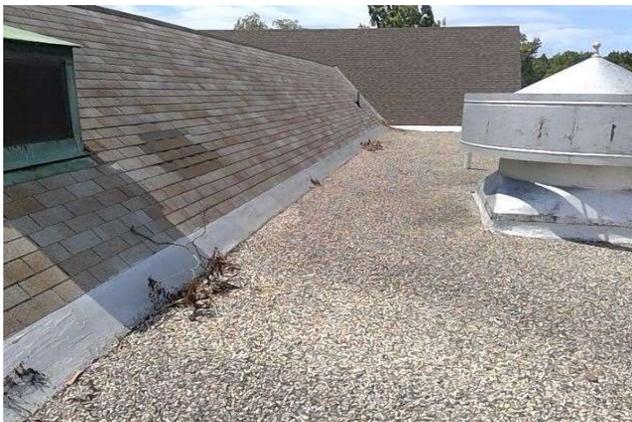
Debris accumulation on roof area.

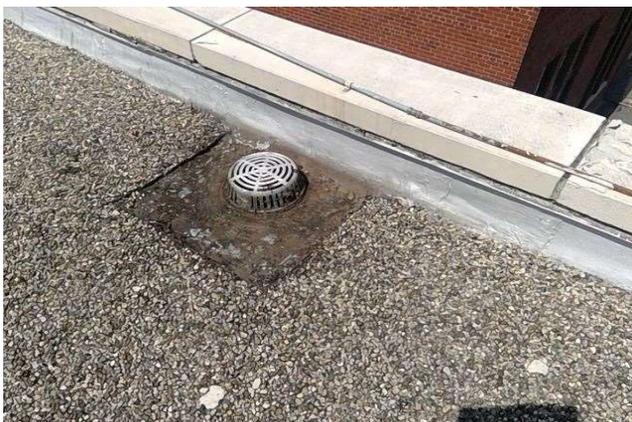
Removed debris from roof and drains.

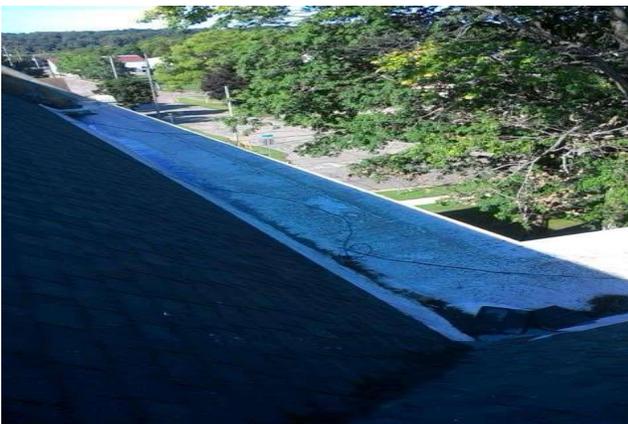
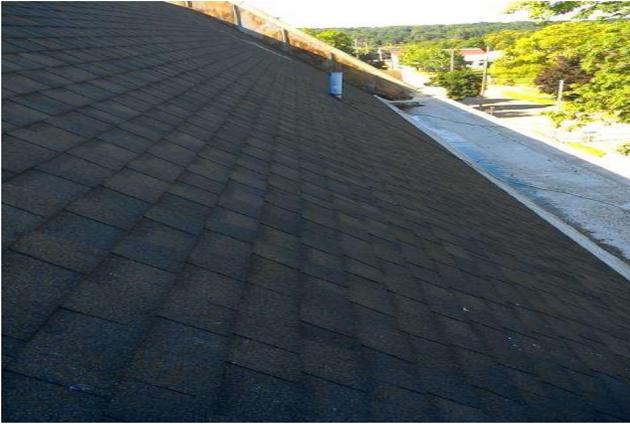
No fall protection.

Work Beyond Scope of Maintenance Agreement (Customer Responsibility)			
Task	Year	Project \$	Task Description
Housekeeping Only	2022		Recommend removing debris from roof and drains.
Perimeter Fall Protection	2022		Recommend installing permanent ladder to safely access roof.
Perimeter Fall Protection	2022		Recommend installing a permanent perimeter fall protection solution.
Repairs Required, Minor	2022		Recommend recoating approximately one square (1 square) of flashing due to coating problems on eastern side of the roof.

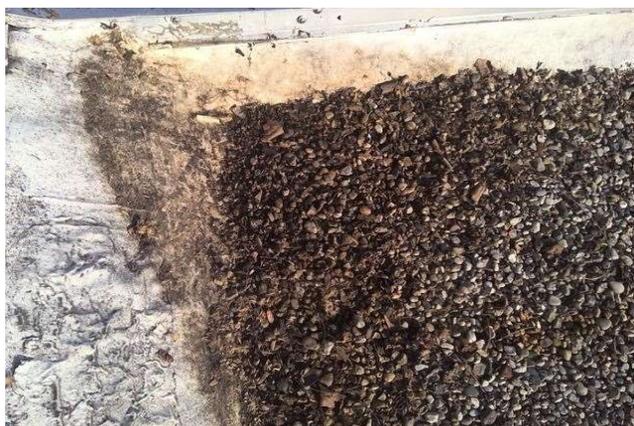
Removed debris.

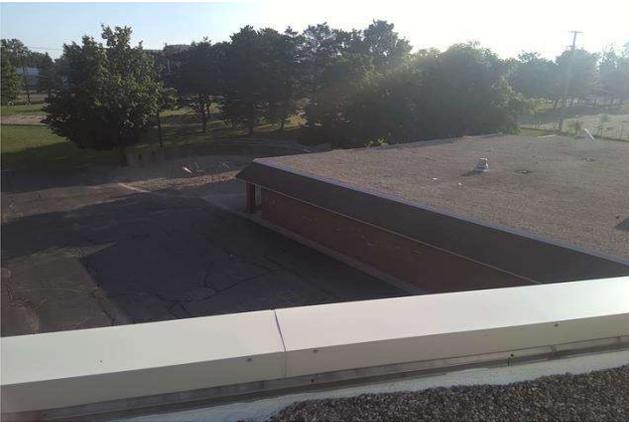
Unprotected edge.

Work Beyond Scope of Maintenance Agreement (Customer Responsibility)			
Task	Year	Project \$	Task Description
Perimeter Fall Protection	2023		Recommend installing a permanent fall protection solution.

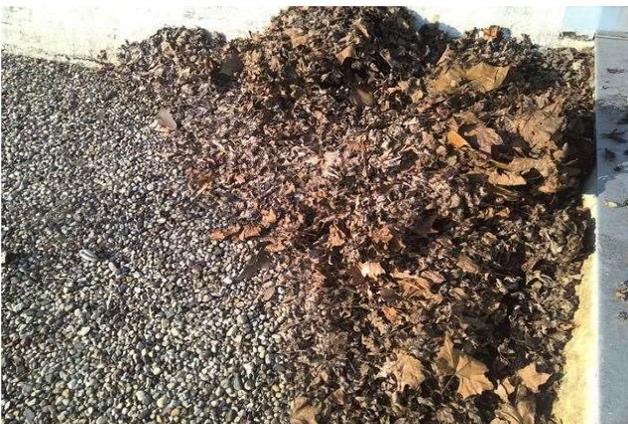
Debris on roof.

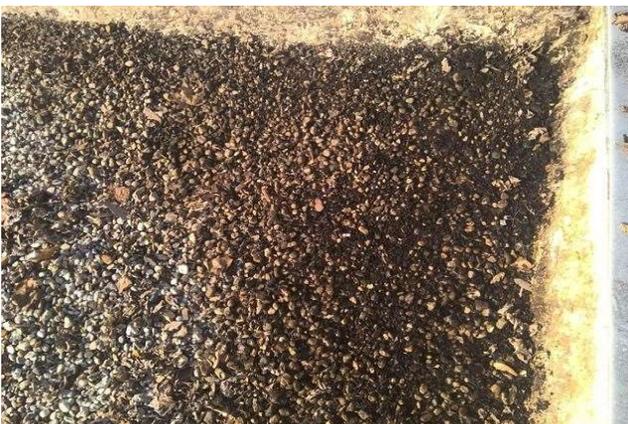
Removed debris.

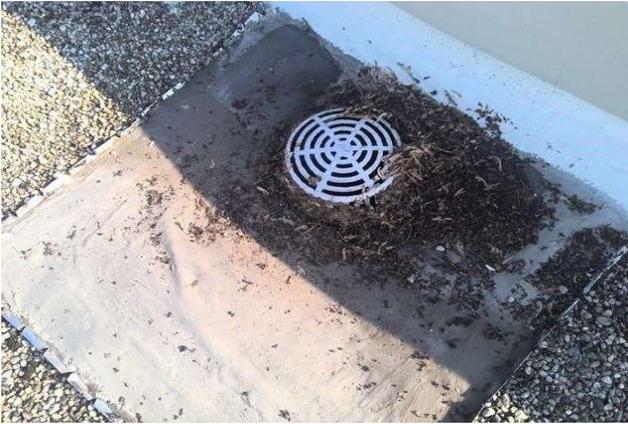
Debris in drain.

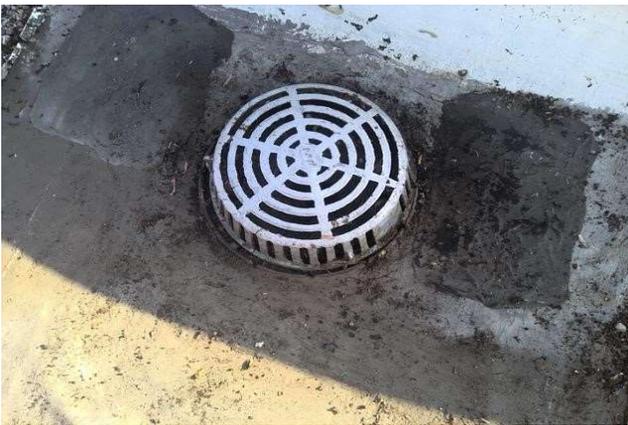
Removed debris.

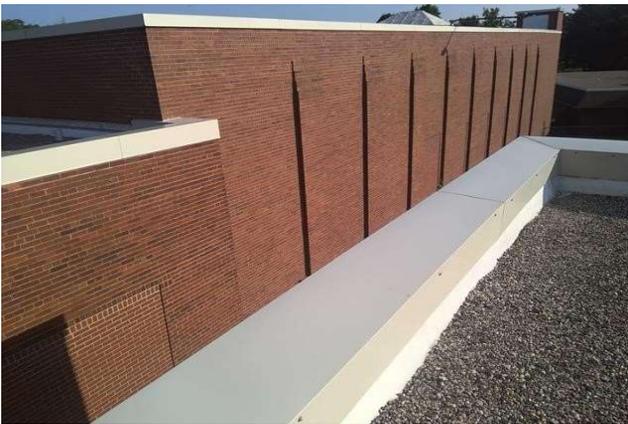
Unprotected edge.

Work Beyond Scope of Maintenance Agreement (Customer Responsibility)			
Task	Year	Project \$	Task Description
Perimeter Fall Protection	2023		Recommend installing a permanent fall protection solution.

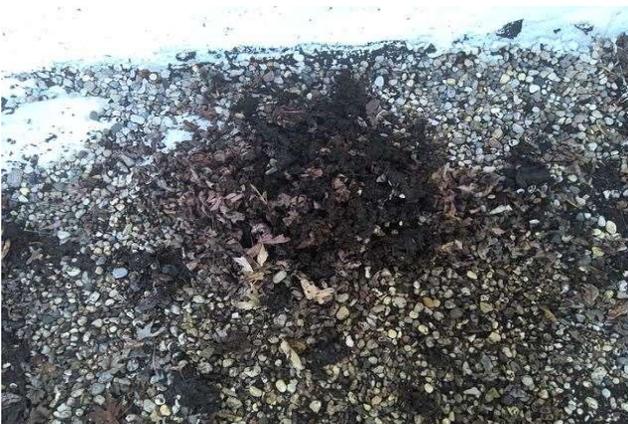
Debris on roof.

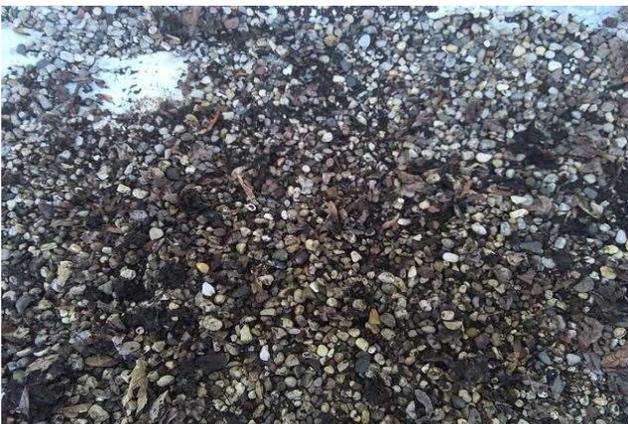
Removed debris.

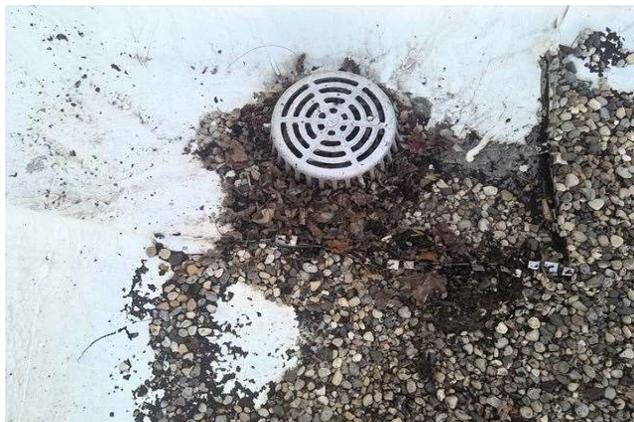
Debris in drain.

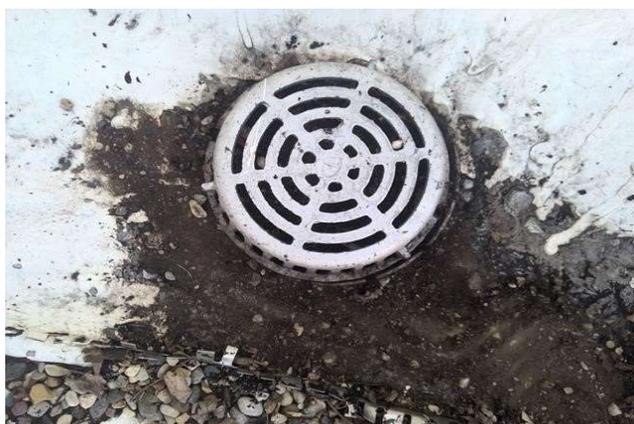
Removed debris.

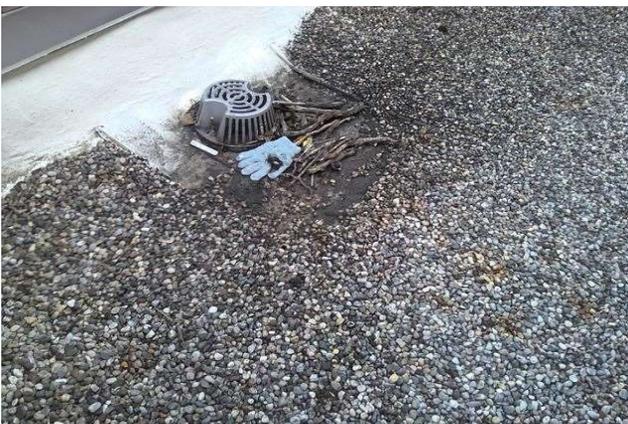
Debris in drain.

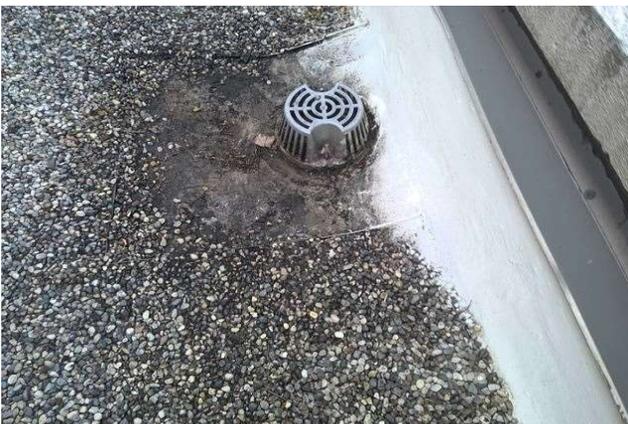
Removed debris.

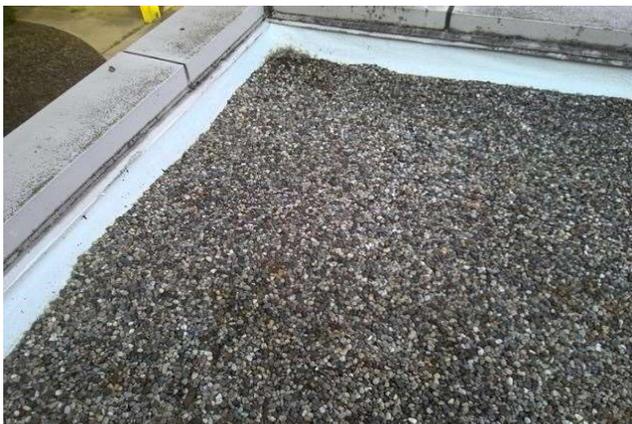
Removed debris.

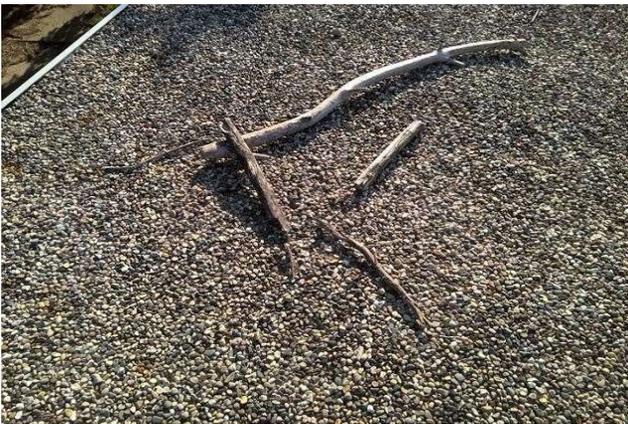
Debris on roof.

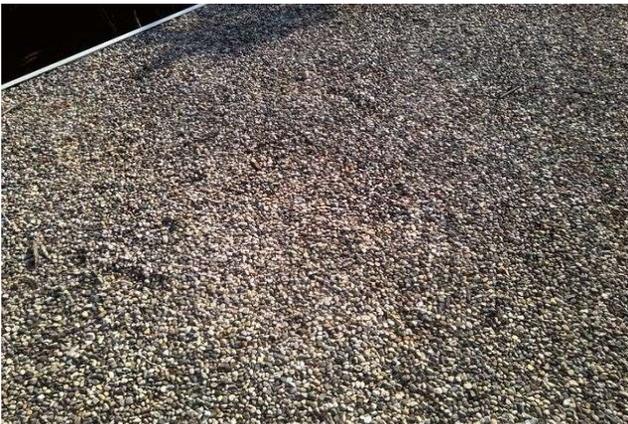
Removed debris.

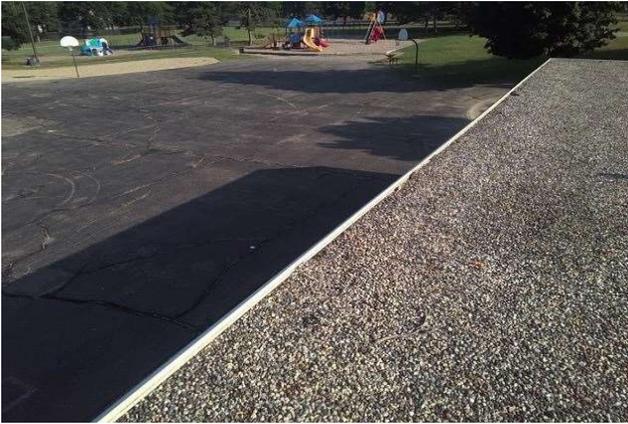
Unprotected edge.

Work Beyond Scope of Maintenance Agreement (Customer Responsibility)			
Task	Year	Project \$	Task Description
Perimeter Fall Protection	2023		Recommend installing a permanent fall protection solution.

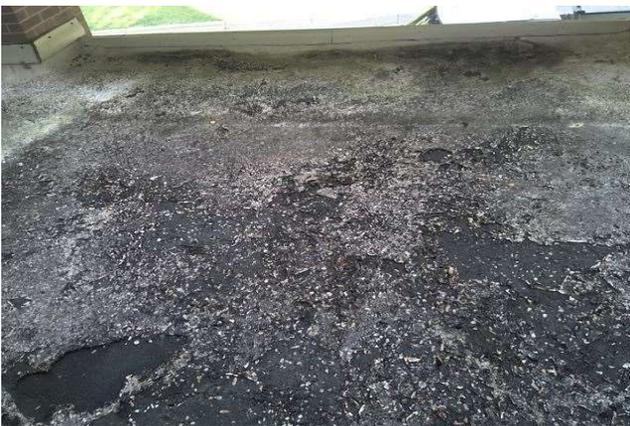
Removed debris.

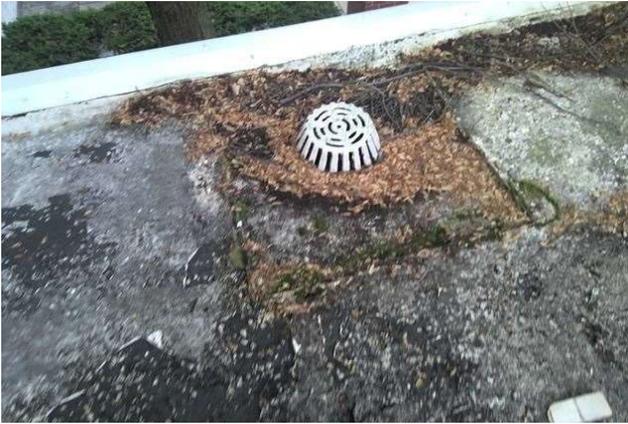
Debris in drain.

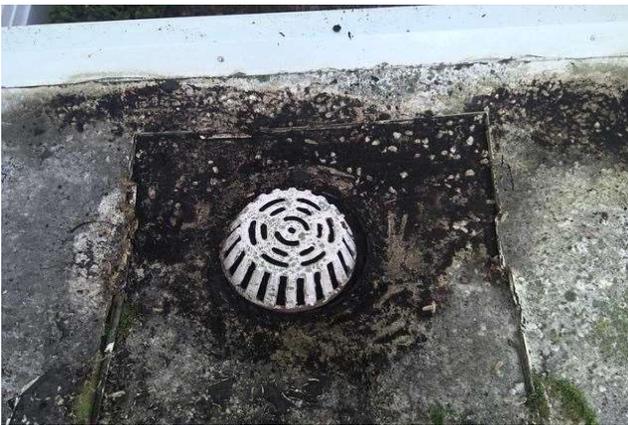
Removed debris.

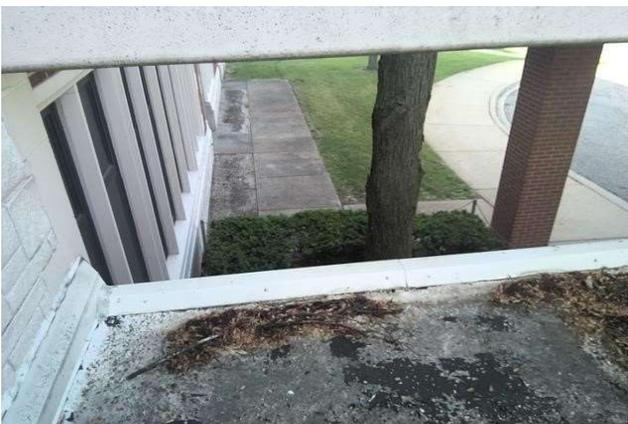
Unprotected edge.

Work Beyond Scope of Maintenance Agreement (Customer Responsibility)			
Task	Year	Project \$	Task Description
Perimeter Fall Protection	2023		Recommend installing a permanent fall protection solution.

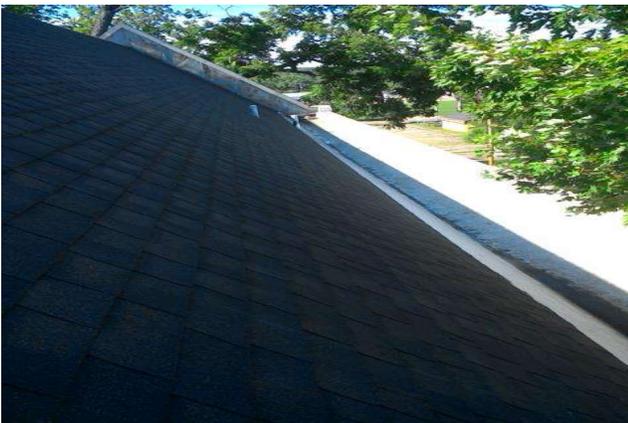
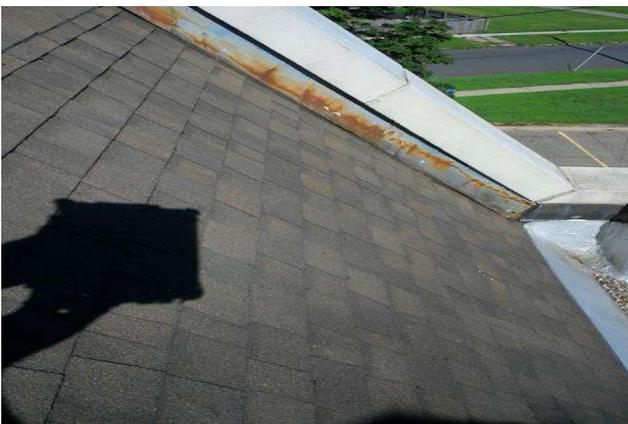
No fall protection.

Work Beyond Scope of Maintenance Agreement (Customer Responsibility)			
Task	Year	Project \$	Task Description
Housekeeping Only	2022		Recommend removing debris from roof and drains.
Perimeter Fall Protection	2022		Recommend installing a permanent perimeter fall protection solution.
Safety Equipment	2022		Recommend installing permanent ladders to safely access roof.
Tree Work	2022		Recommend trimming back tree branches from roof.

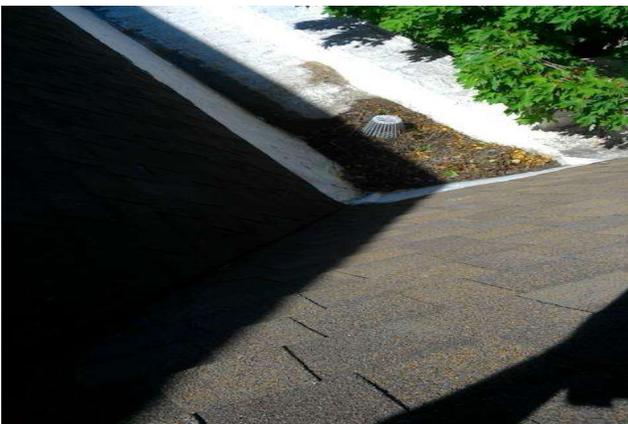
Debris.

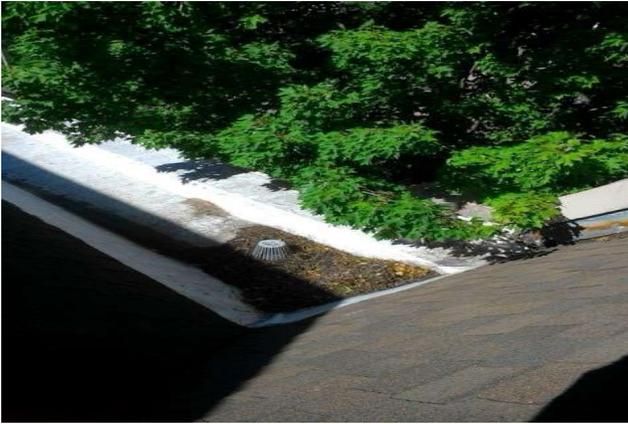
Overhanging trees.

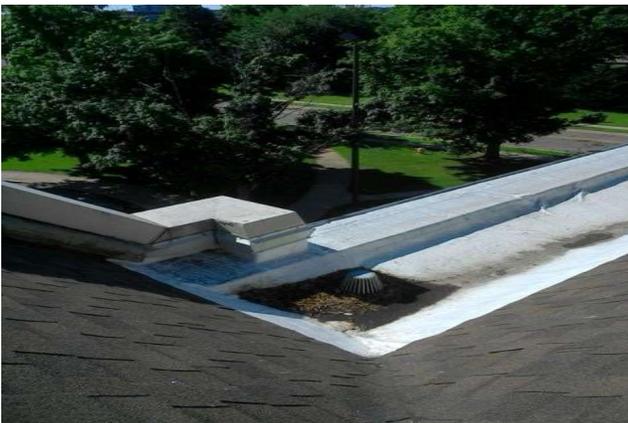
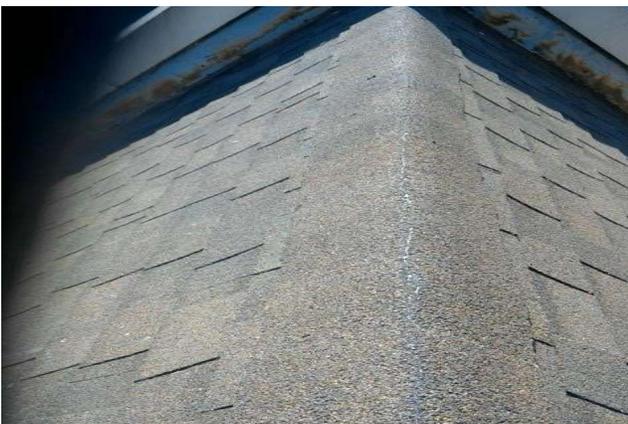
No fall protection.

Work Beyond Scope of Maintenance Agreement (Customer Responsibility)			
Task	Year	Project \$	Task Description
Housekeeping Only	2022		Recommend removing debris from roof and drains.
Perimeter Fall Protection	2022		Recommend installing a permanent perimeter fall protection solution.
Safety Equipment	2022		Recommend installing ladders to safely access roof.

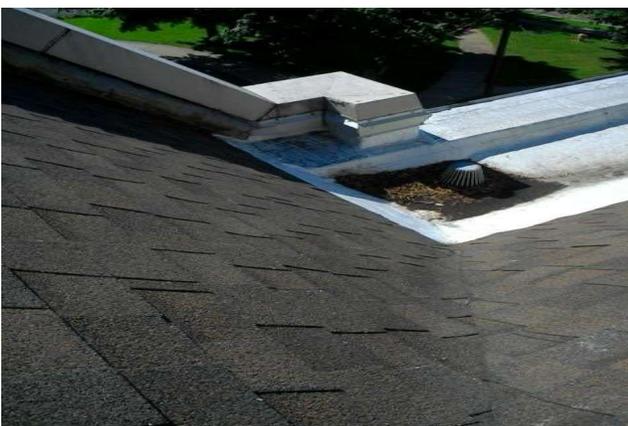
Debris.
